# INDIAN ARCHAEOLOGY 2007-08

## - A REVIEW

# INDIAN ARCHAEOLOGY 2007-08 - A REVIEW

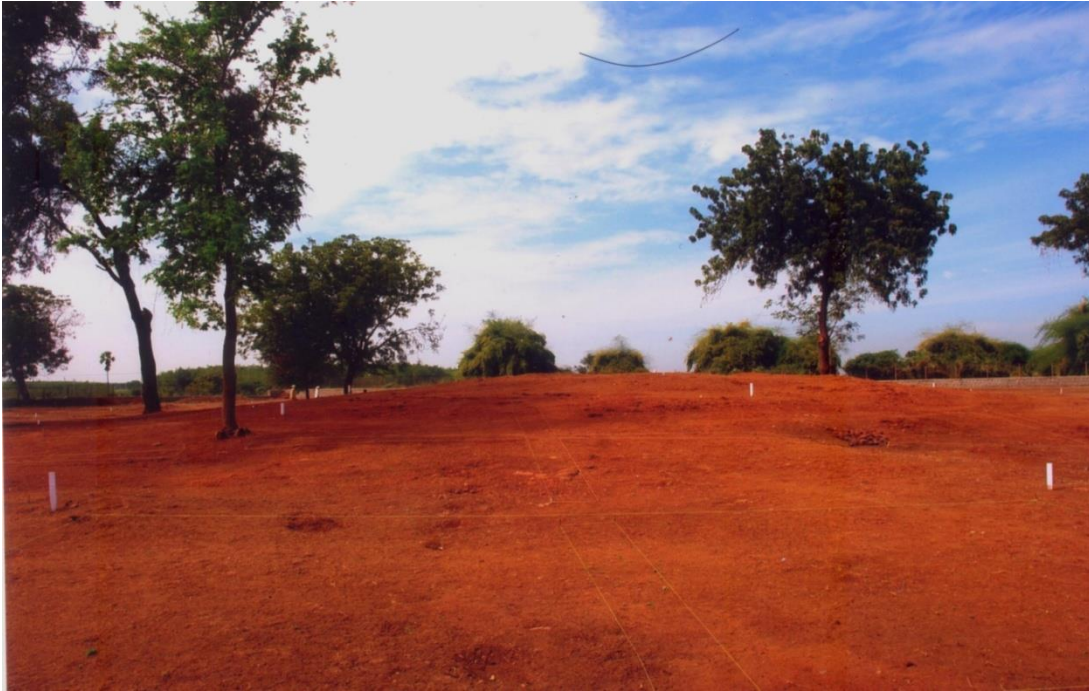
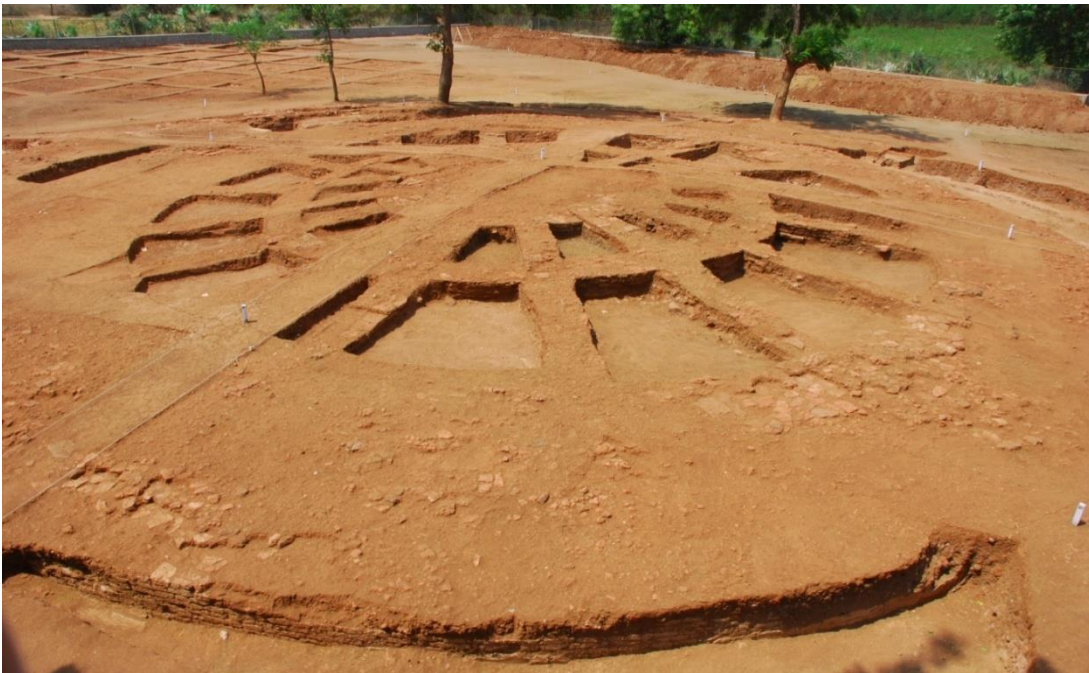
Plate 1

Alluru: A; general view of the site and B; plan of the exposed stupa.

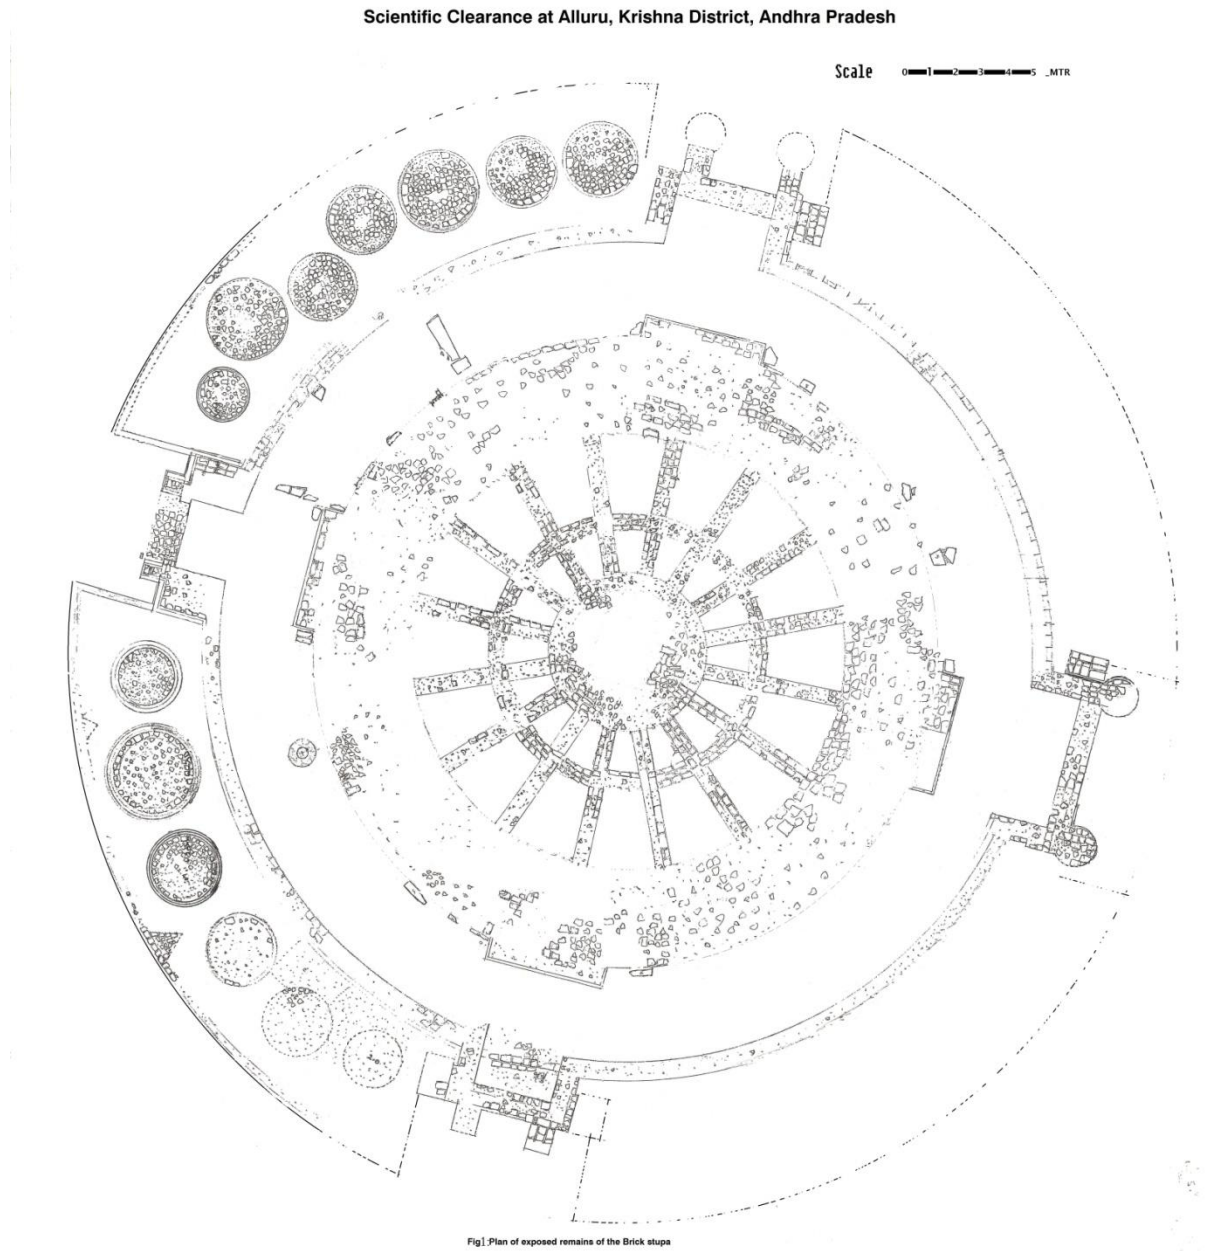
**Fig. 1**

Alluru: Plan of the exposed Brick Stupa.

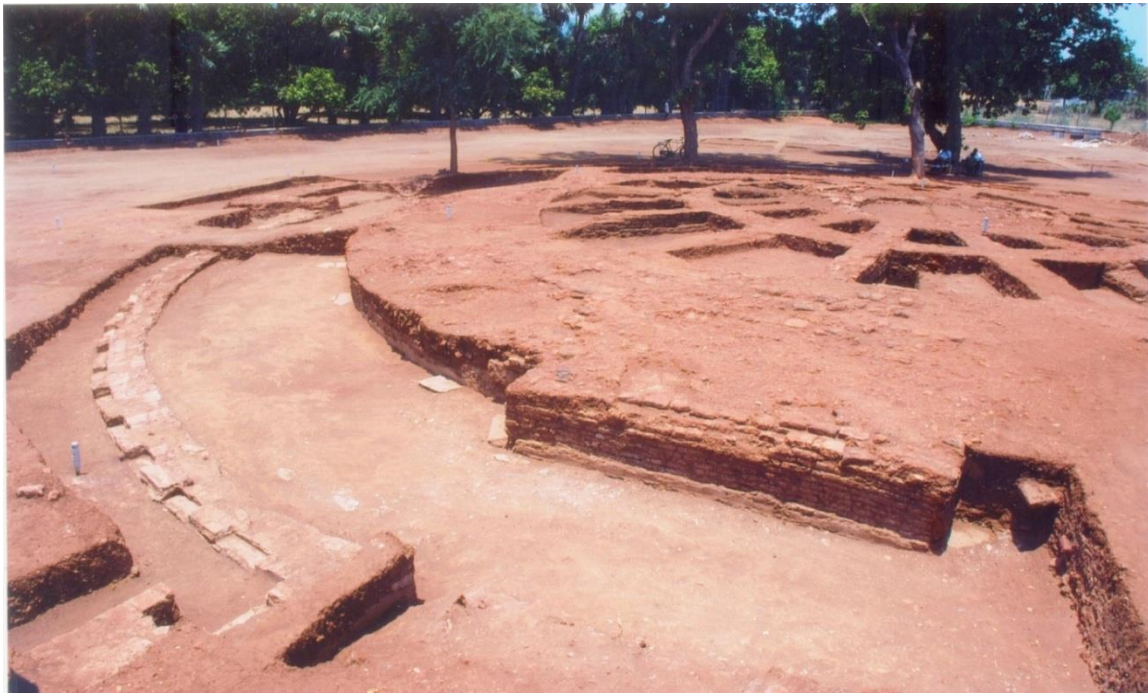
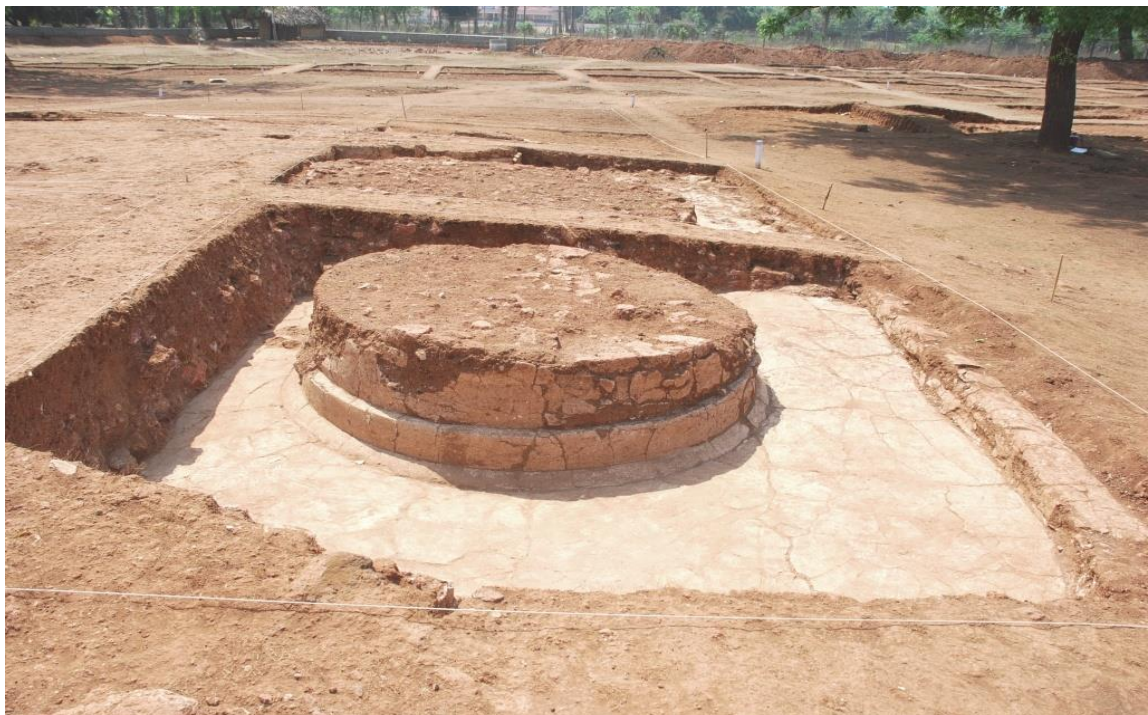
Alluru: A; view showing remains railing and B; remains of the lime plastered brick votive stupas.

and then plastered and the later one (above 90cm) was stone flooring in Kadapa stones. The evidence also suggests that during the 2<sup>nd</sup> phase, the stupa was provided with four lime plastered brick gateways in front of the *ayaka* platforms in the same axis. Further, in place of railing pillars, a brick railing in recessed intervals were provided and lime plastered brick votive stupas were built around the railing (wall?) externally (Pl. 2A). In all remains of 13 votive *stupas* were exposed on the south eastern and south western sides of the *Mahastupa*. All these votive stupas aligned almost parallel to the railing. Of these, 7 are located between the northern and western gates (north western side) and 6 between western and southern gates (southwestern side) of the stupa. Presumably, once, all the sides of the *Mahastupa* were surrounded with votive stupas. Due to quarrying of earth and robbing activities at the site, the evidence of votive *stupas* was damaged and got lost on the north eastern and south eastern sides. All the votive stupas measuring between 1.9m to 3m diameter were invariably built of brick and covered with lime plaster. The floor (about 3m wide) over which these votive stupas were built was also lime plastered (Pl. 2B).

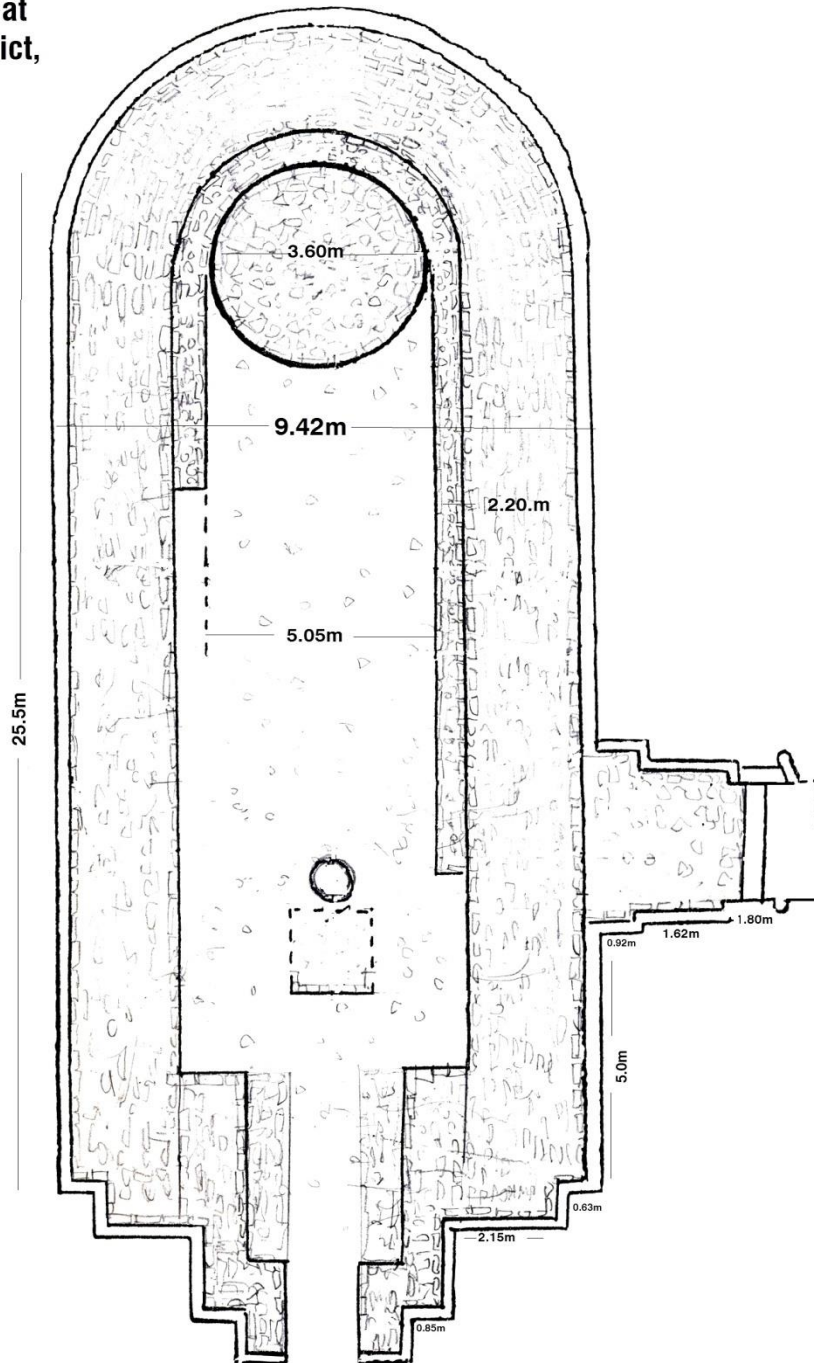
**Fig.2. plan of exposed large brick stupa**

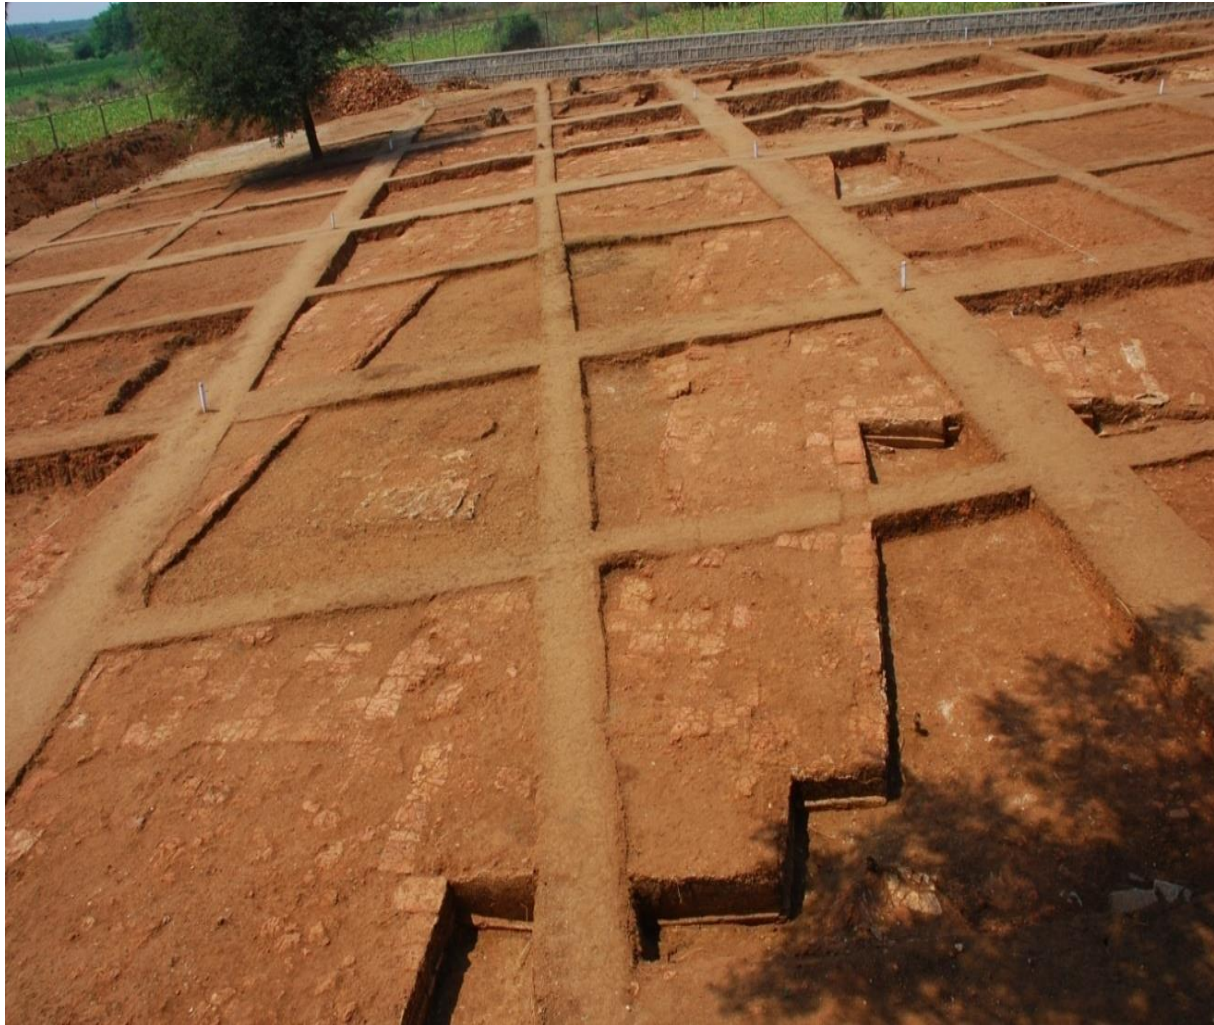
Alluru: remains of large stupa *chaitya* during excavation.

1.9m. Amongst them the larger *chaityagriha* (Chaitya 1) was located on the south western side of the stupa. It was made of brick and apparently lime plastered. The exposed remains consist of the three lowest courses only. Evidently the *chaitya* was lime plastered. The wall thickness of this structure is 2.20m. The main entrance is marked by a four faceted elongated projection on the eastern side and the circular brick platform (of stupa) on the western interior is marked by a circular brick platform/pedestal of 3.6m diameter, and was probably meant for a statue of Buddha. The open interior floor space measures 22m x 5.5m. Another noteworthy feature of this stupa *chaitya* is that it was provided with one more entrance measuring about 4.3m x 3m on the northern side (Fig. 2 & Pl. 3). A feature of such double entrances for a *chaitya* is a rare phenomenon in the Buddhist architecture of known Buddhist sites in Andhra Pradesh and can probably be attributed to the post *stupa* phase. The second *stupa chaitya* (Chaitya 2) remains were exposed on the northern side of the larger *chaitya* located to the west-north-west of the main stupa. This *stupa chaitya* was evidently raised over an earlier *chaitya* on its northern wall. The remains of the earlier *chaitya* was not fully intact and even the full dimensions are not possible to arrive at. However, it measures 24m length and 8.75m width and the thickness of the wall is 2.20m. The *chaityas* are east west oriented with entrance from the east and measures 12.8m x 6.7m (Pl. 4A). Near the boundary wall, on the western side of the stupa were exposed remains of lime plastered

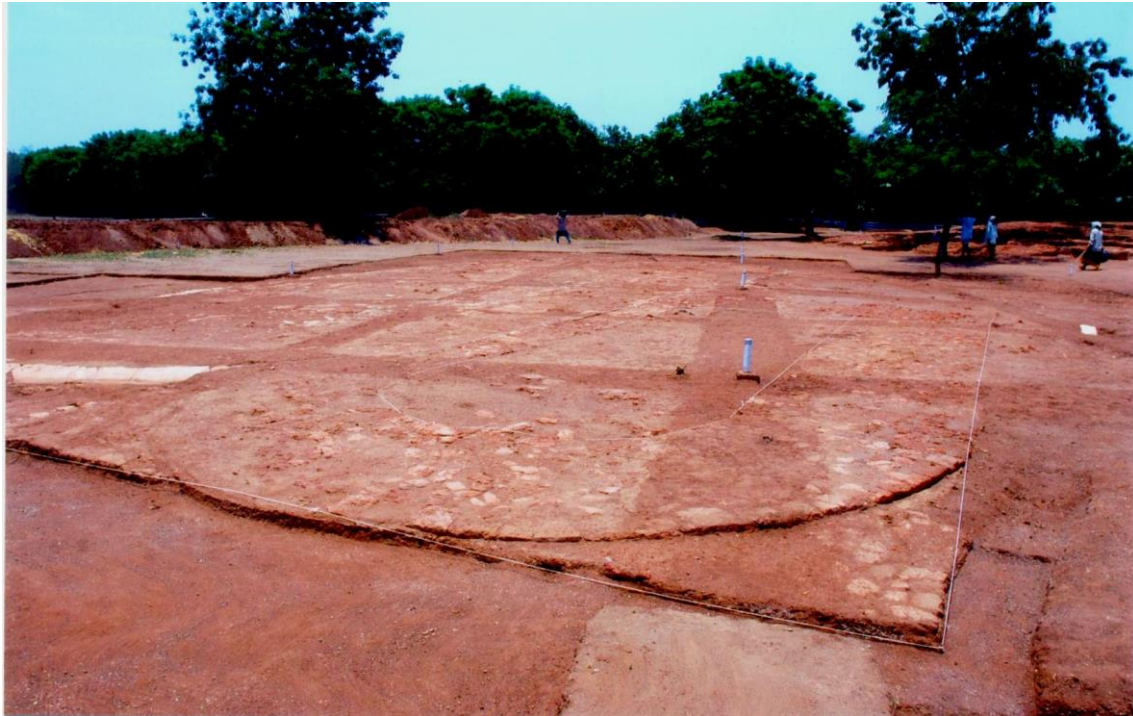
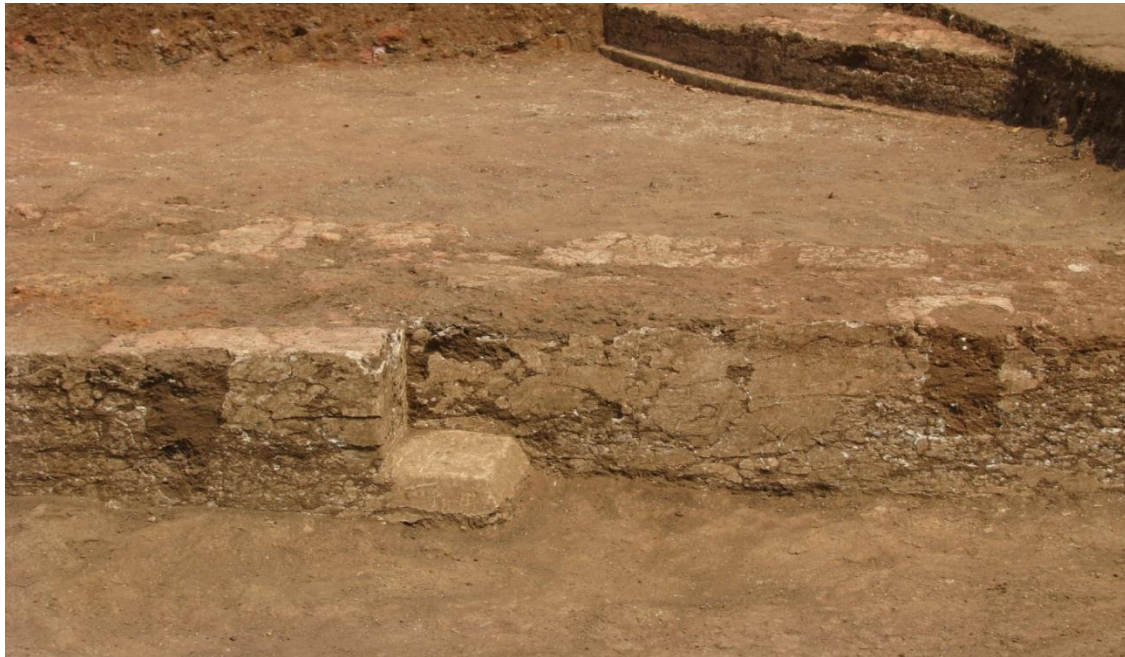
Alluru: A; exposed remains of double *chaityas* and B; plastered brick chambers, western side of the *stupa* and *chaityas*

brick monastic cells and other structures. Evidence of post holes was also noticed in the structural activity of brick chambers (Pl. 4B). The other important finds include fragments of stone pillars, red ware pottery of medium to coarse fabric that includes a huge storage jar with stamped decoration exposed insitu in the *pradakshinapatha* area of the stupa (Pl. 5A). The shapes met with include vase, *handi* and spouted vessels and few beads, besides substantial numismatic evidence pertaining to Satavahana and post Satavahana periods. The surface evidence including numismatic (Pl. 5B) also indicates the different phases of the Buddhist establishment at the site and also that Buddhism had received prolonged patronage.

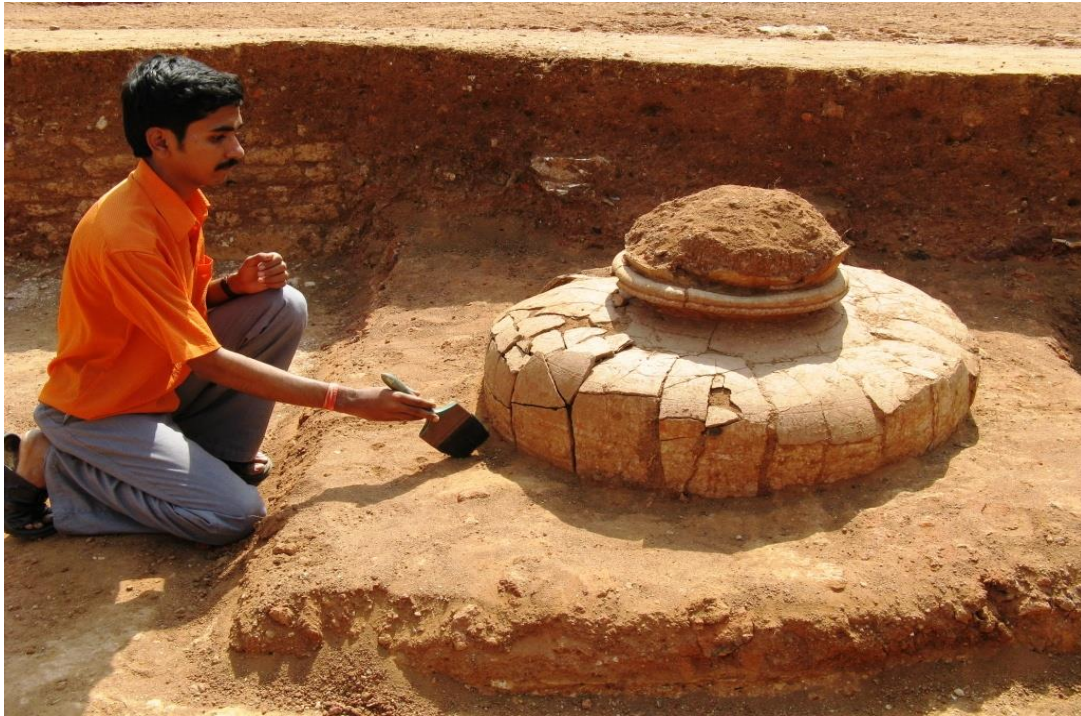
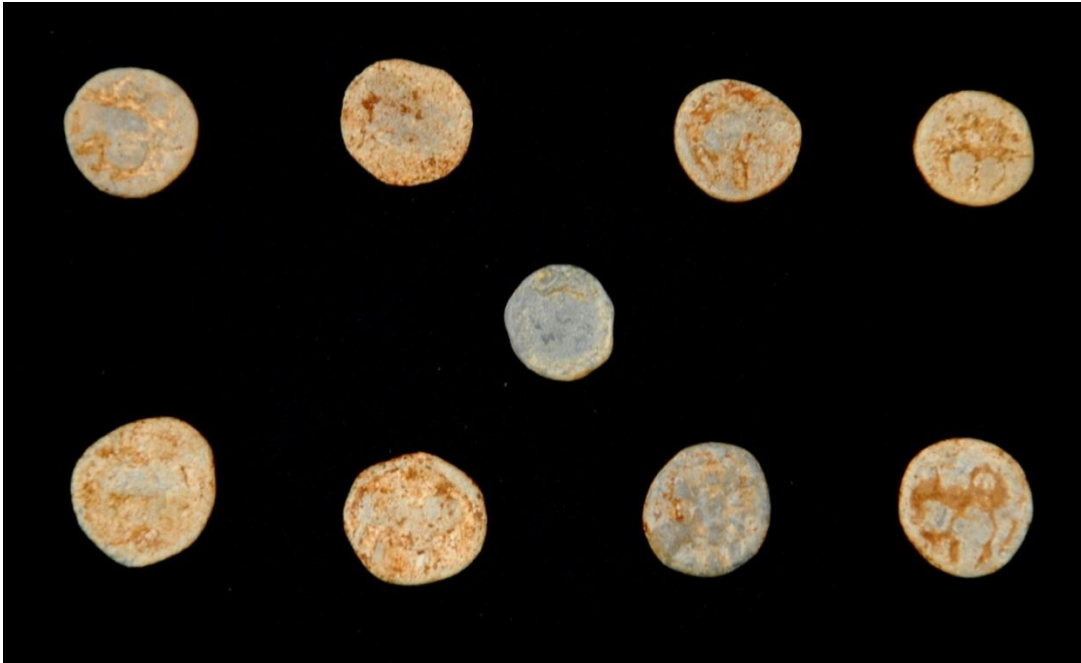
Plate 5

Alluru: A; close view of the storage jar and B; lead coins of Satavahana and post Satavahana period

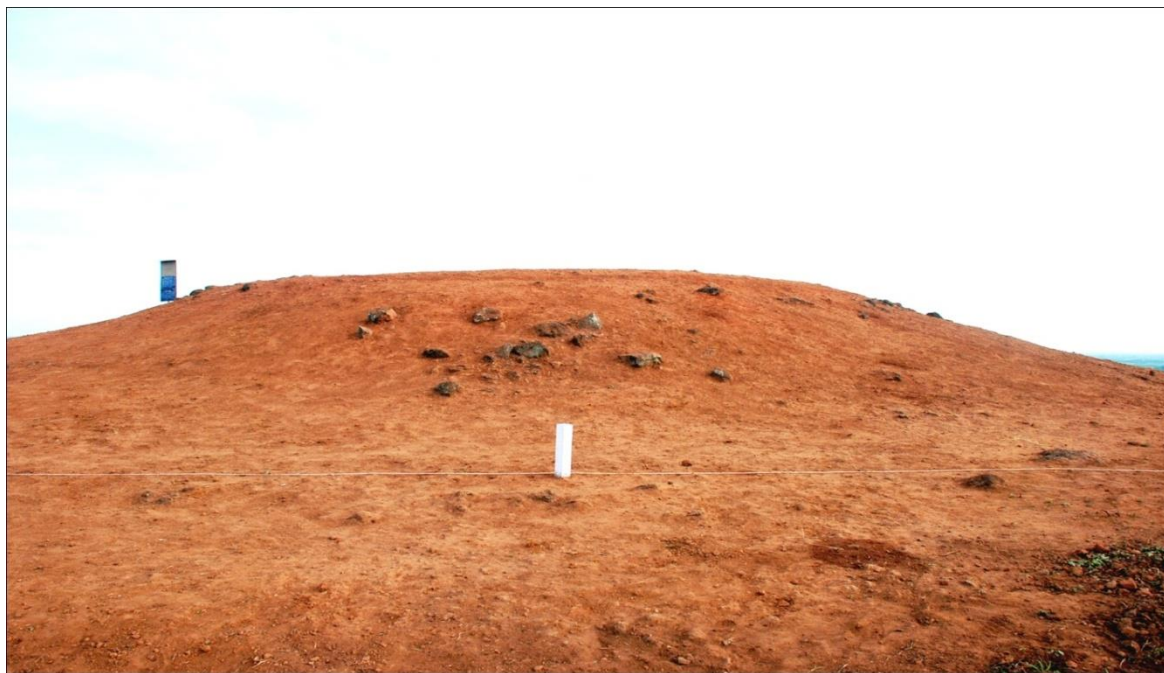
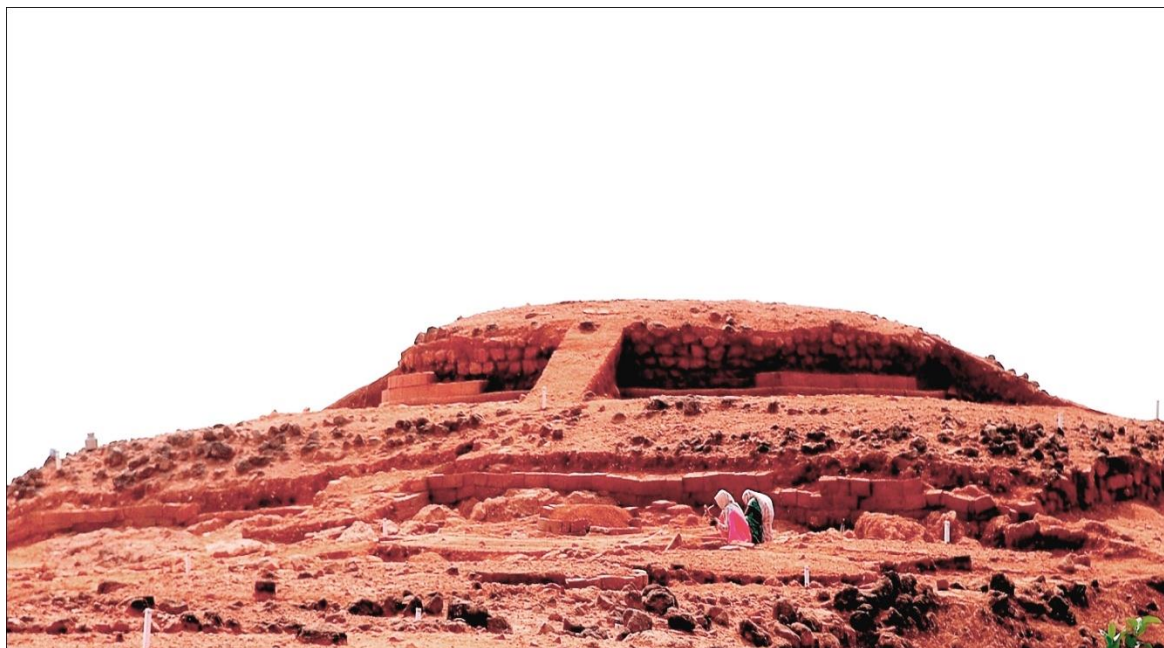
Kodavali: A; general view of *stupa* and B; exposed remains of *stupa* and large square platform.

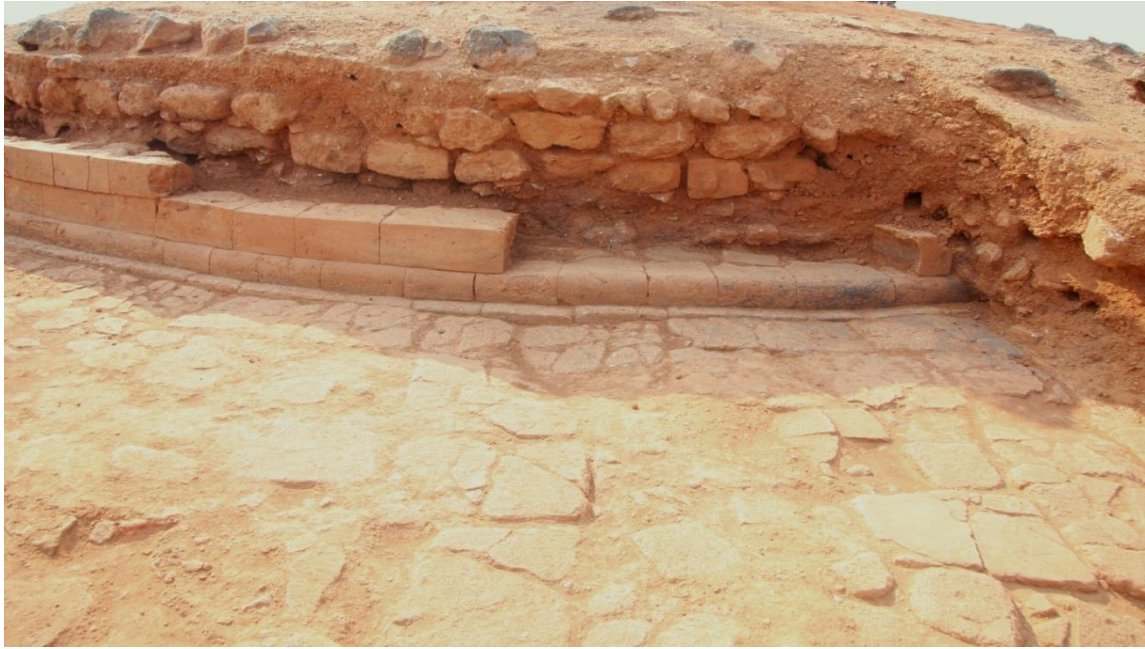
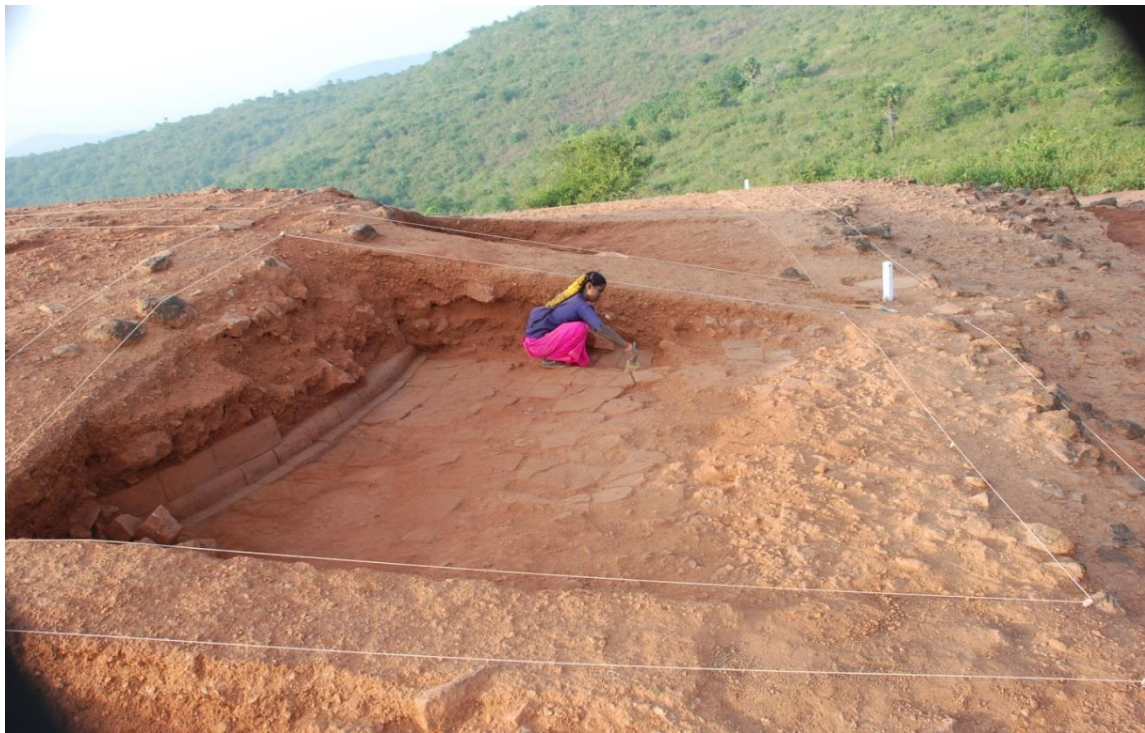
Plate 7

Kodavali: A-B; close view of the exposed dressed stone pavement around the *stupa*

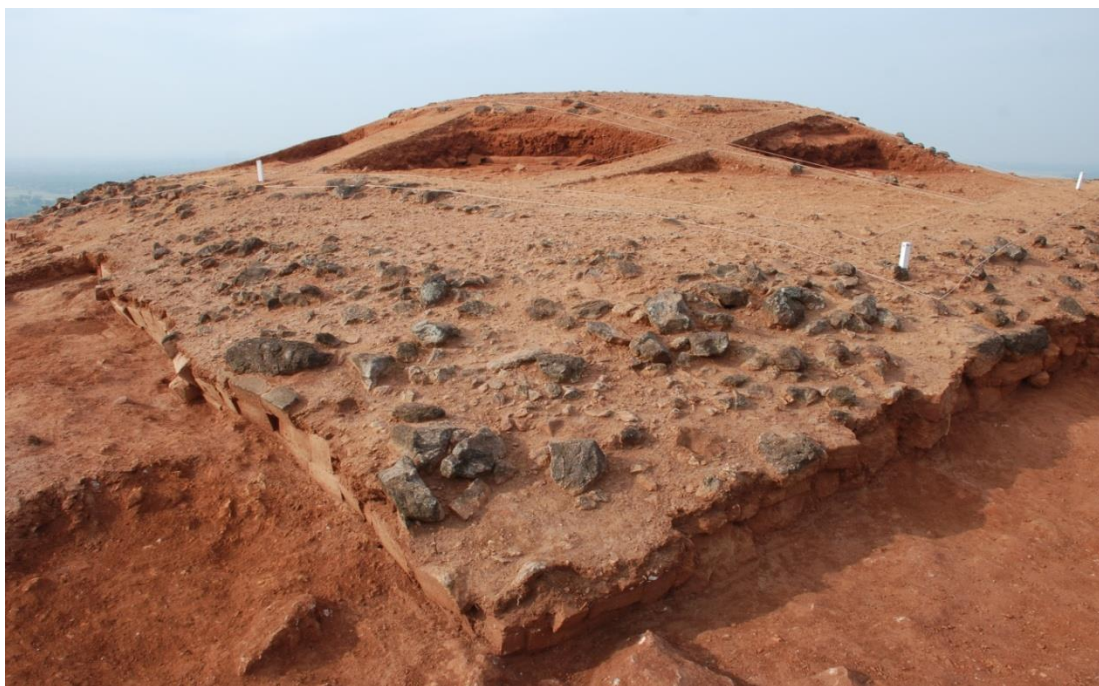
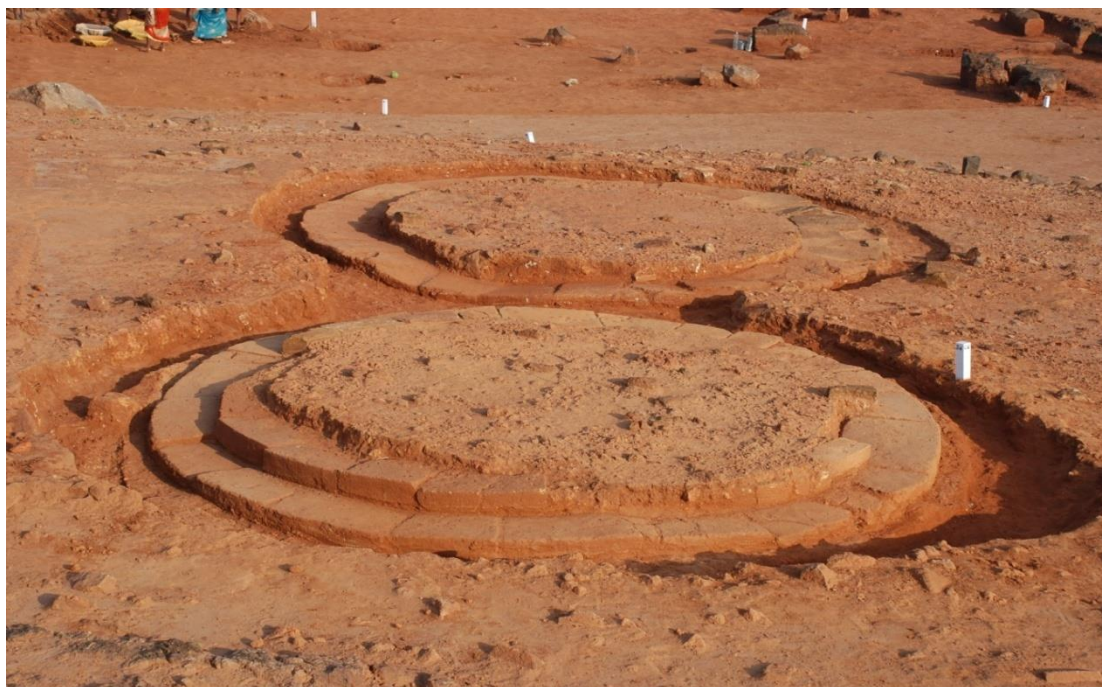
Kodavali: A; close view of exposed remains of square stone platform and B; votive *stupa*.

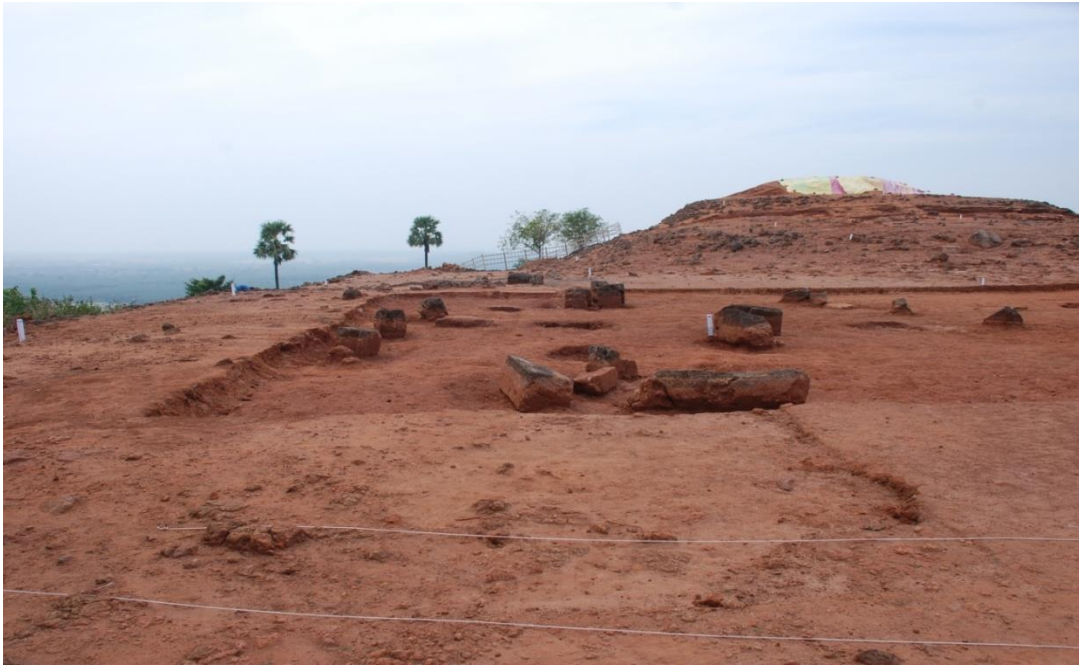
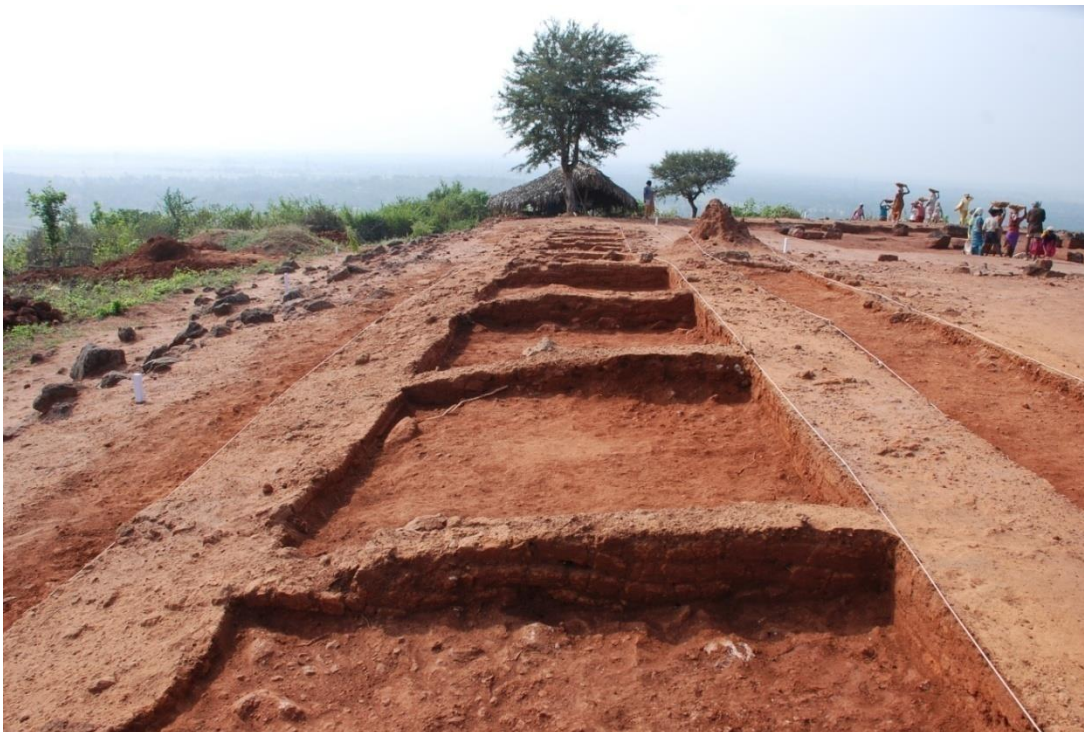
Kodavali: A; close view of exposed remains of pillared hall and B; brick monastic cells on the eastern side of the site.

traces of the monastic cells (numbering about 13) measure about 40m in length. The site is completely vandalized (Pl. 9B). Some fragments of stone caskets, stone fragments of *chhatra* (umbrella) and other structural fragments indicate the amount of vandalism and damage done to this Buddhist establishment (Pl. 10). Red ware fragments mostly of bowls, vases and carinated *handi* shapes in medium fabric were found. A small stone fragment having a label inscription of four and half *Brahmi* characters datable to circa 2<sup>nd</sup> century CE was found at the site.

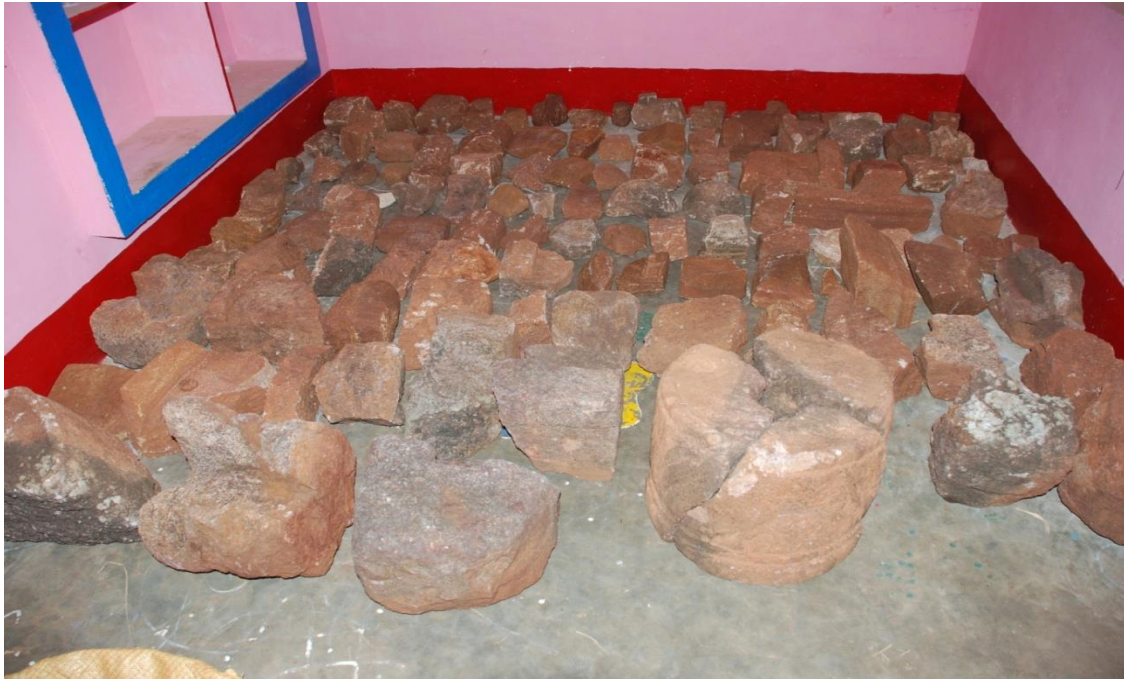
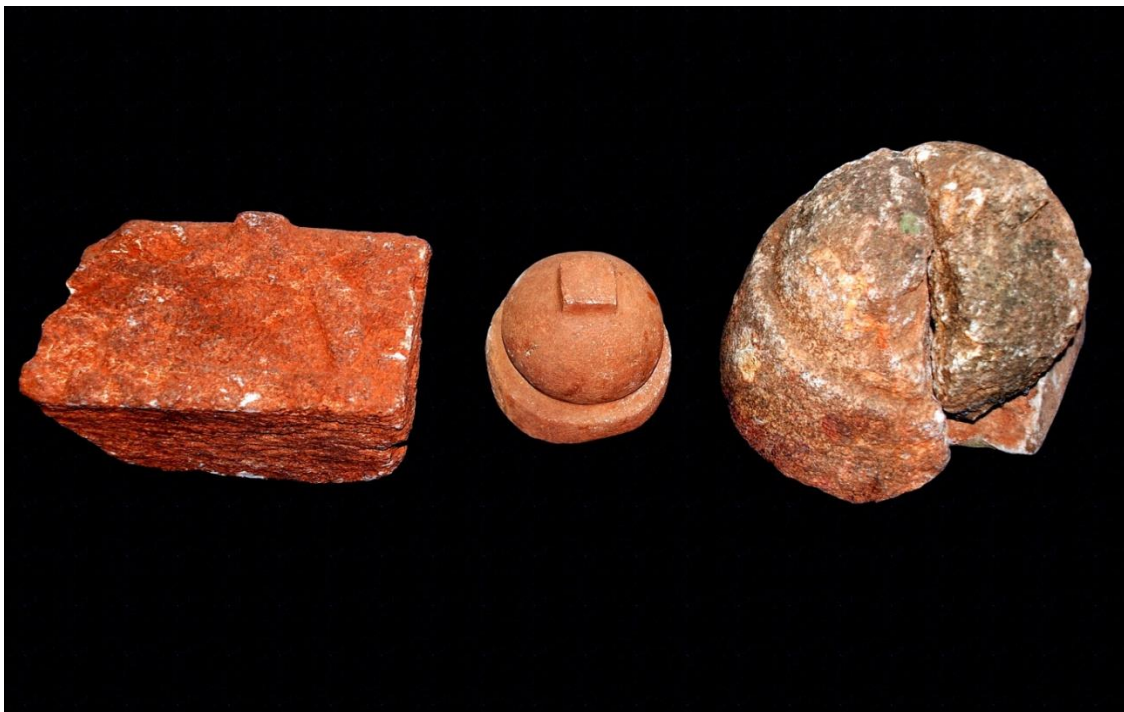
Plate 10

Kodavali: A-B; fragments of stone caskets.

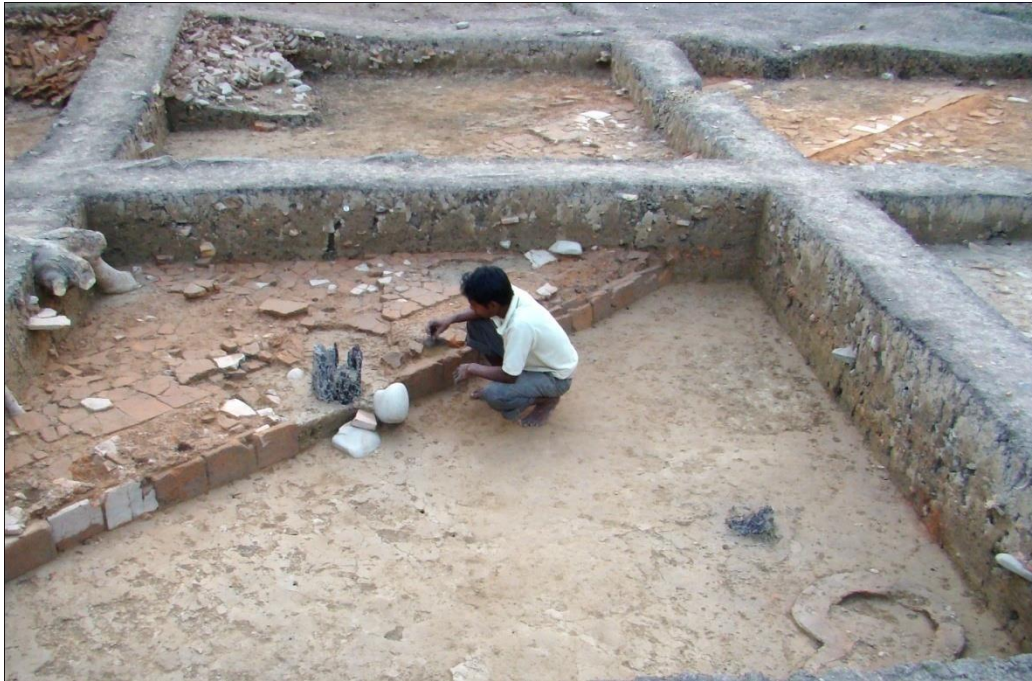
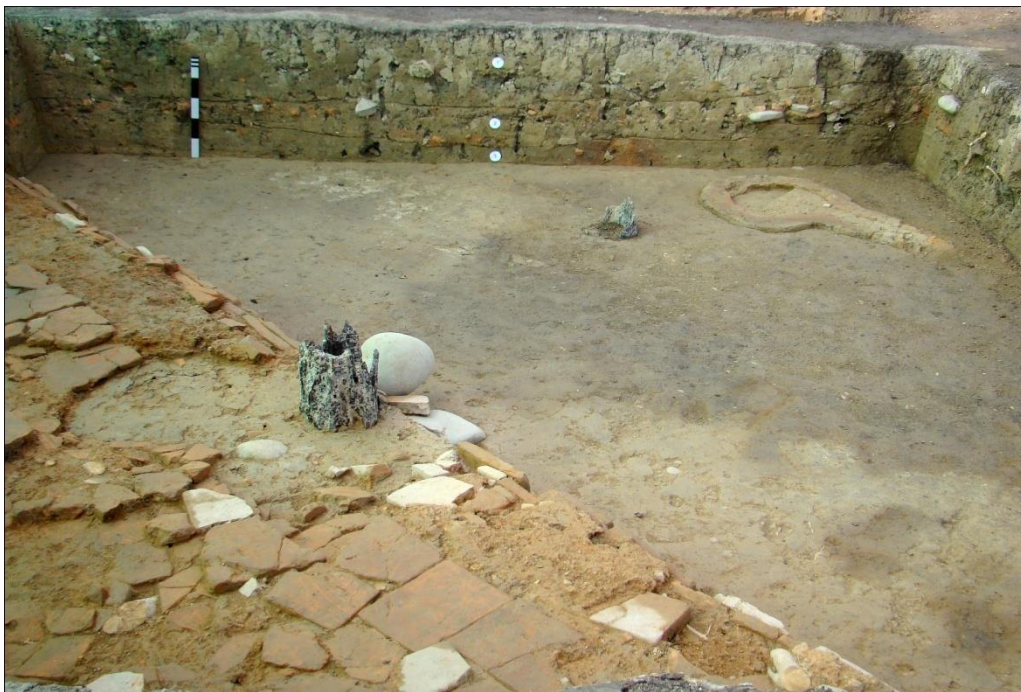
Garhgaon Raja's palace: A; exposed trenches and B; brick structure and wooden post.

During the course of excavation a huge burnt brick wall running in north-south orientation was partially exposed. Only the foundation of the structure is found and is contemporary to layer 2. The exposed structure measures 11.75m in length and 2.65m in width. The structure is mainly made of brickbats and is supported on both sides by bricks-on-edge (26 x 21.5 x 3cm). The width of the middle portion of the structure is 1.90m and in between this

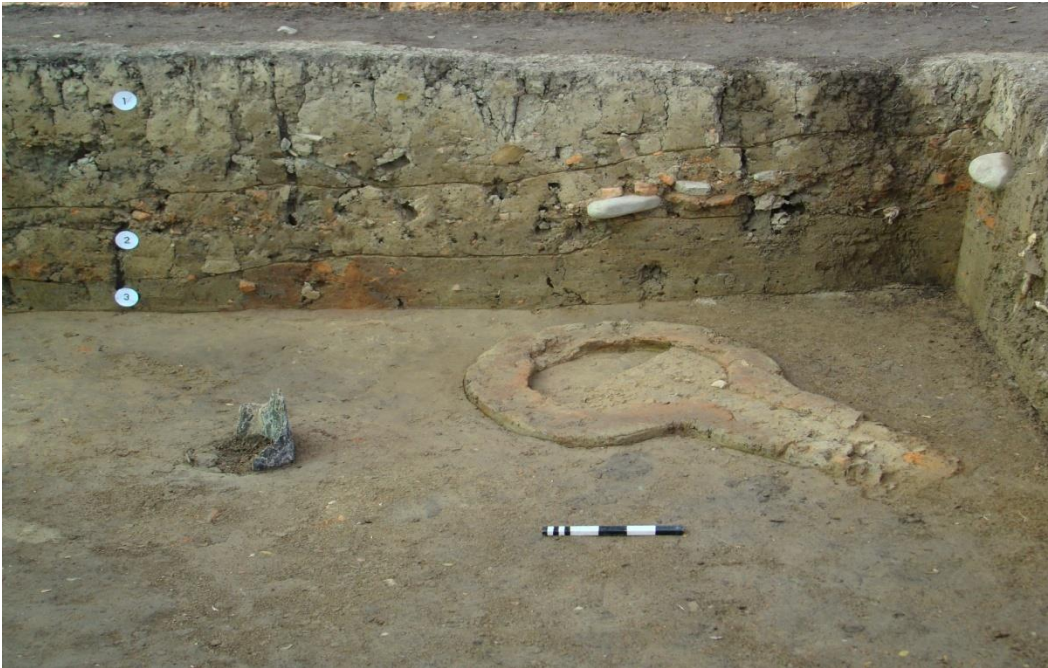
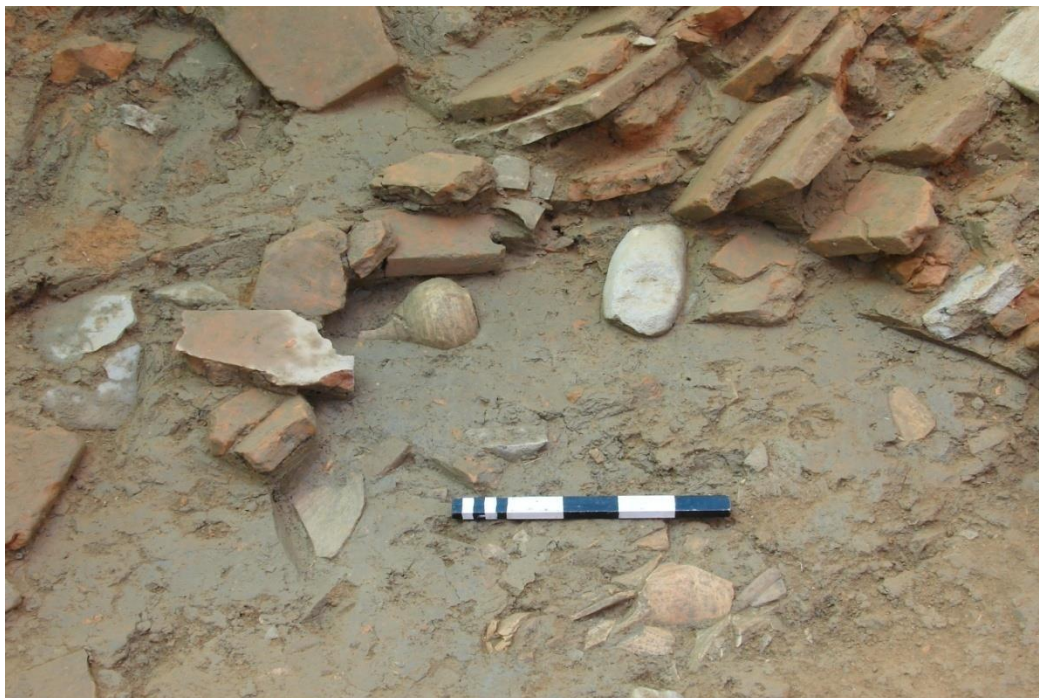
Plate 12

Garhgaon Raja's palace: A; exposed wooden post and hearth and B; in-situ pots.

A circular hearth with elongated mouth has been exposed, which is sealed by layer 2 and is contemporaneous to layer 3. The hearth measures 90cm in length, 65cm in width with an inner space of 40cm. The arm of the hearth measures 14cm in width. Evidence of lime floor is also found in patches.
