# INDIAN ARCHAEOLOGY 2007-08

## - A REVIEW

# INDIAN ARCHAEOLOGY 2007-08 - A REVIEW

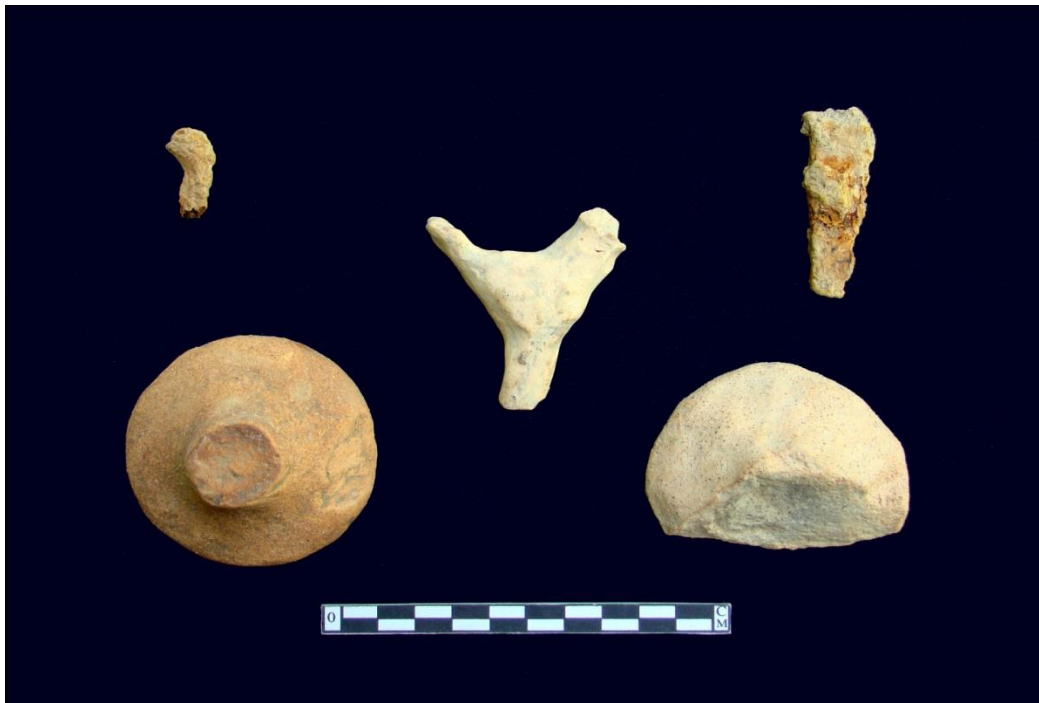
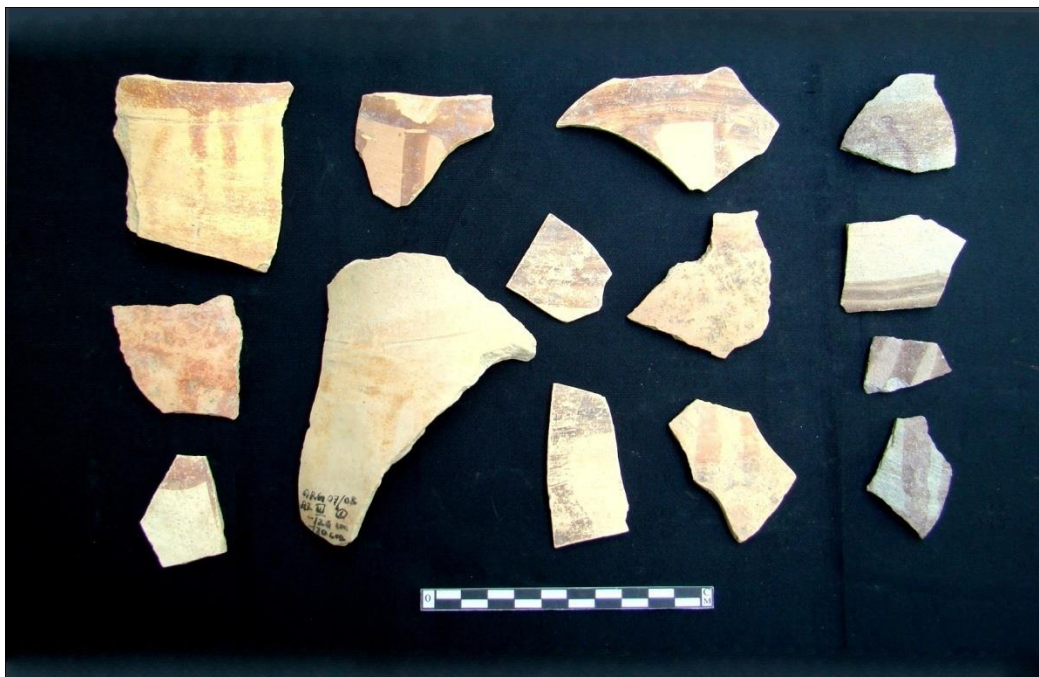
Garhgaon Raja's palace: A; antiquities and B; painted pot-sherds.

devoid of any metallic sound. Few sherds are found to be painted in chocolate colour. The paintings are executed on the surface and are represented by combination of horizontal bands and short vertical lines or strokes. The pigment used is maroonish chocolate. From the shapes of the pottery it can be presumed that the painted as well as plain wares were meant for common household use. All the three layers yielded bowls with footed discular flat base, externally pointed and internally grooved, splayed and featureless rim, vases with high and corrugated splayed neck. Layers 1 and 2 had lids with conical short and domed knob and spouted pots having conical spouts. While in layer 1 the smoking pipes were of medium fabric it was of fine fabric in layer 2. In addition layer 2 yielded jars of different sizes and drain pipe of red ware and medium fabric.

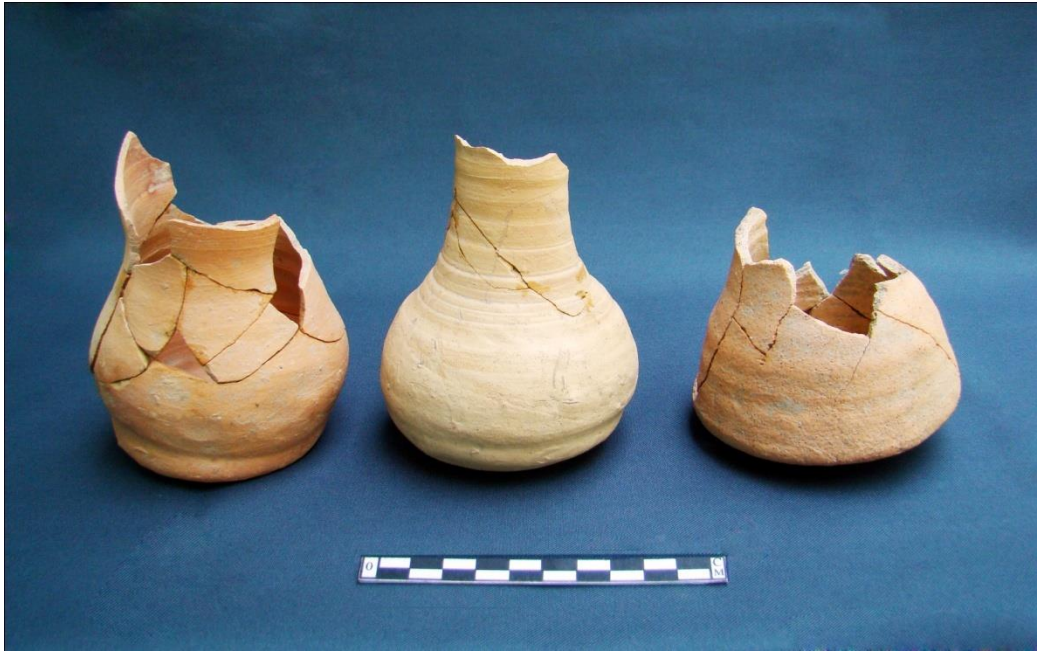
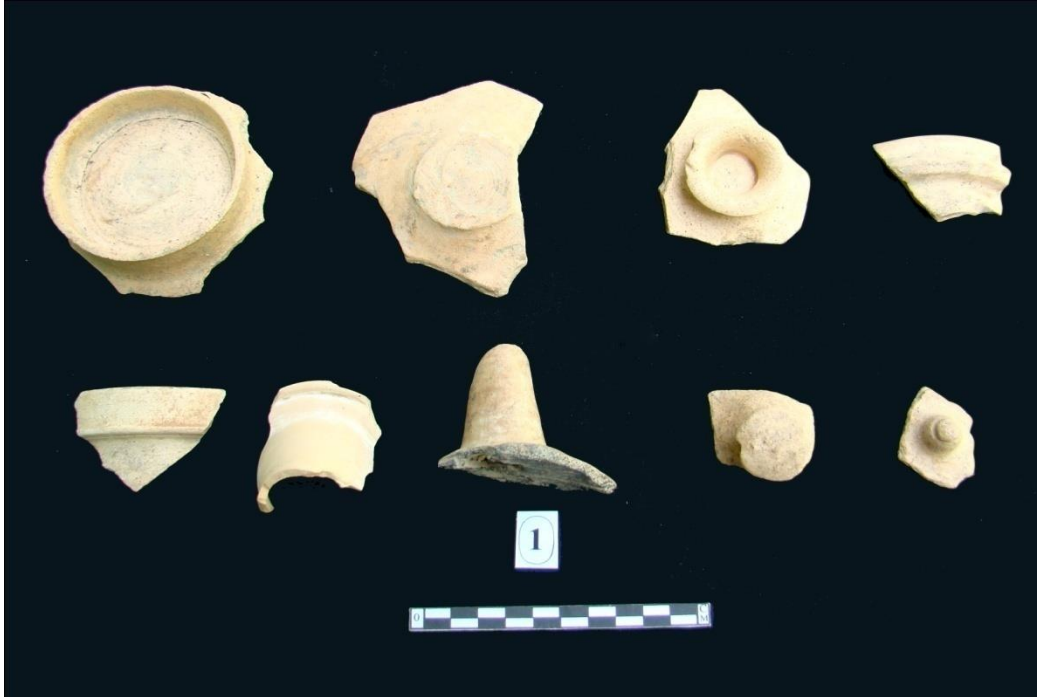
Plate 14

Garhgaon Raja's palace: A-B; Pottery.

The ceramic industry of the site is dominated by red ware, buffish red ware and few grey wares, which is available in medium and coarse fabrics and is occasionally applied with slip. All the potteries are found to be wheel-turned, though quite a percentage of hand made potteries is also found. The clay is not well levigated and contains small particles. The texture of the pottery varies from fine to coarse and the fabric varies from medium to thick. All the potteries are well fired but

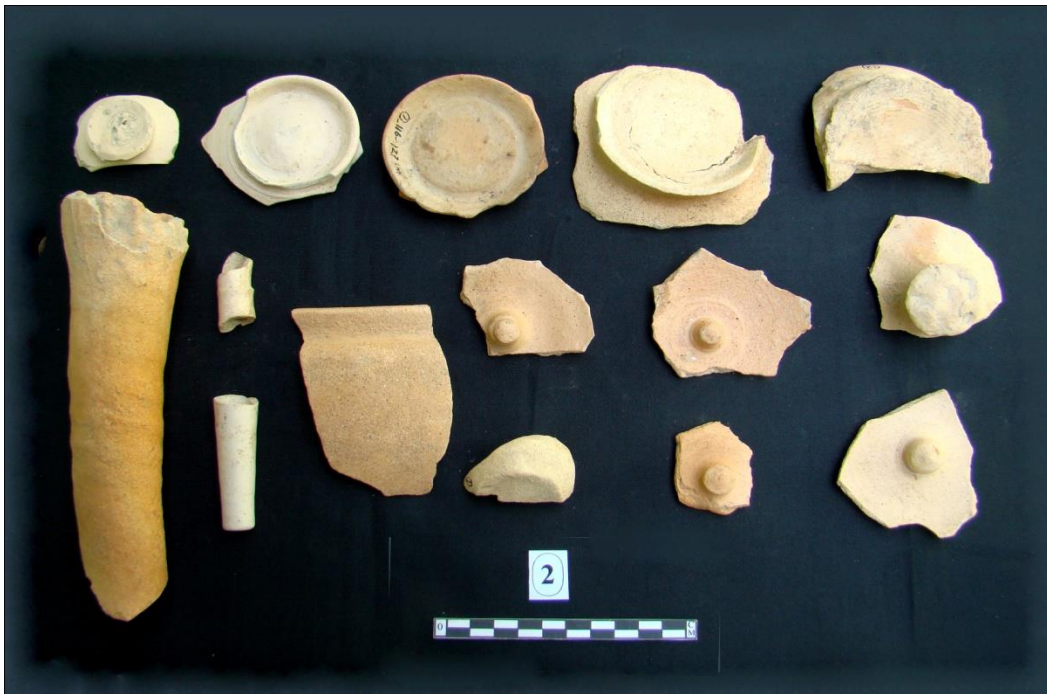
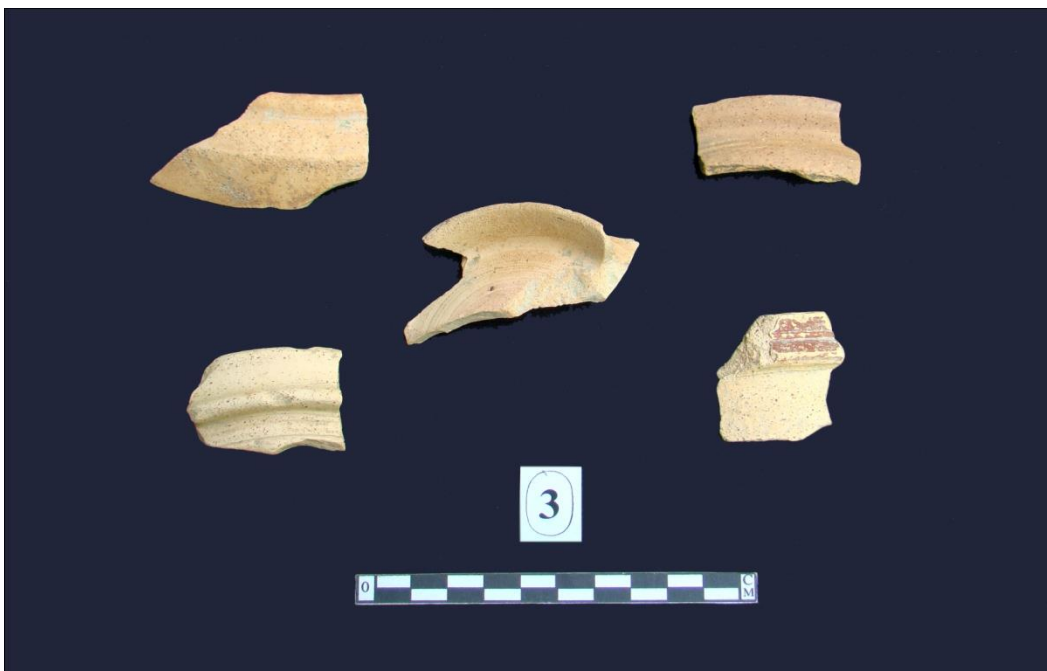
Garhgaon Raja's palace: pottery of A; layer 2 and B; layer 3.

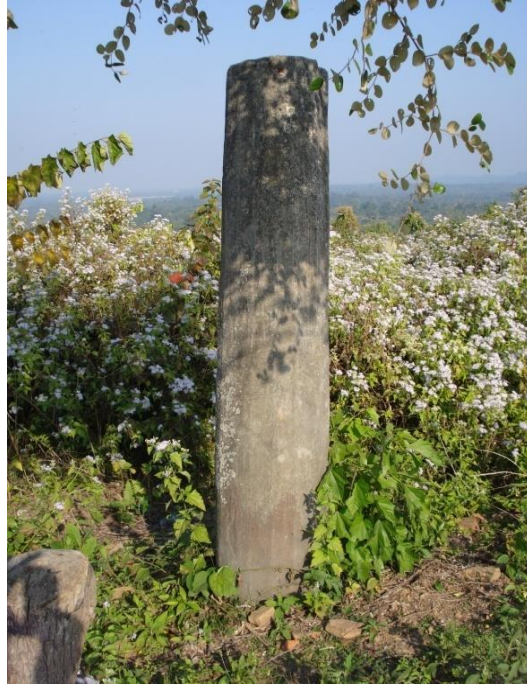
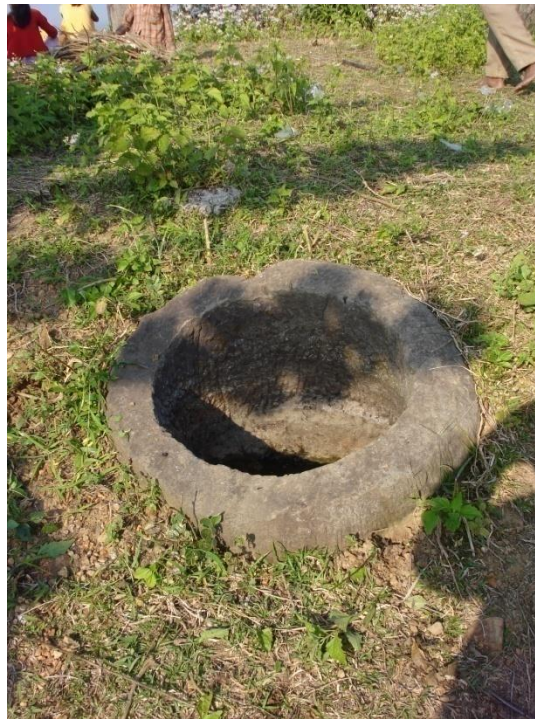
Plate 16

Lankuri Dol: A; stone pillar and B; pillar base.

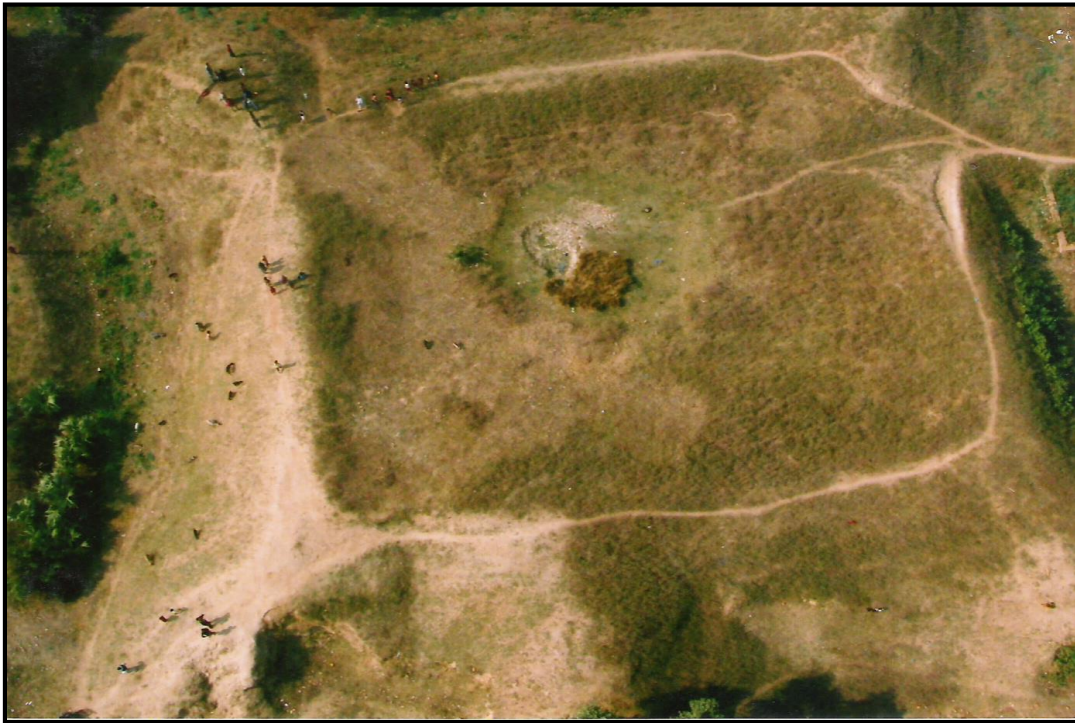
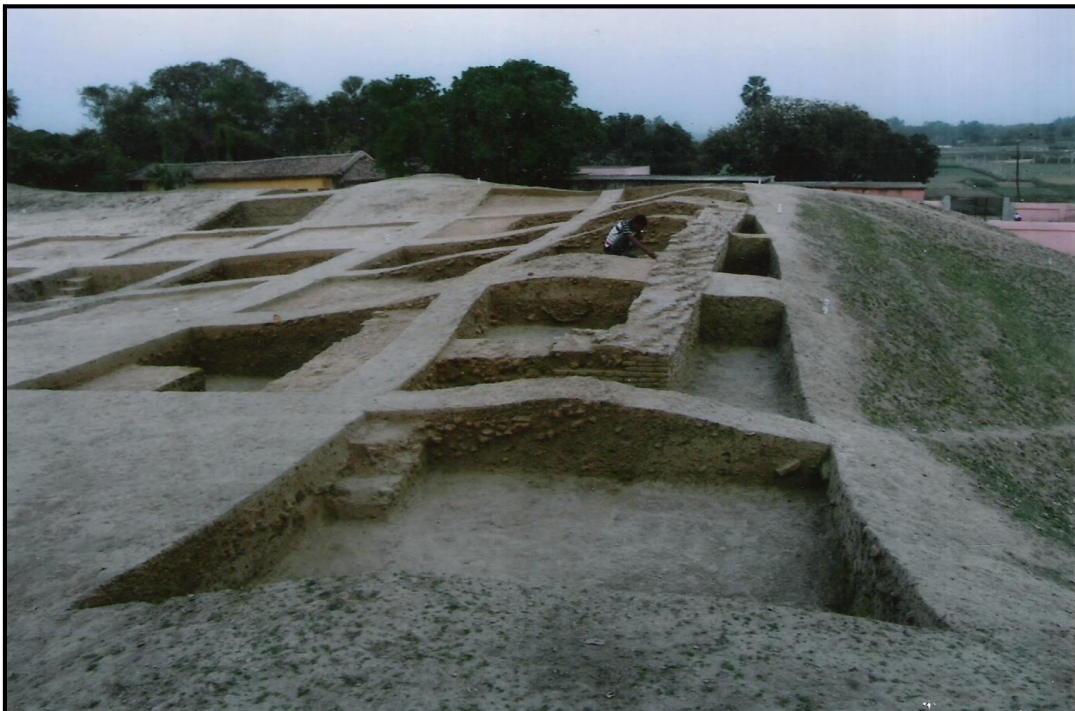
Begumpur: A; aerial and B; view of mound after excavation.

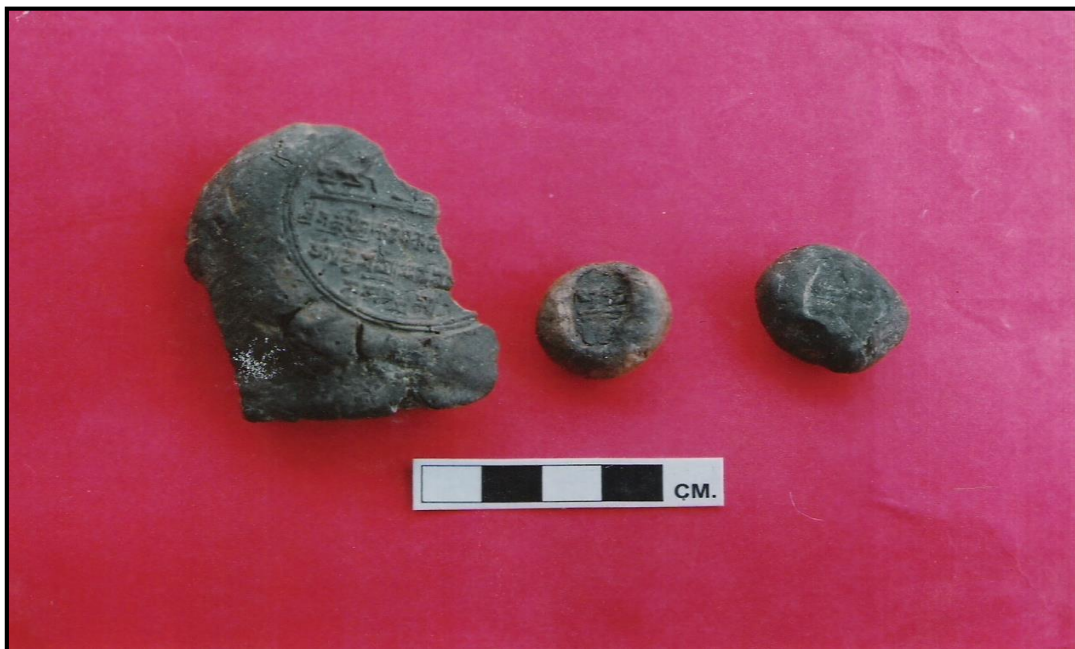
Begumpur: A; structural remains, Period II and B; terracotta sealings.

No structural remains of Period I was found during excavation. A terracotta ring well of the Period II at the depth 1.50m was exposed which started from the layer 5 and continued to layer 7. The diameter is about 0.90m and the height 1.05m, having seven rings, and the width of each ring is 0.17m. In Period III remains of rammed floor of brick bats was exposed in the trenches A<sub>1</sub> x II/III and A<sub>2</sub> x I at a depth of 0.45m. Rammed floor was made after leveling the surface and paving with brick bats. A three course brick structure was also noticed in the south-east corner of trenches A<sub>1</sub> x II. A 3.15 x 2.00m burnt brick platform was noticed in the north-east corner of the trench A<sub>2</sub> x II, and two miniature stone stupas were also exposed in the same trench. Evidence of lime-surkhi floor was also noticed. A headless stone image of Buddha in a niche was also exposed in the trenches A<sub>2</sub> x IV. Debris of brick structures and decorated stucco plaster was encountered in layer 2. It indicates that a religious brick structure or temple might have existed near the site. It

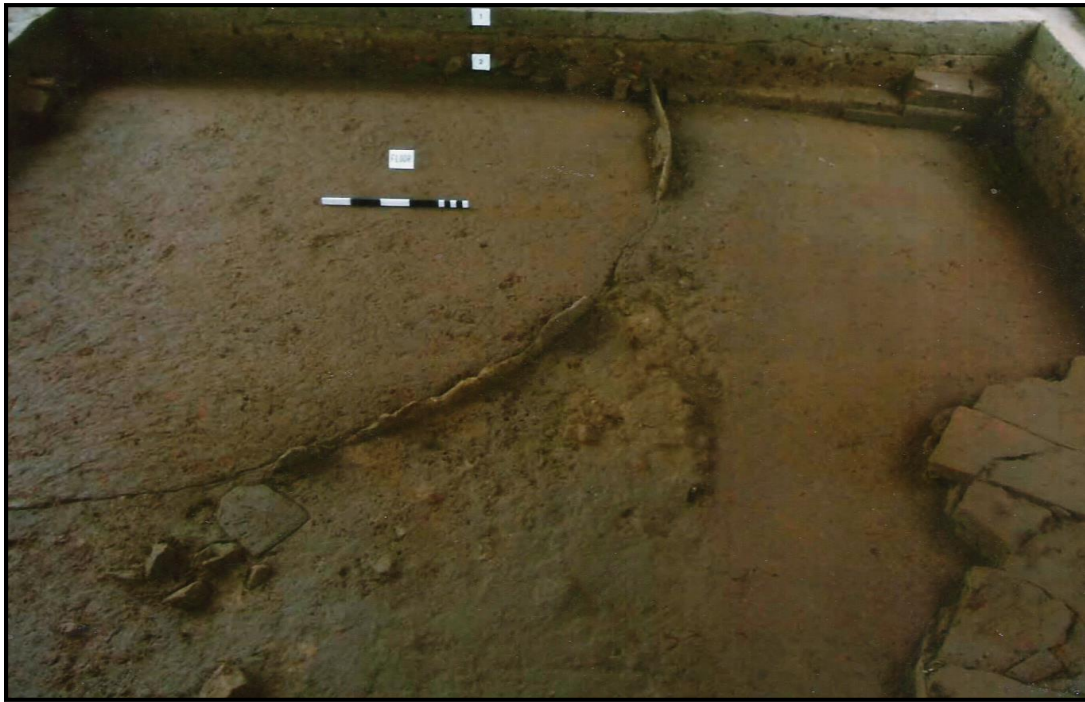
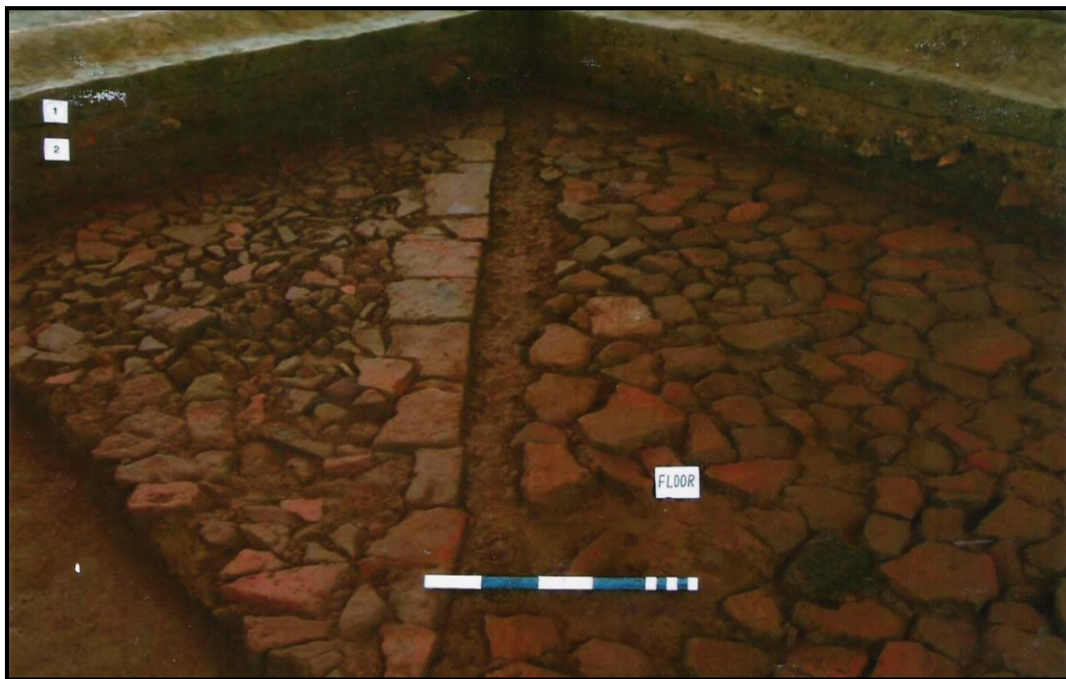
Daman-khanda: A; remains of floor made of brick jelly and B; pavement of brick-bats.

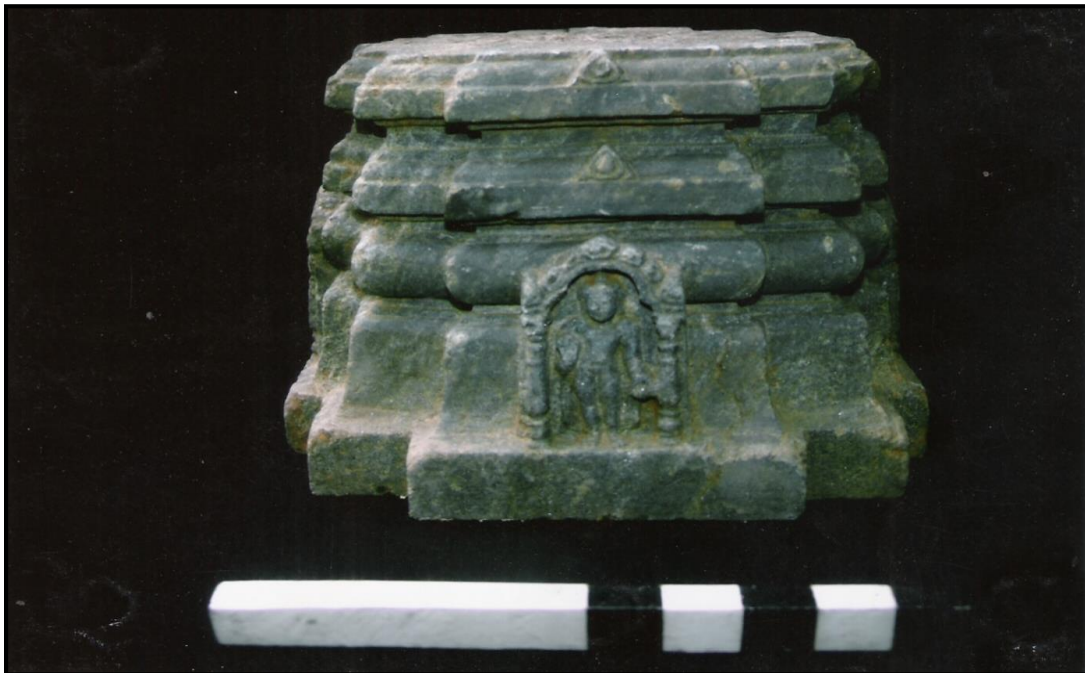
A

Daman-khanda: A; stone votive stupa and B; remains of decorative stone pieces.

Buddhist creed bearing the inscription, “*ye dharma hetu.....*” in characters of about the 10<sup>th</sup> century CE. The other two were fragmentary worn out. Small stone sculptures of Buddha in *bhumisparsa* and *dharmachakrapravartan* pose and Vishnu in *samabhanga* pose were also found. Nail and nail parer are among the iron objects. Bone point and fragments of votive stupas made of stone were also the noteworthy findings (Pl. 22).

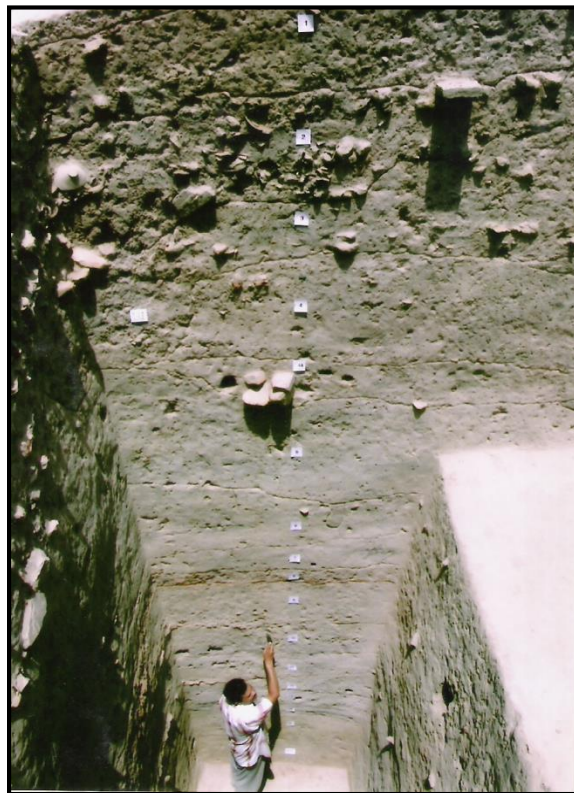
B

Ghorakatora: A; general view of the site and B; a section facing west trench A4 quadrant 4.

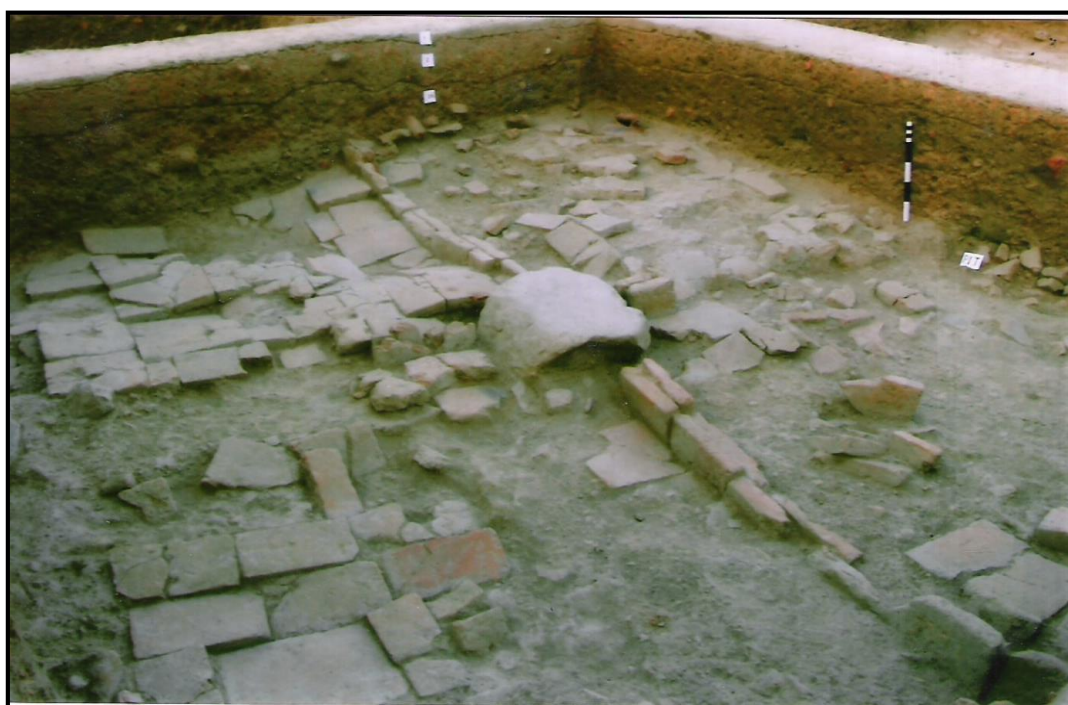
B

Ghorakatora: A; trench A' Qt. I and B; workshop of artisan, trench A1 Qt. 4, Period V.

A workshop of an artisan was found in square A<sub>1</sub> quadrant IV having a brick paved work shop with a stone anvil in the middle and an earthen pot at the north east corner of the quadrant. An unfinished basalt stone block was also recovered near the workshop in square A<sub>2</sub> quadrant II.

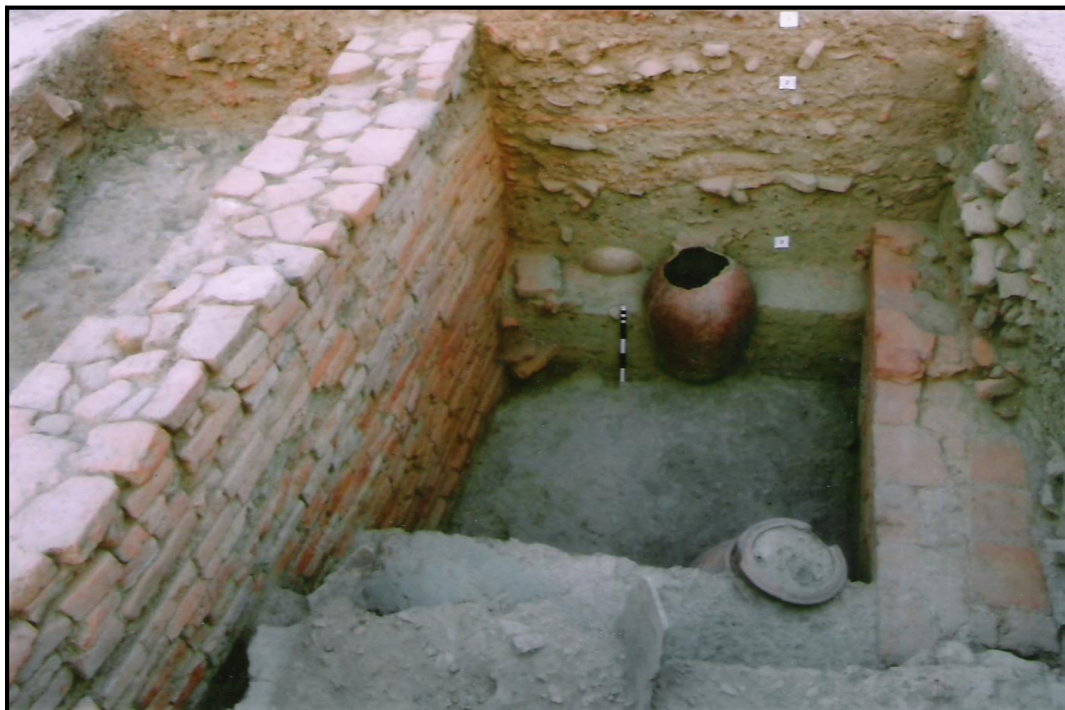
Ghorakatora: A; structural remains and B; storage jar filled with cowries, Period V

A massive wall belonging to Period V having a width of 81cm and length of 11.3m was found in square A<sub>2</sub> quadrant IV, A<sub>2</sub> quadrant III and B<sub>2</sub> quadrant IV and the continuity of the wall could be seen extending in B<sub>2</sub> quadrant III, B<sub>2</sub> quadrant IV. A parallel brick wall of length 10.5m and width 55cm was found in square A<sub>1</sub> quadrant I A<sub>2</sub> quadrant II and B<sub>2</sub> quadrant I. Another parallel wall of length 2.5m and width 60cms was noticed in square A<sub>2</sub> quadrant II and it could be traced in square B<sub>2</sub> quadrant I, B<sub>2</sub> quadrant II and C<sub>2</sub> quadrant I. A wall having an alignment in north south direction was found in square A<sub>1</sub> quadrant II having a width 80cm and it was traced in the form of a ghost wall in square A<sub>1</sub> quadrant II A<sub>2</sub> quadrant III A<sub>2</sub> quadrant I and they intersected each other at right angle with the main wall in square A<sub>2</sub> quadrant I.

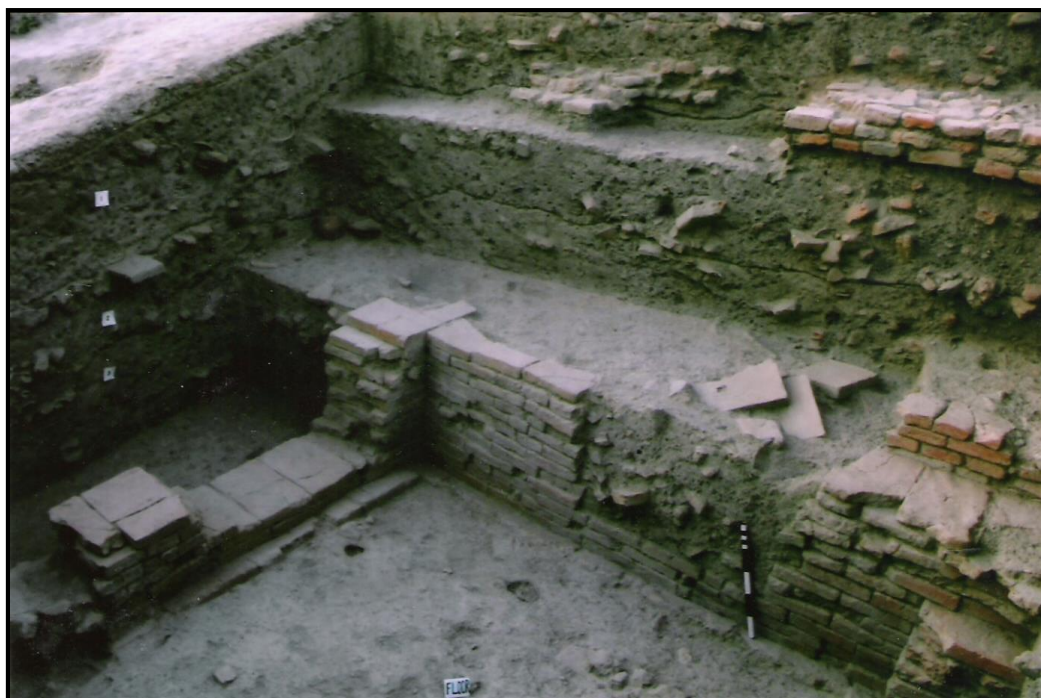
Ghorakatora: A; storage jar and B; structural remains, Period III and IV, trench A<sub>4</sub> x III.

Burnt brick structures of various phases were encountered in almost all the trenches which were found damaged mainly due to large scale vandalism and brick robbing in the past. Three rooms of a house complex measuring 2.5 x 2.2m, 1.5 x 1.9m and 1.6 x 1.9m made of burnt brick belonging to Period III was noticed in square A<sub>4</sub> quadrant IV (Pl. 24B).

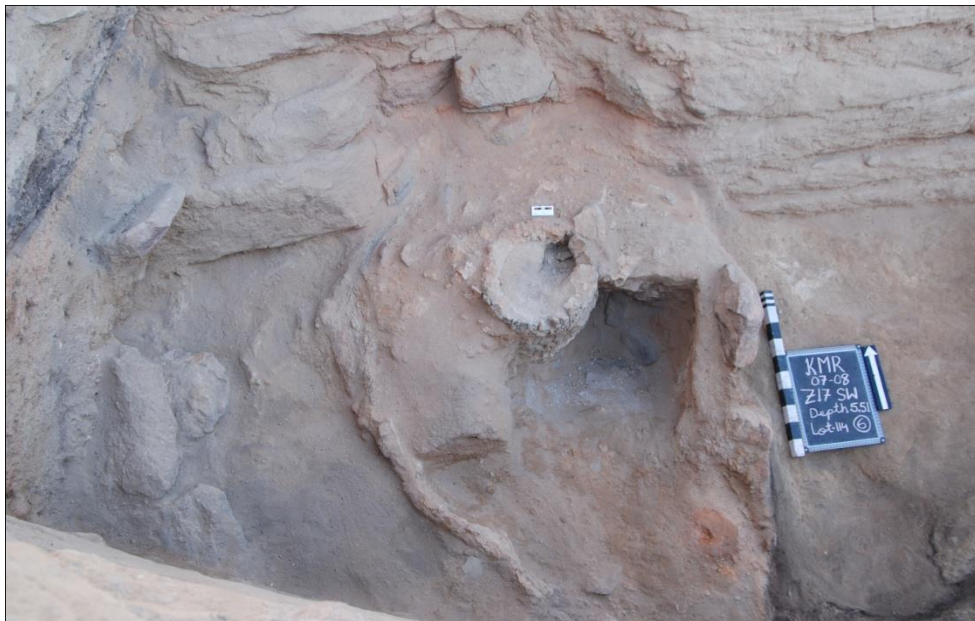
Kanmer- A; kiln with central column from KMR IIb and B; bead rough outs of carnelian.

A bulb shaped plan of a furnace with a central cylindrical hollow column (diameter 31cm, depth 35cm) was exposed (Pl. 30A) in trench Z17 about 10m west of the north eastern corner of the fort. It was built close to the inner face of the wall and was oriented in NNW-SSE direction. It measured 1.40m (N-S) and 96cm (E-W). The clay walls of the furnace were barely 4cm thick and the area between the column and outer clay wall was found completely filled with ash. The column with an opening only from top was found filled with whitish ashy material. The burnt red colour of the cylindrical column, the outer clay wall and the earth around the furnace indicate that the temperature raised in the furnace may have been more than 700° C. Indications are that the heat generated in the furnace also damaged the face of the fort wall. A small square (90 x 90cm) platform made of flat stones just to the east of the furnace also seems to be associated with it. This platform was prepared on a floor level. A thick cubical sandstone block was found lying on the eastern margin of the floor to which was found sticking some whitish substance identical to what was found inside the column. Several tubular faience beads were recovered from the furnace area and near the square platform. Therefore, it is likely that this was a faience bead making furnace. This furnace was found sealed by layer number 4. This layer consists of several heaps of ash which was possibly thrown from the top of the fortification wall and also belonging to KMR II B phase. The furnace seems to have been built during the initial stage of this phase.

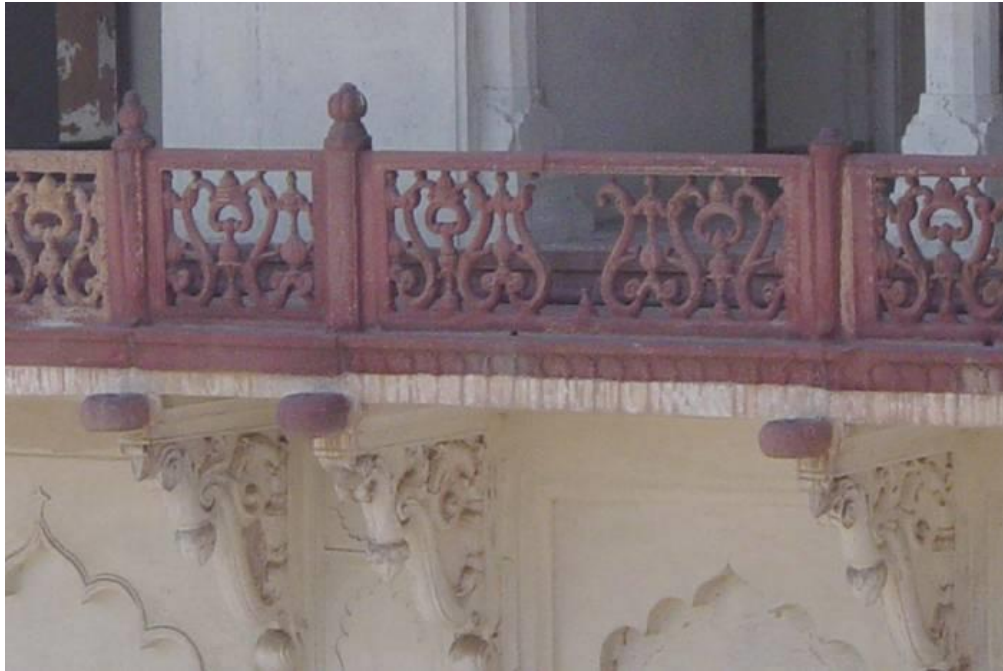
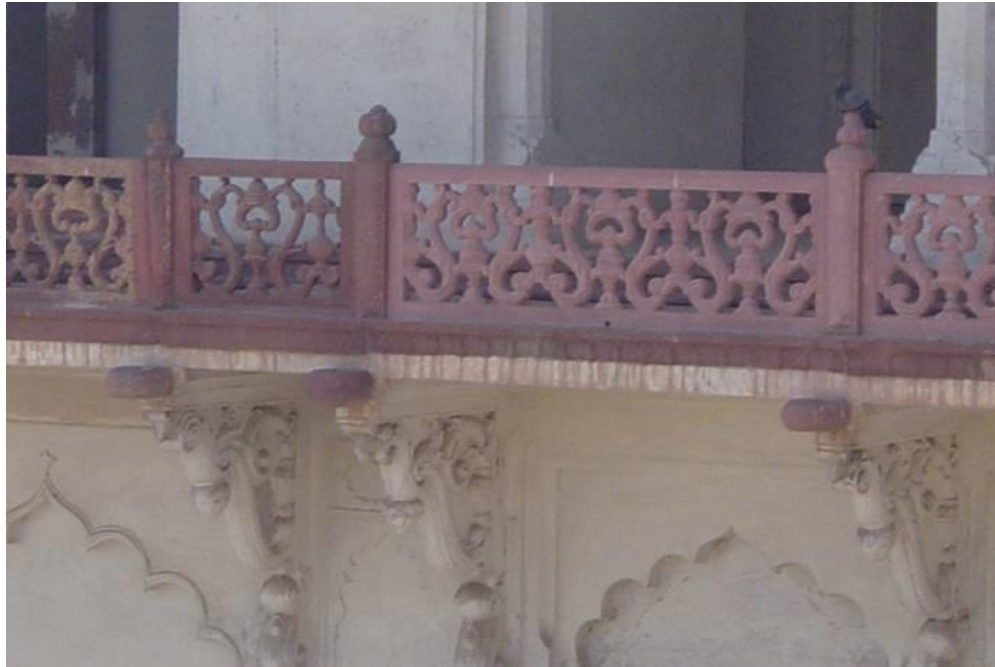
Angoori Bag: before and after conservation, broken red sand stone jali railing, Muttaka,

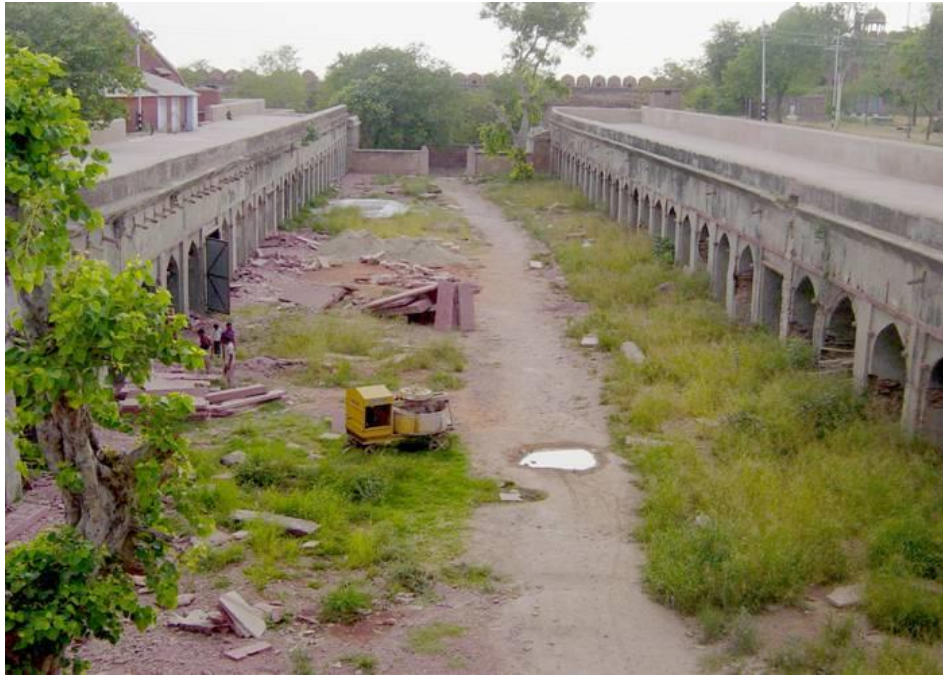
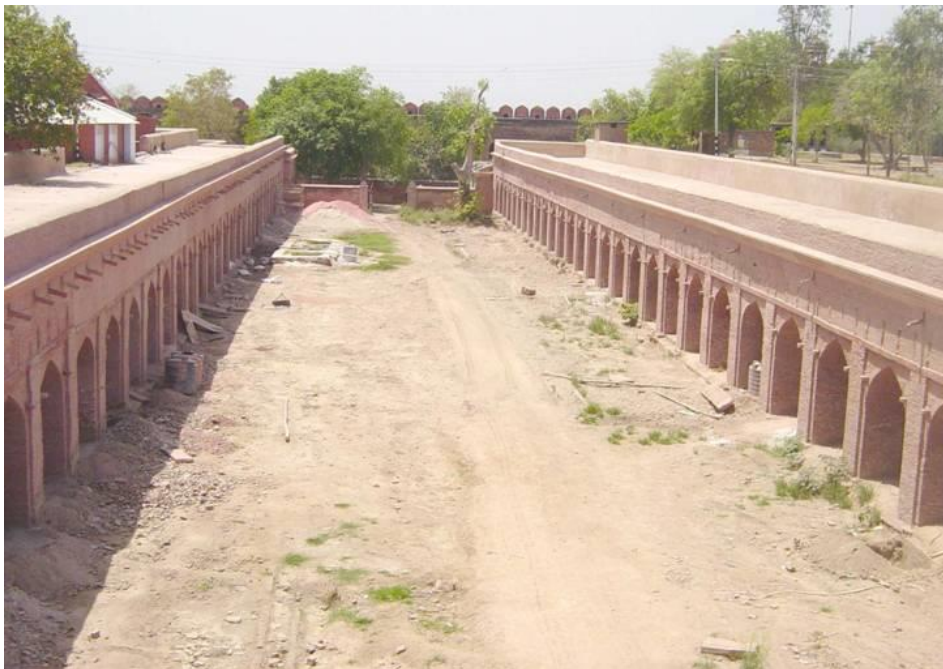
Agra fort: before and after conservation of Meena bazar 3<sup>rd</sup> Complex,

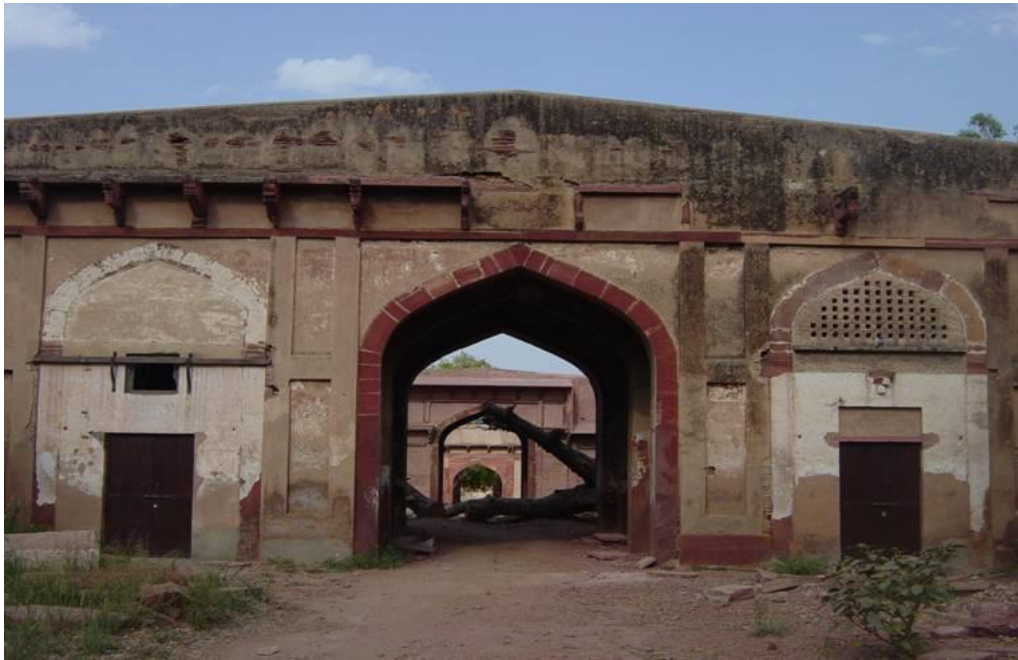
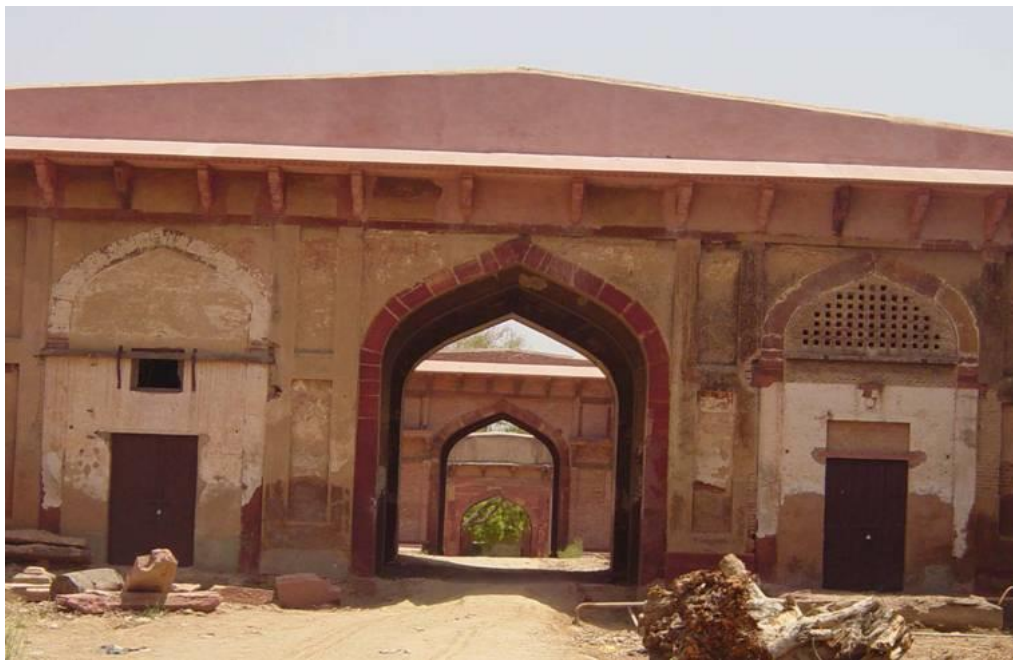
Agra fort: before and after conservation of gate of Meena bazar 3<sup>rd</sup> Complex,

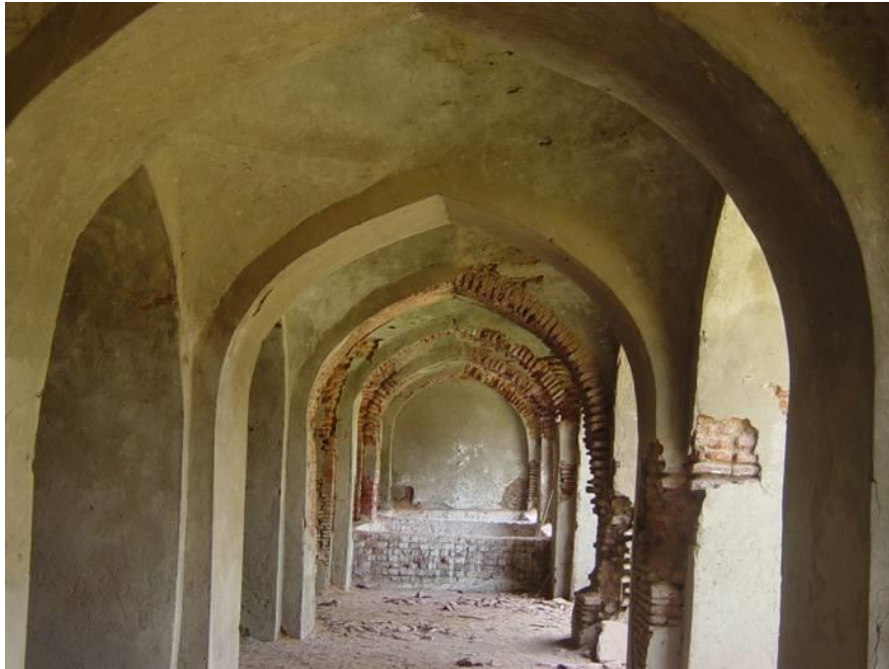
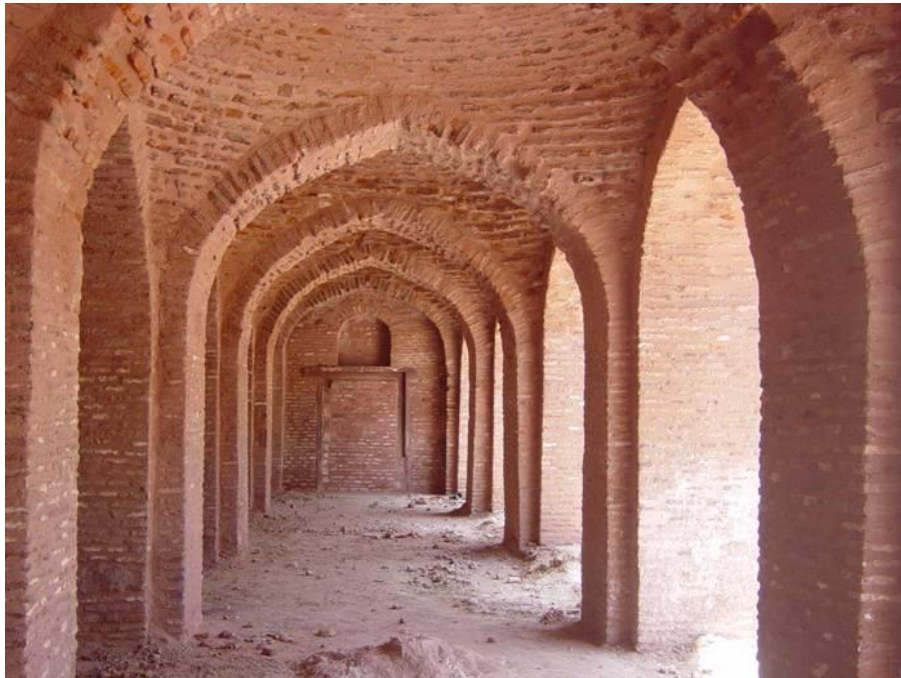
Agra fort: before and after conservation of interior of the verandah of Meena bazar 3<sup>rd</sup> Complex,

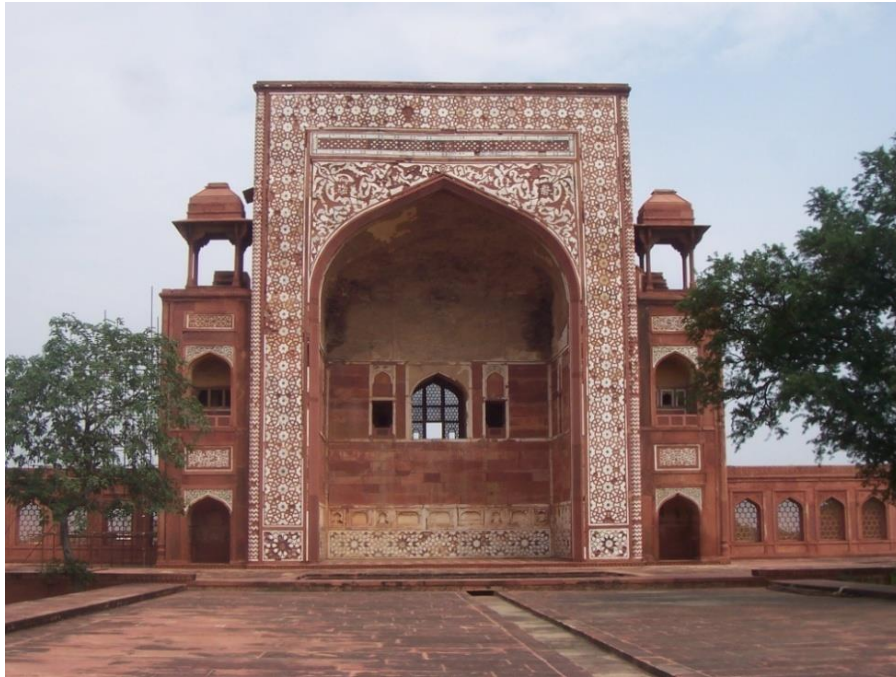
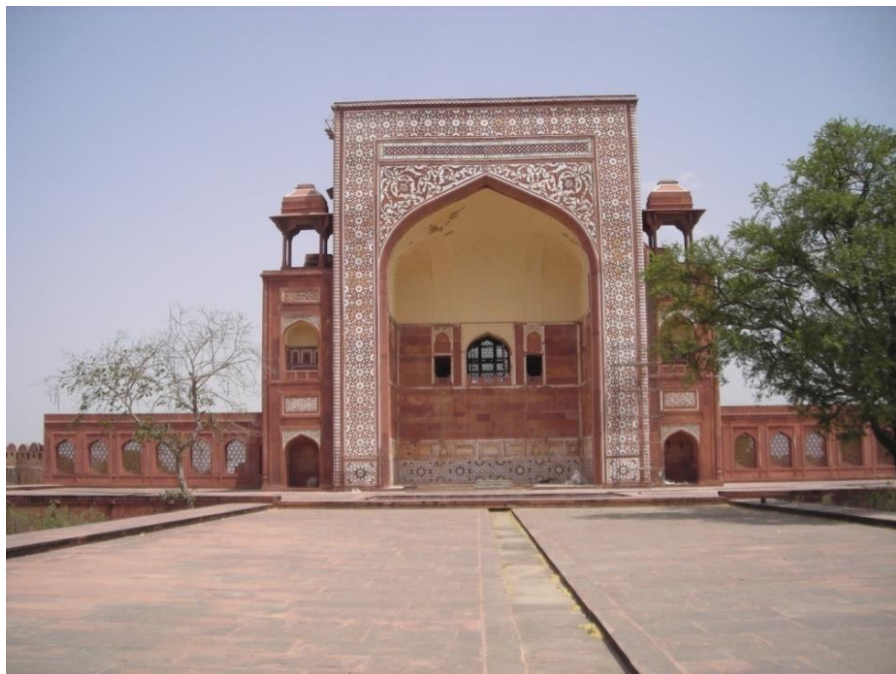
Sikandara: before and after conservation of eastern gate, Akbar's tomb.

The eastern gate of the tomb complex was taken up for repair. The dead and decayed plaster of the mainarch was removed and re-plastered matching to the original. Similarly, the old and decayed plaster of the first floor has also been removed and re-plastering work is in progress. Missing stone *jali* and inlay pieces at the gate has been provided (Pls. 67-68).

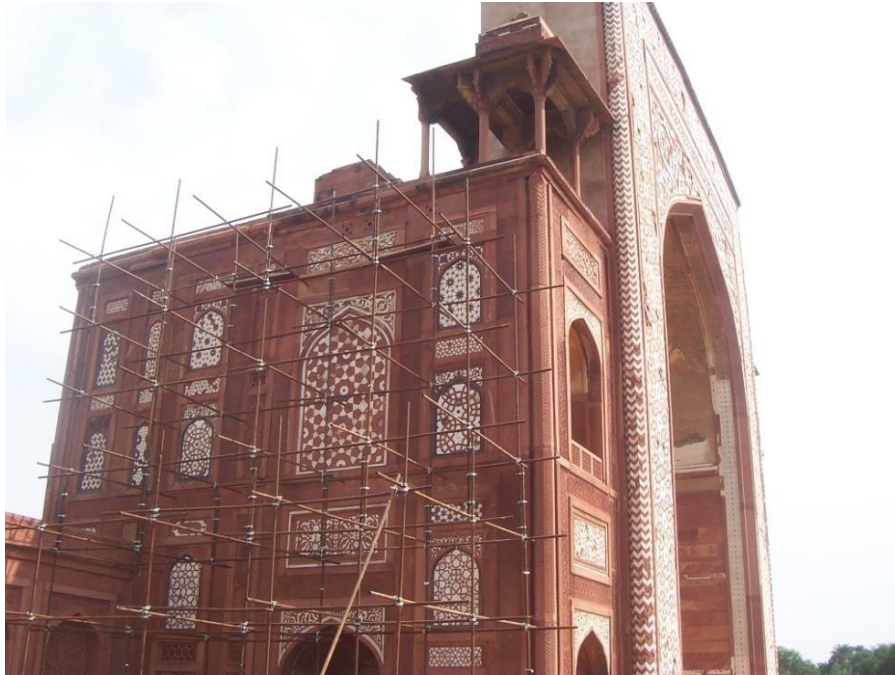
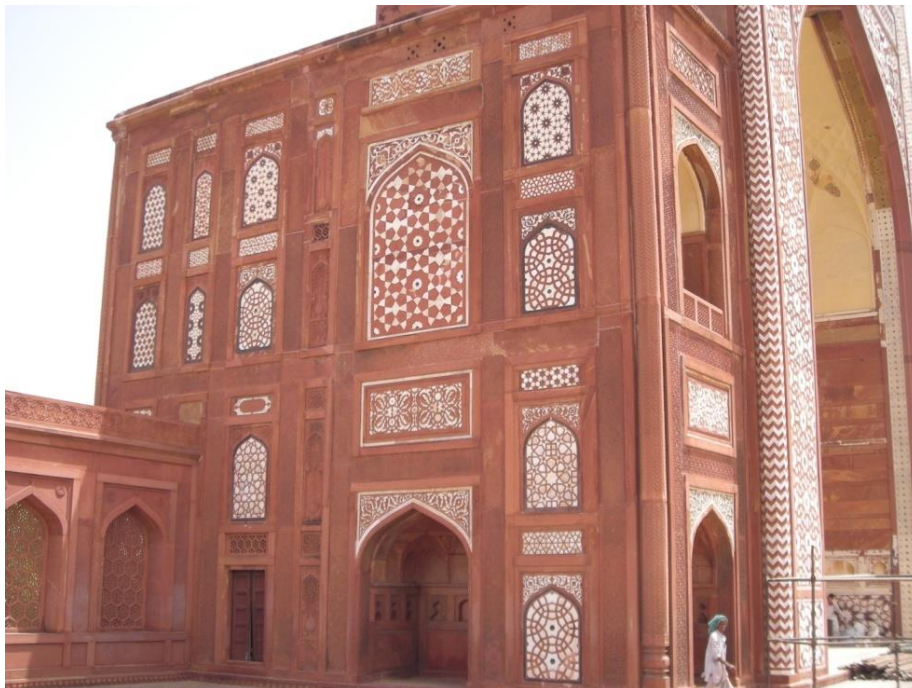
Sikandara: during and after conservation of northern façade of eastern gate, Akbar's tomb.
