# INDIAN ARCHAEOLOGY 2007-08

## - A REVIEW

# INDIAN ARCHAEOLOGY 2007-08 - A REVIEW

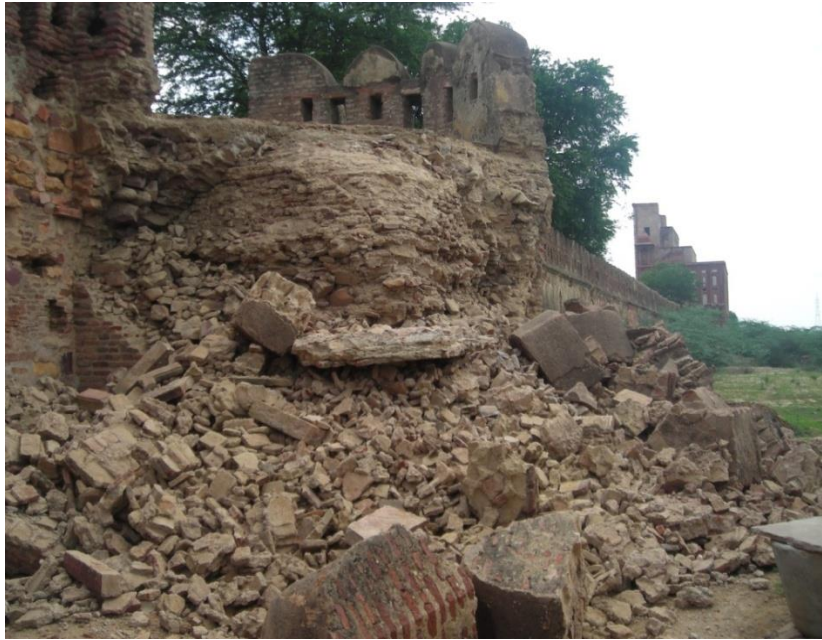
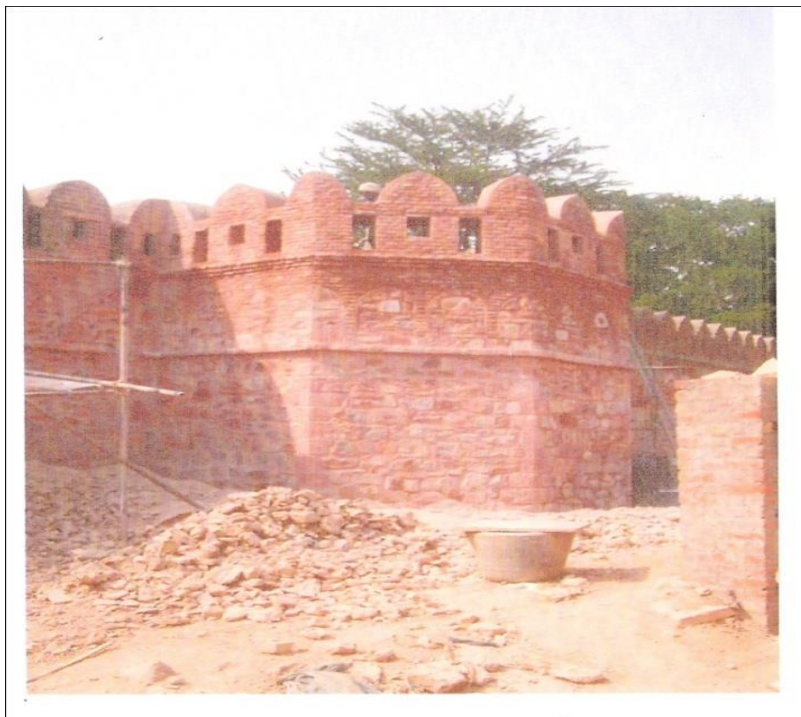
Sikandara: before and after conservation of compound wall of Akbar's tomb.

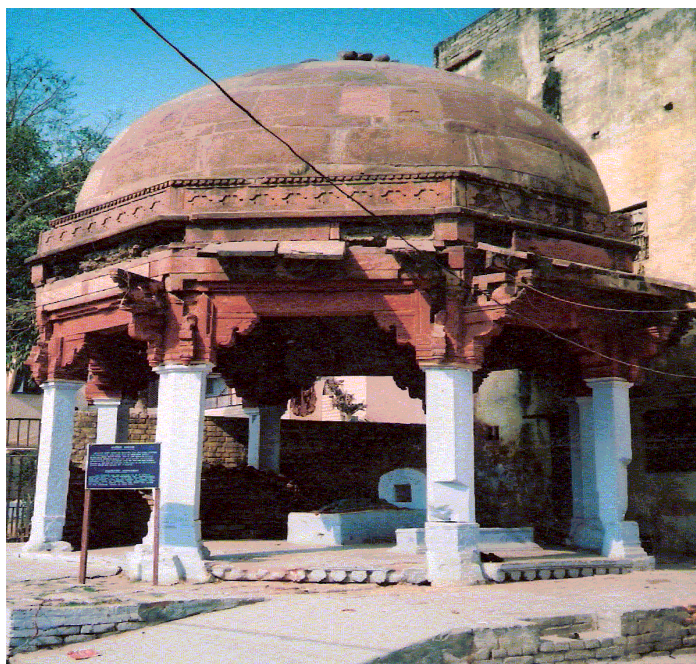
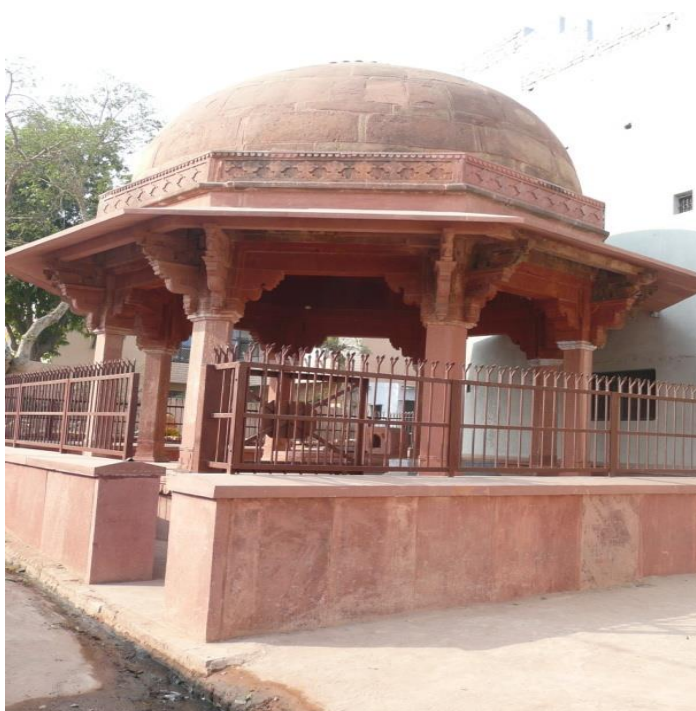
Tajganj: before and after conservation of Bara Khamba.

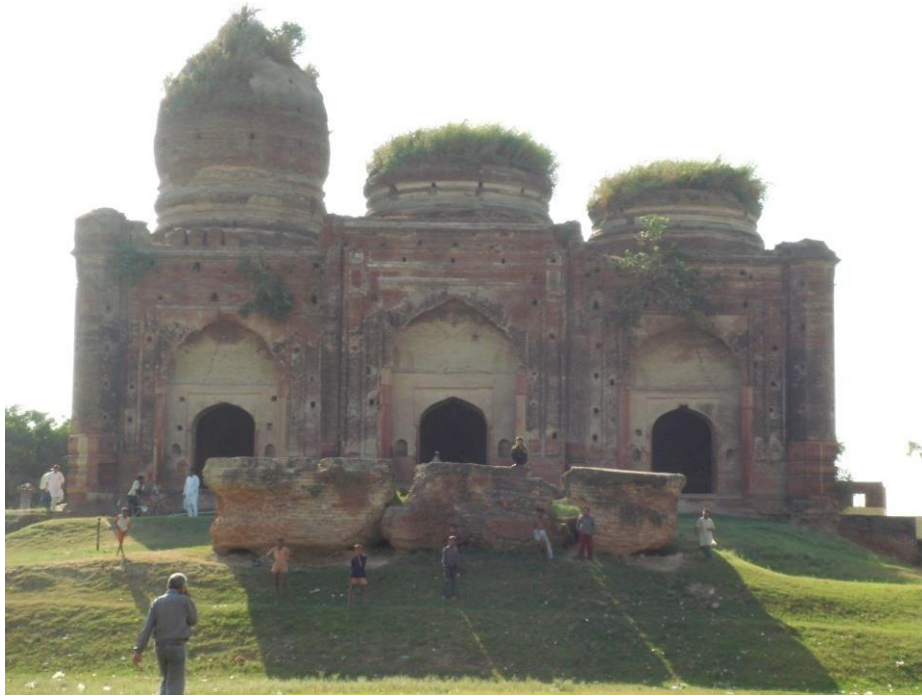
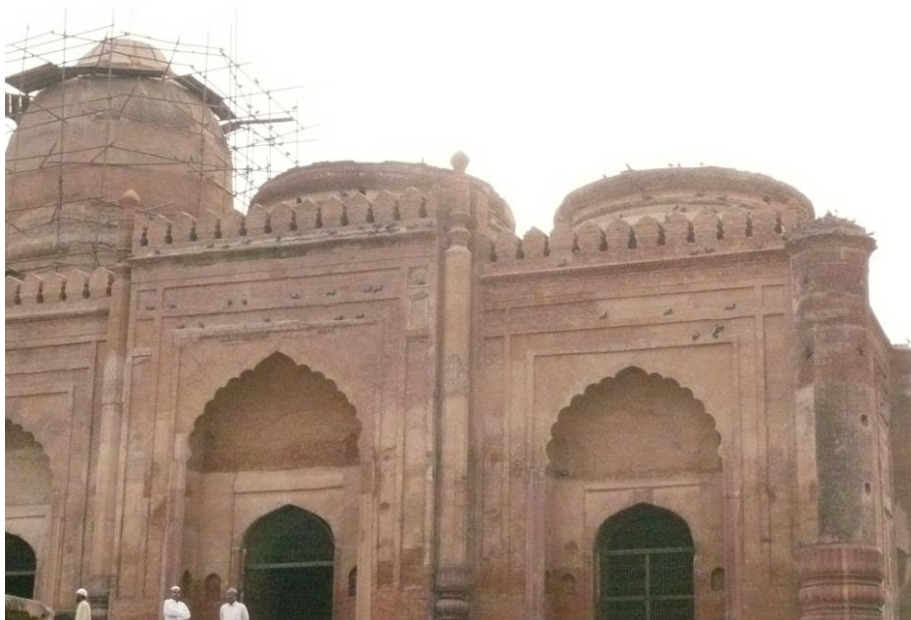
Aonla: before and during conservation of Begums' masjid.

Old and bulged red sandstone *pan-patti* design, depressed moulding *dasa* and *dab* and quid were removed and provided with new one as per the original wherever required. A pathway in red sandstone and an apron around the mosque was also provided.

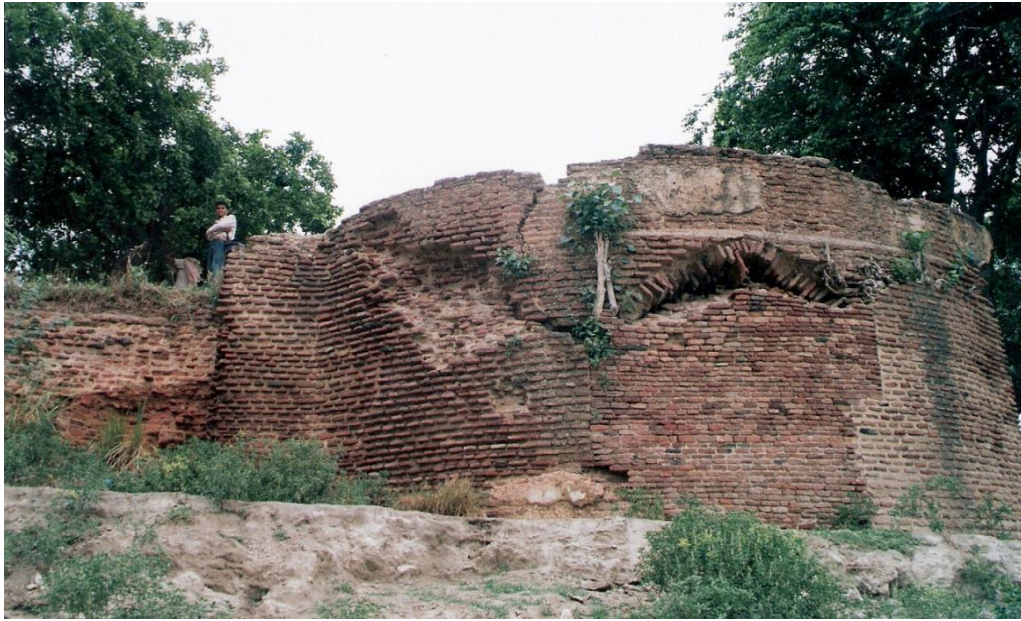
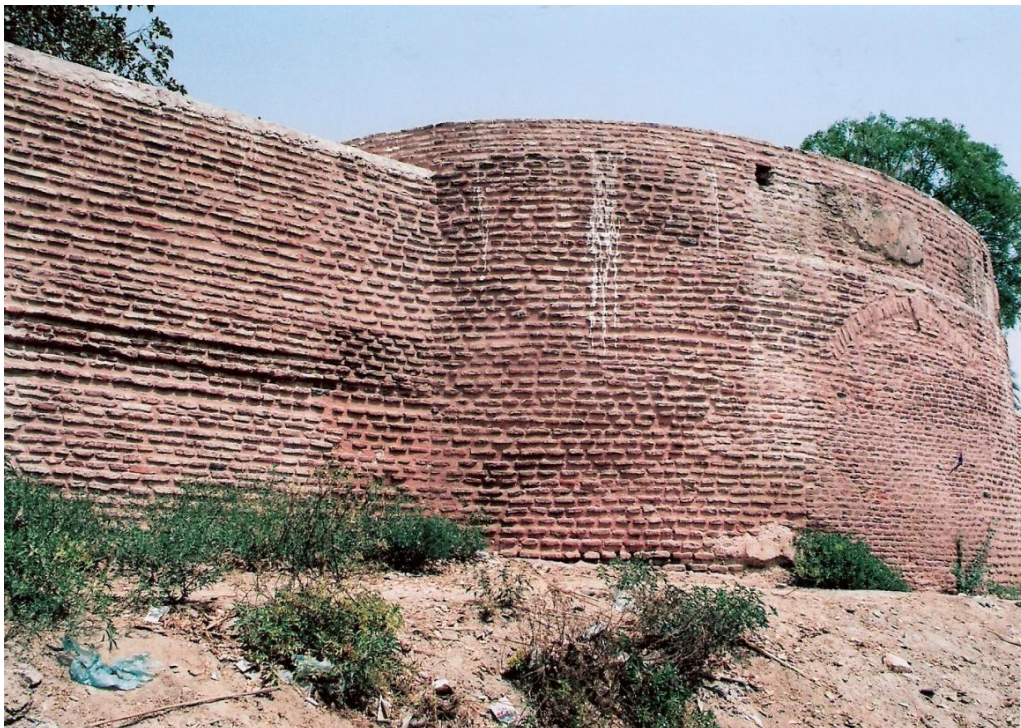
Agra: before and after conservation of eleven steps at Kachhpura.

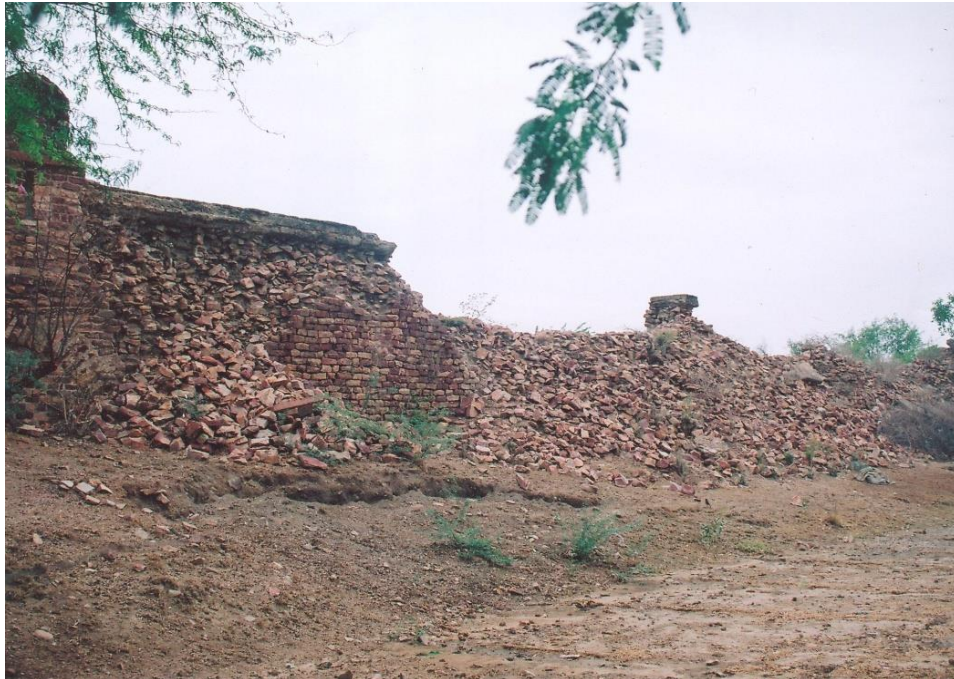
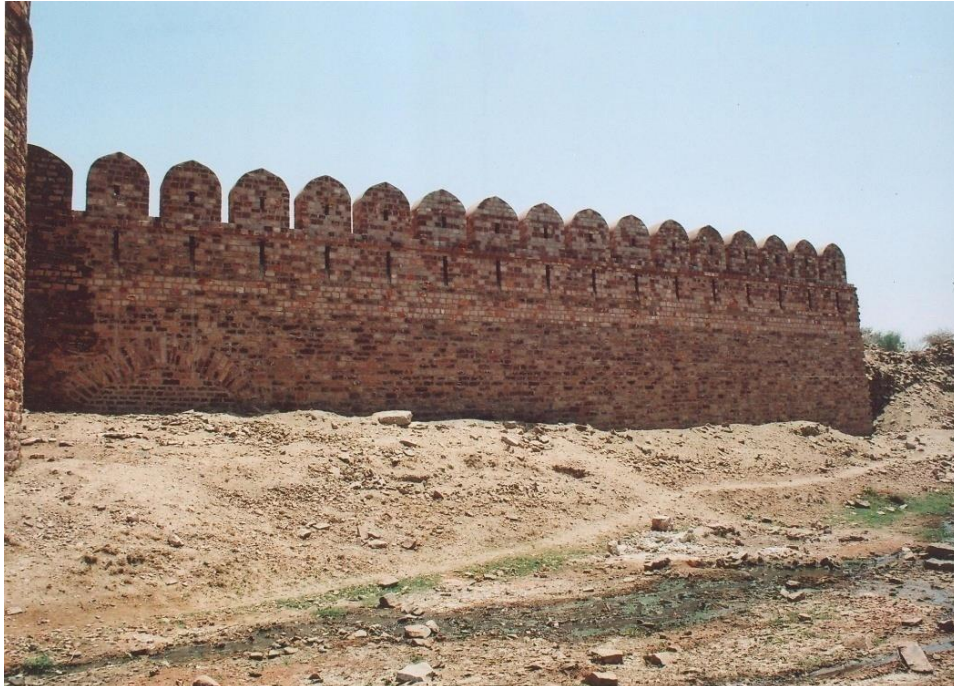
Fatehpur Sikri: before and after conservation of city wall near Delhi gate.

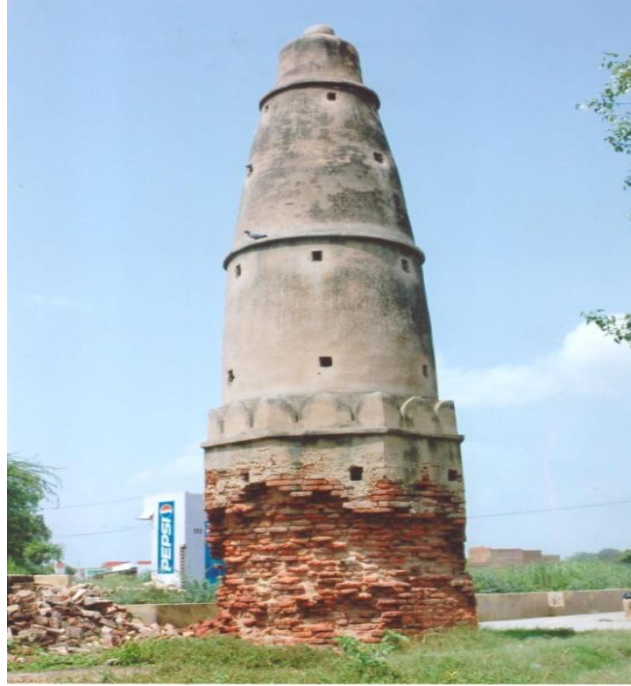
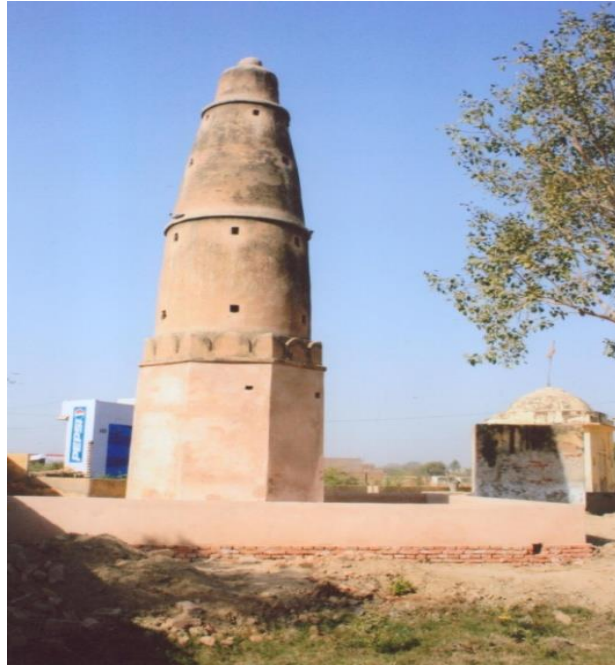
Chhata: before and after conservation of Kos minar, Mile 19 Furlong 1.

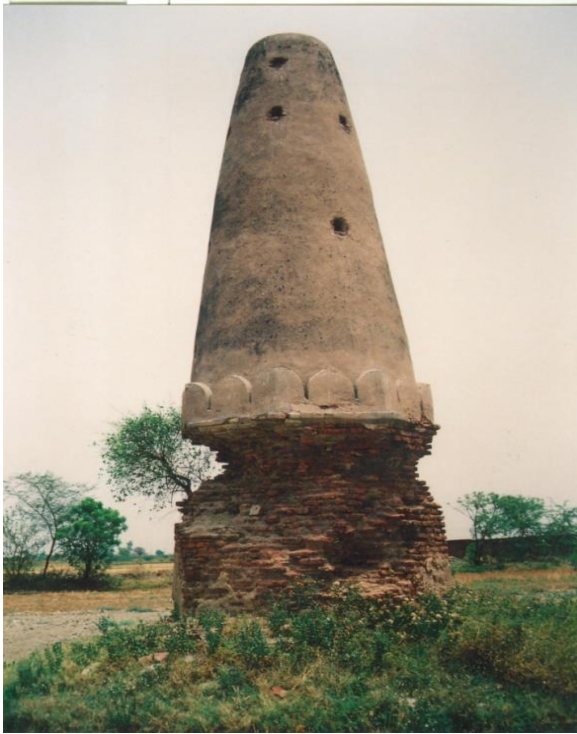
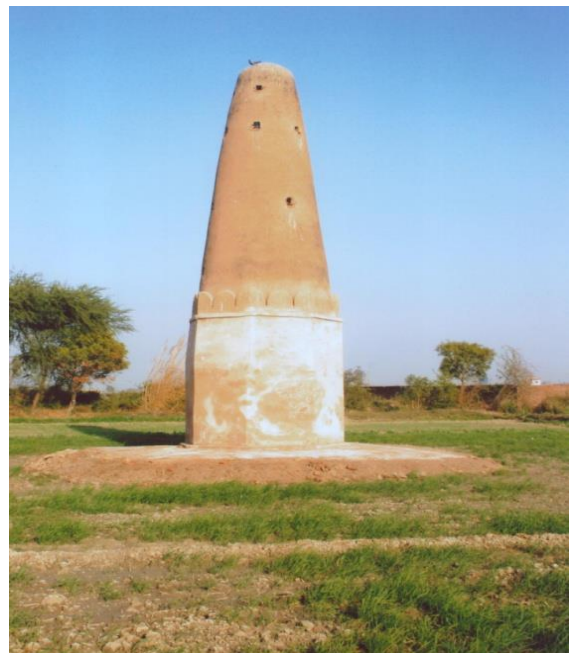
Chhata: before and after conservation of Kos minar, Mile 29 Furlong 4.

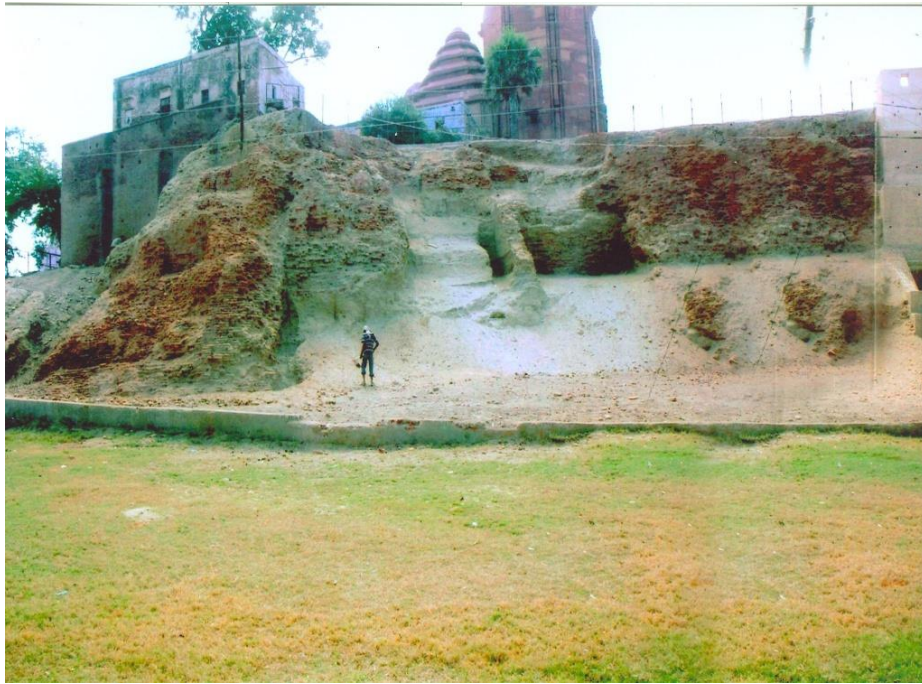
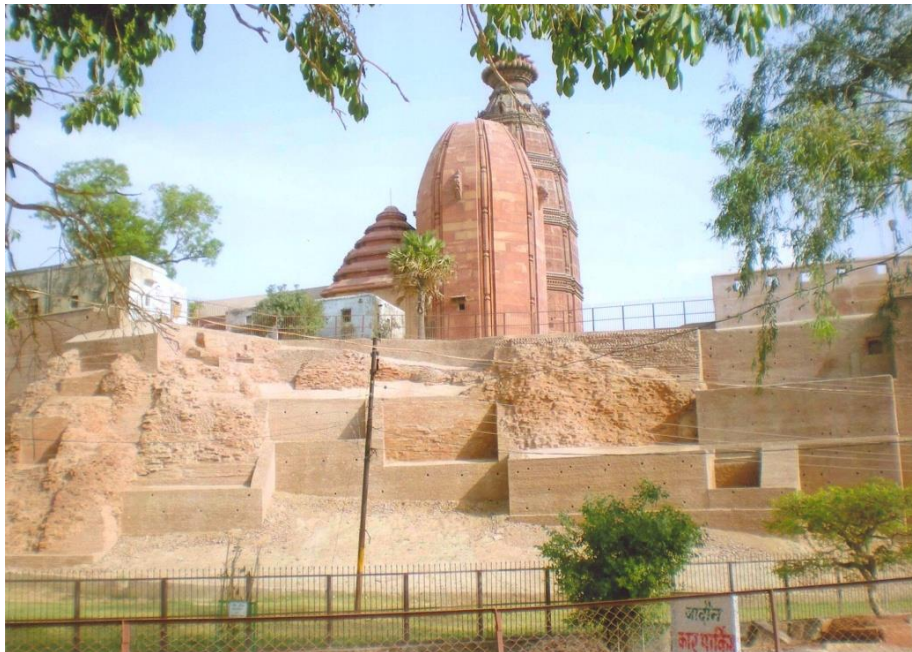
Madan Mohan temple, Brindaban: before and after conservation of brick walls and cells in riverside.

The temple has been constructed on a mound. To control erosion activity on the river side, a retaining wall was constructed

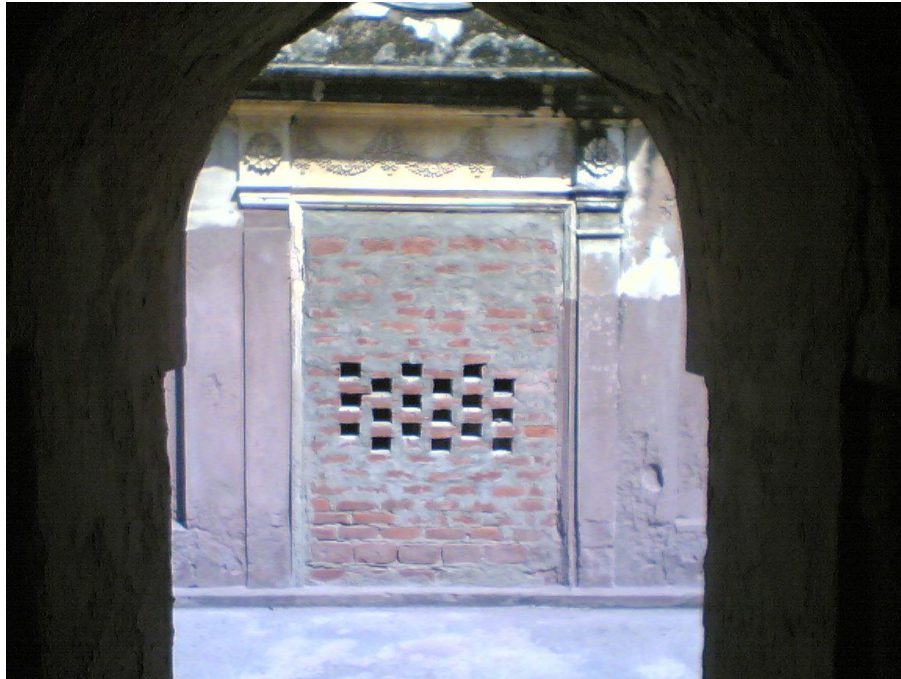
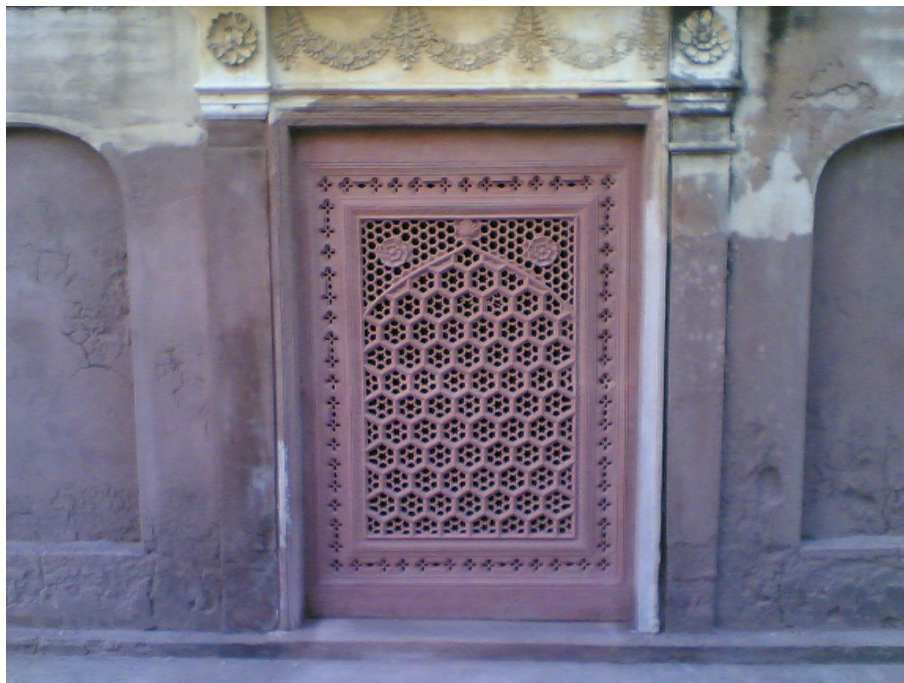
R.C. cemetery, Sardhana: before and after conservation of red sandstone jali.

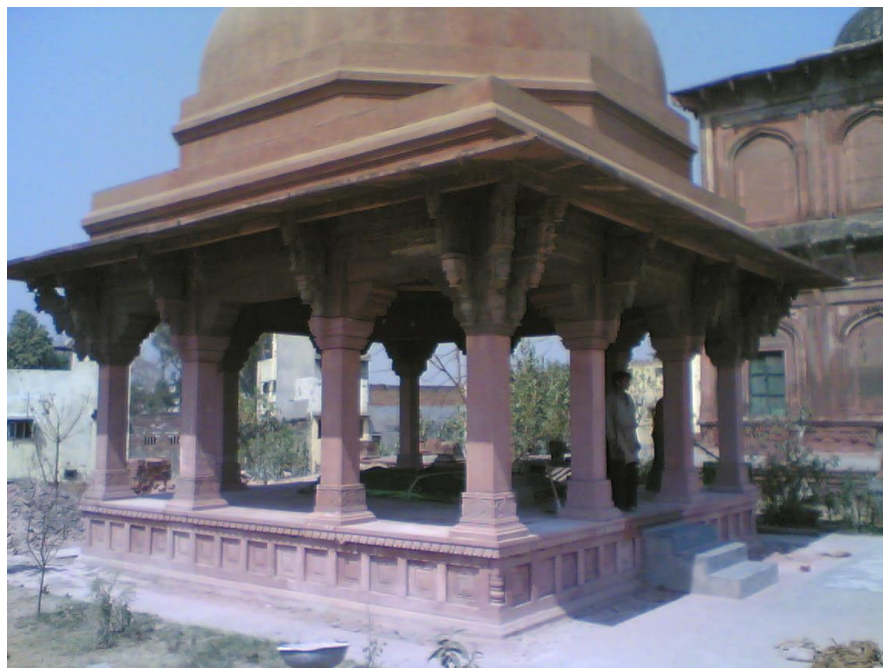
Meerut: before and after conservation of Shah Peer tomb.

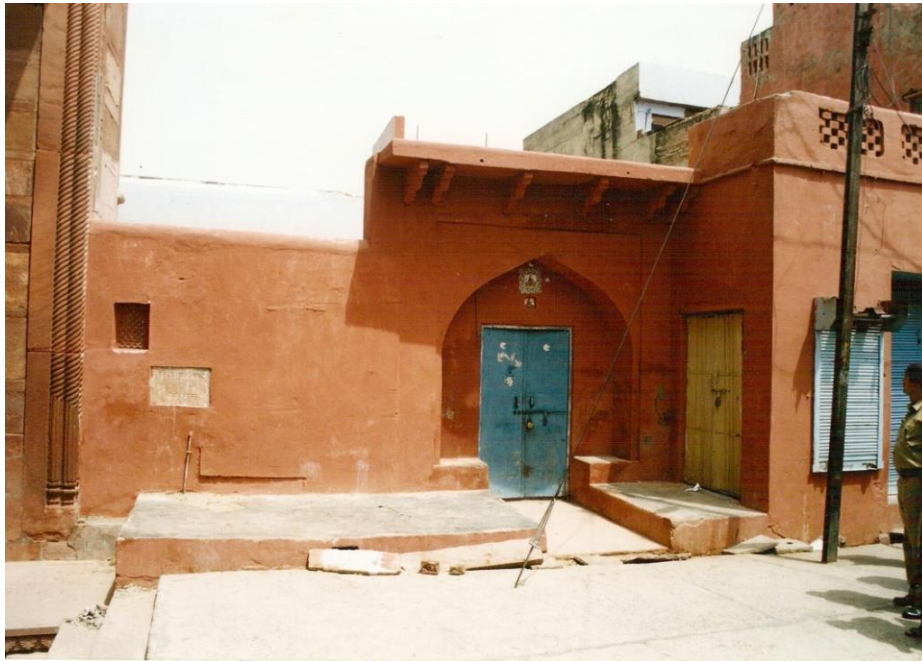
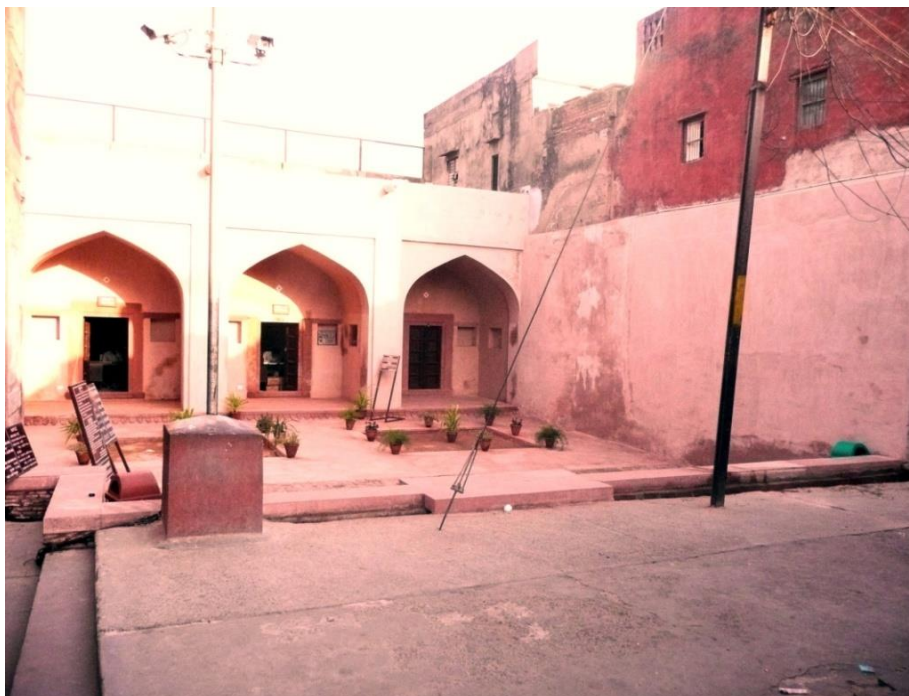
Taj Mahal, Agra: before and after conservation of Dalans and cells near the southern gate.

The chambers of *dalan* were repaired as per the original (Pl. 79). Since the original level of the *dalan* is below the existing street level, provision for water harvesting through deep boring has been made. Subsequently, the existing booking counter and cloak room facility has now been shifted to the recently conserved one. The western, southern and eastern facade of the main entrance gate was conserved by replacing the damaged and worn out red sand stone members like *dasa*, *gola*, carved veneer and inlay panels etc. (Pls. 80-81).

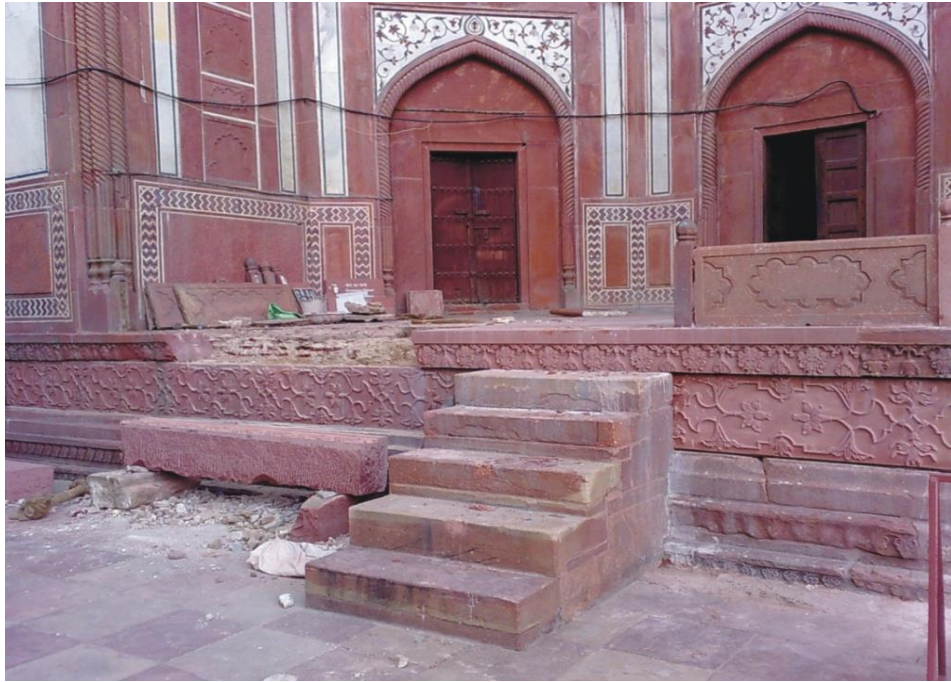
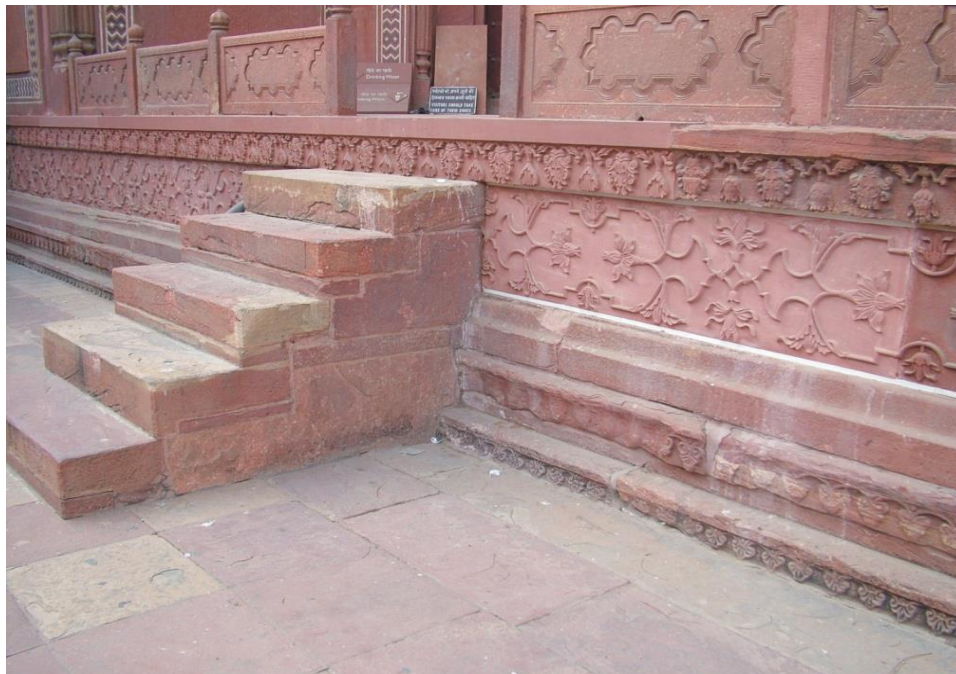
Plate 80

Taj Mahal, Agra: before and after conservation of decayed dasa panel of main entrance gate.

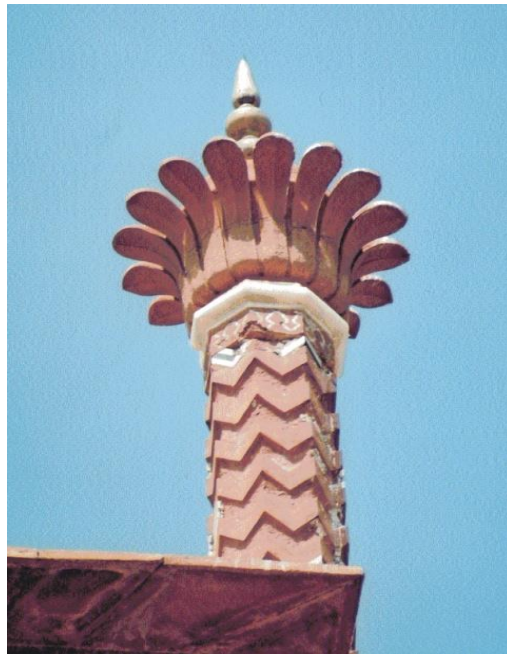
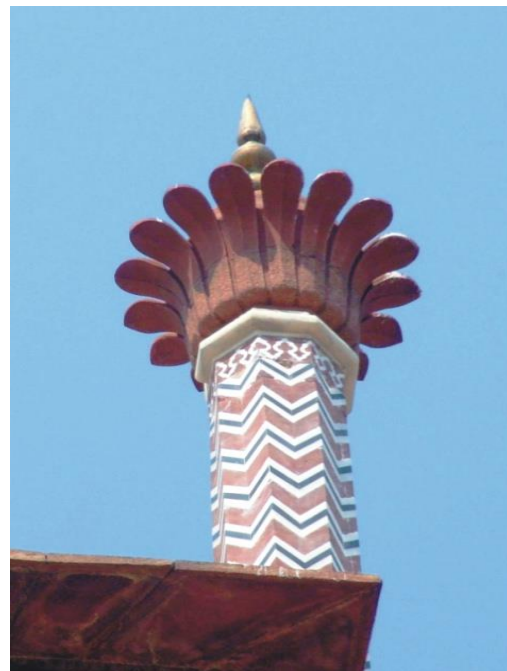
Taj Mahal, Agra: before and after conservation of missing inlays in turret of main entrance gate.

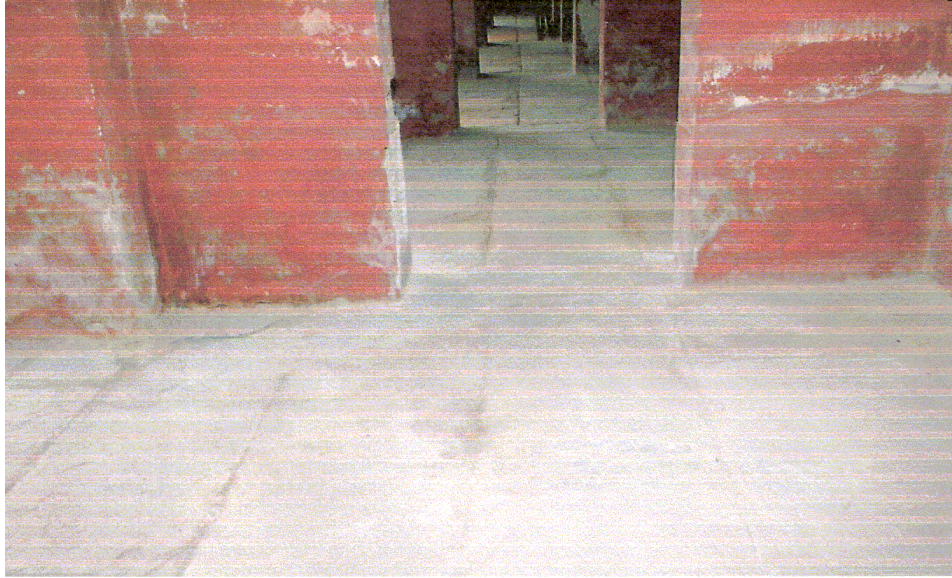
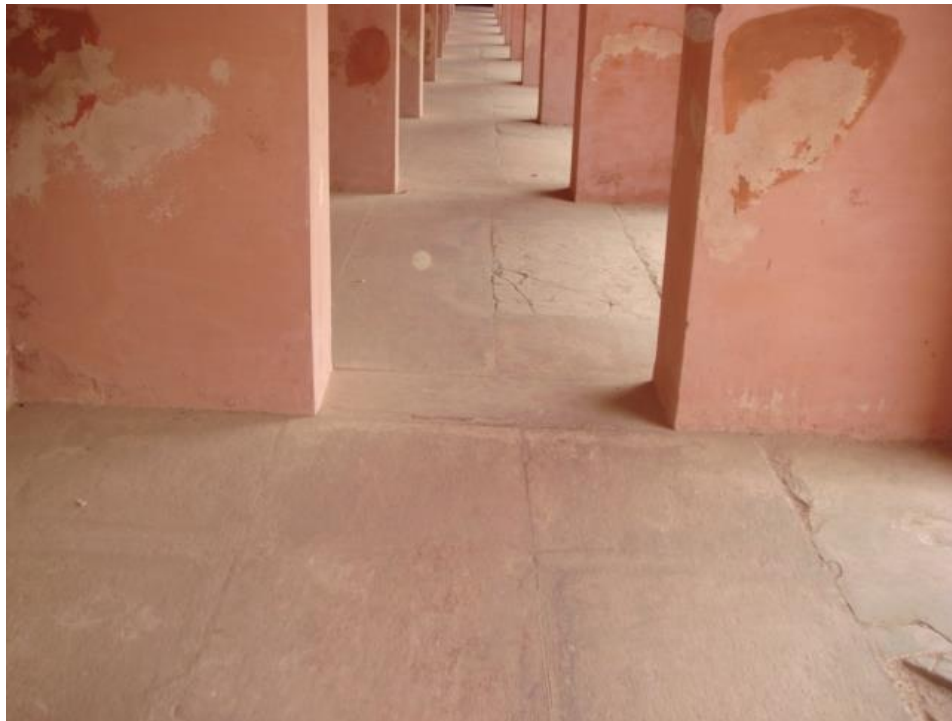
Plate 82

Taj Mahal, Agra: before and after conservation of damaged flooring of north-east dalan of Fore court.

The north-east *dalan* of the forecourt was conserved by way of racking out the cement plaster and re-plastering it with lime plaster. Damaged red sand stone flooring in the *dalans* was also repaired with new ones after proper documentation (Pl. 82). The ceiling of domes and corner of arches of the cells were also repaired as per original. Aprons were provided in front of north-east *dalans* as per pattern adopted inside the Taj complex (Pl.83).

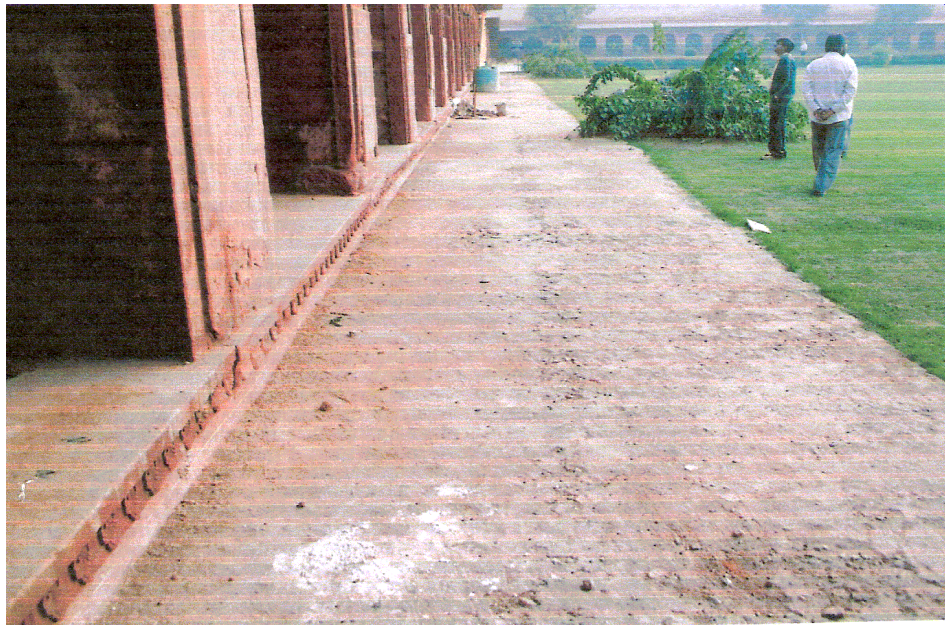
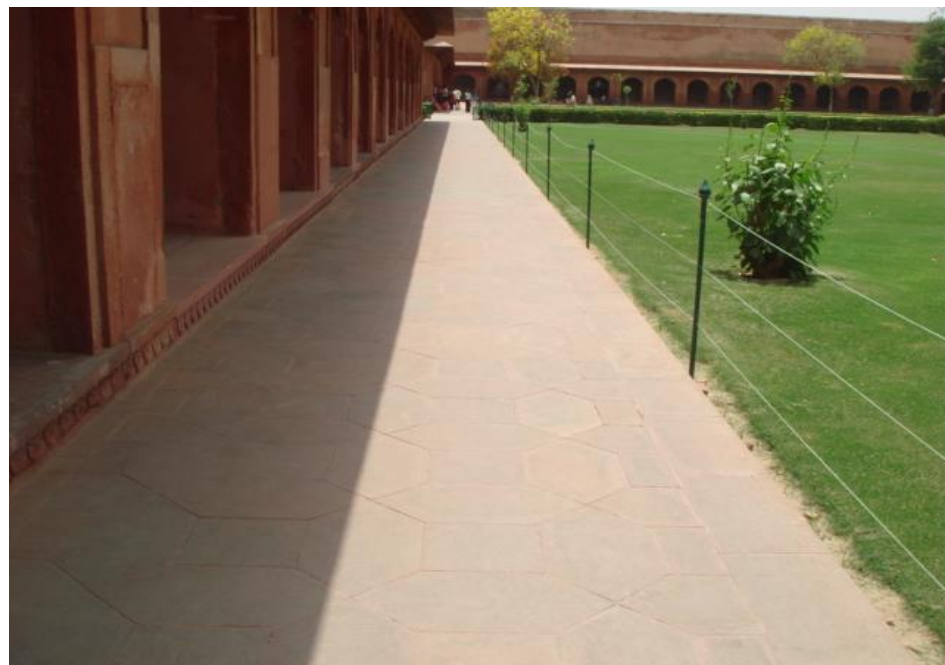
Taj Mahal, Agra: before and after conservation of pathway and apron of north-east dalan of fore court.

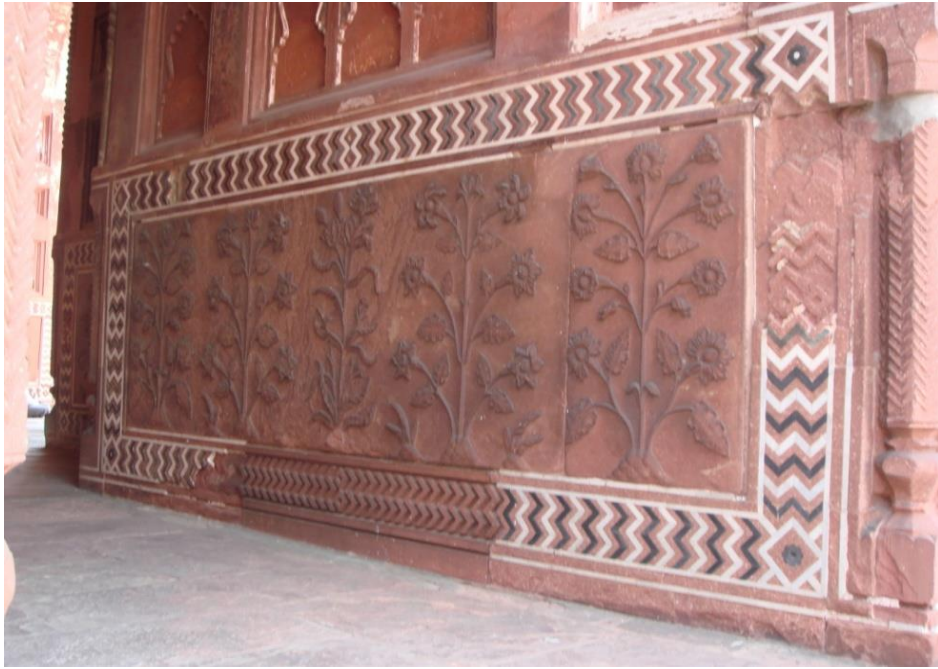
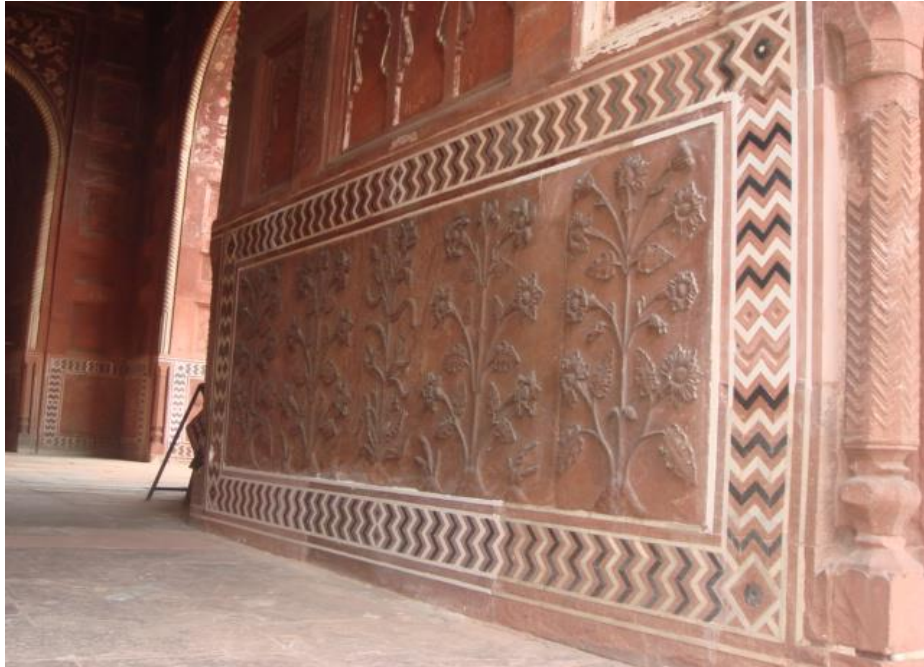
Plate 84

Taj Mahal, Agra: before and after conservation of embossed and inlaid panel, Mehman khana.

The carved veneer panels with floral pattern and the inlaid panels of the Mehman Khana were replaced wherever found missing/damaged. Missing inlay pieces of the wall panels in different shape and size in white and black marble have been restored as per the original (Pls. 84-85). The *dasa* with embossed carvings and flooring of Mehman Khana have also been conserved by replacing the old and damaged red sand stone slabs with new ones in original pattern. Similarly, veneer panels having carved floral pattern, *dila* with depression and inlaid panels of the mosque have been conserved wherever found damaged/missing.

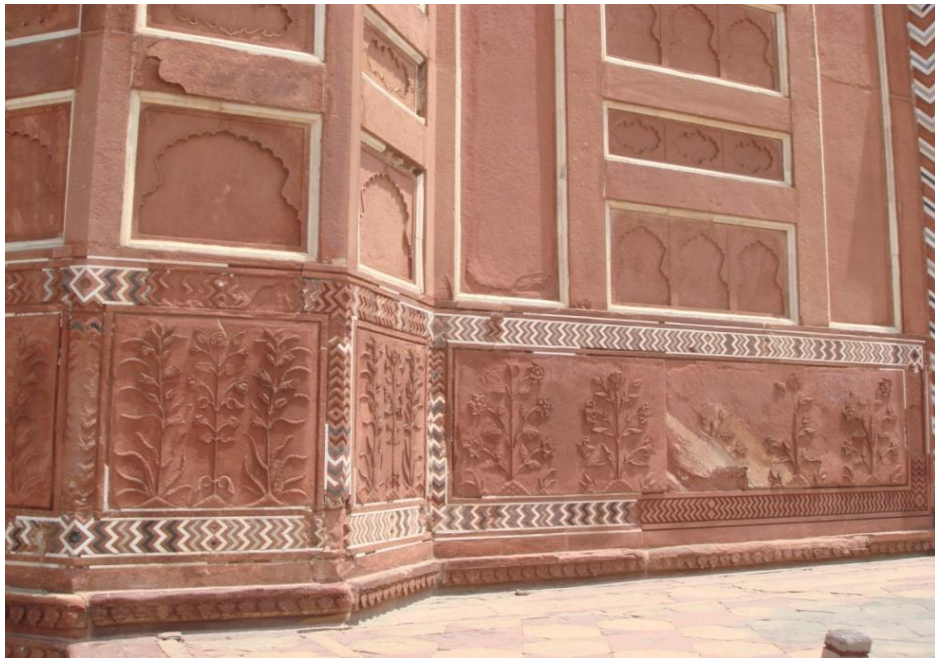
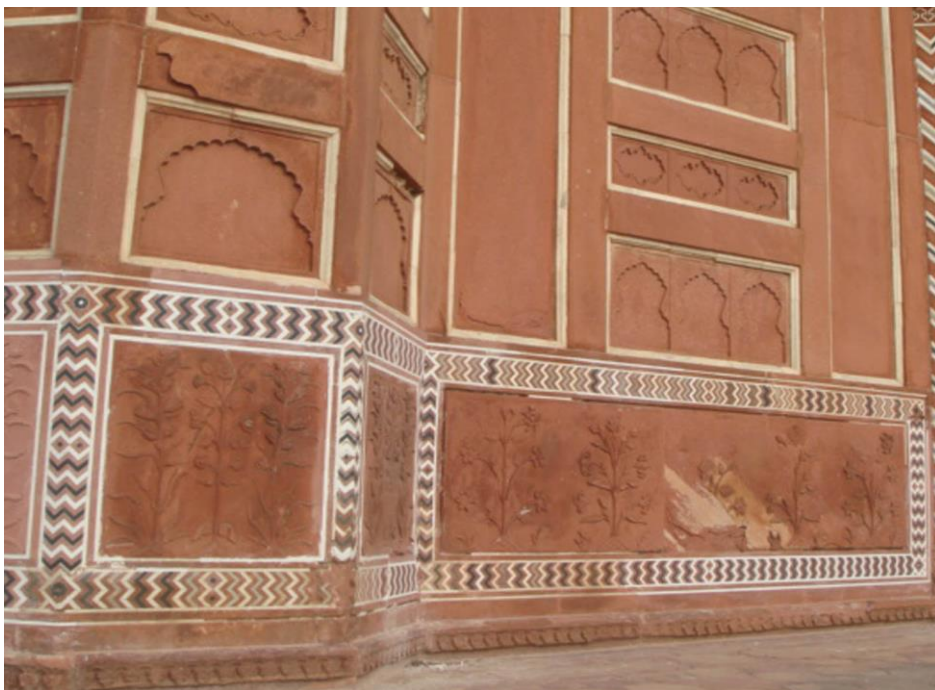
Taj Mahal, Agra: before and after conservation of embossed and inlayed panel, Mehman khana.

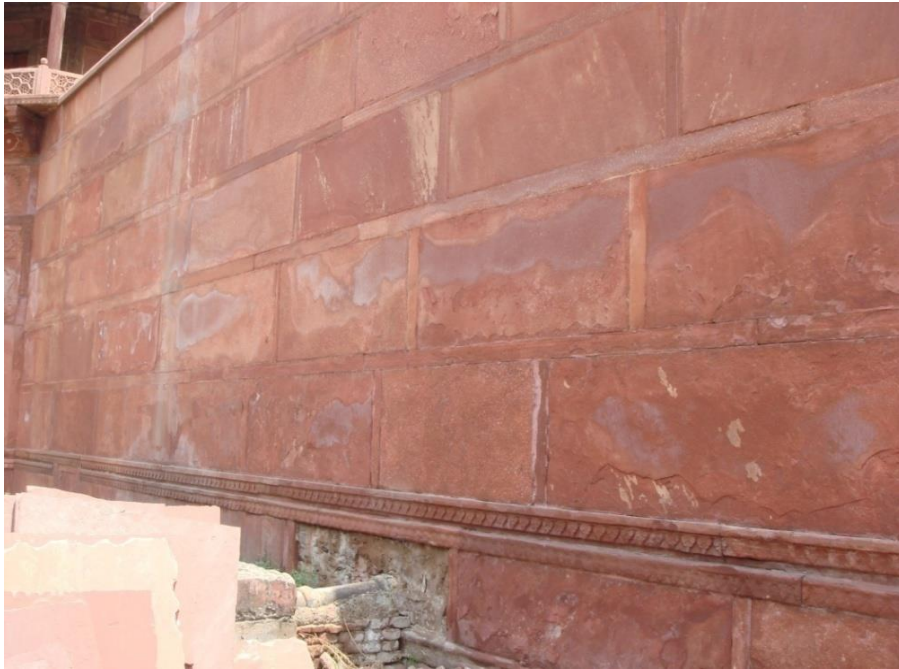
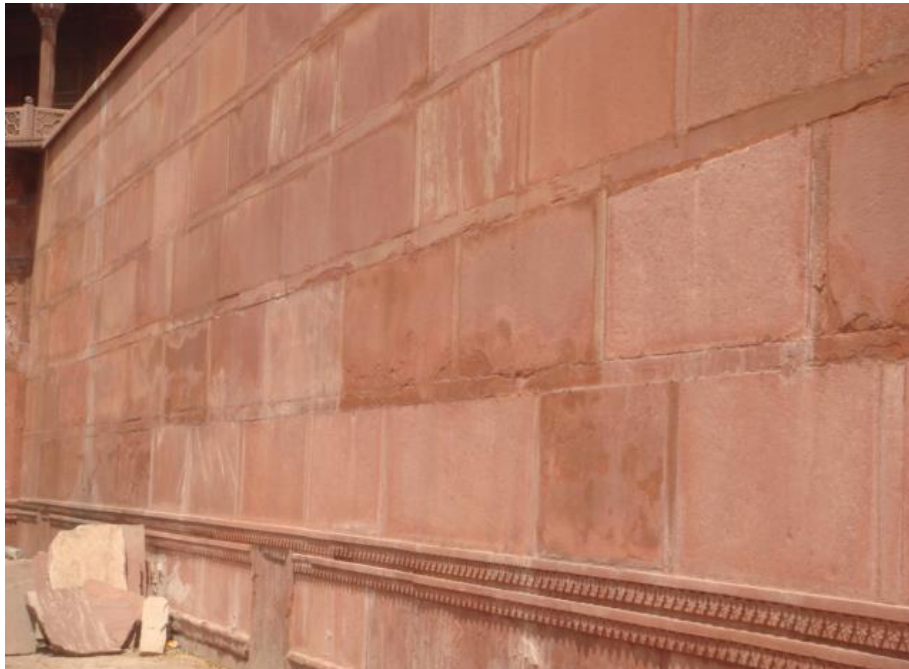
Plate 86

Taj Mahal, Agra: before and after conservation of western enclosure wall.

The decayed and bulged *dasa* with floral pattern in the front veneer, dab, quid of red sand stone of the western side enclosure wall were restored as per original pattern (Pl. 86) and set in lime mortar by using copper dowels in place of iron. The broken and bulged stones from bastion have also been conserved by replacing with red sand stone members as per original.

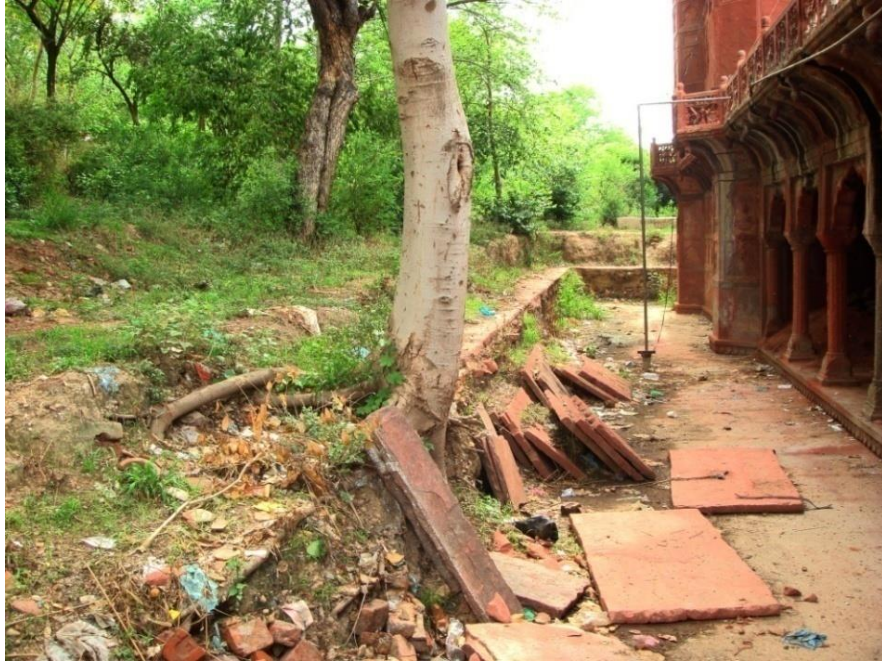
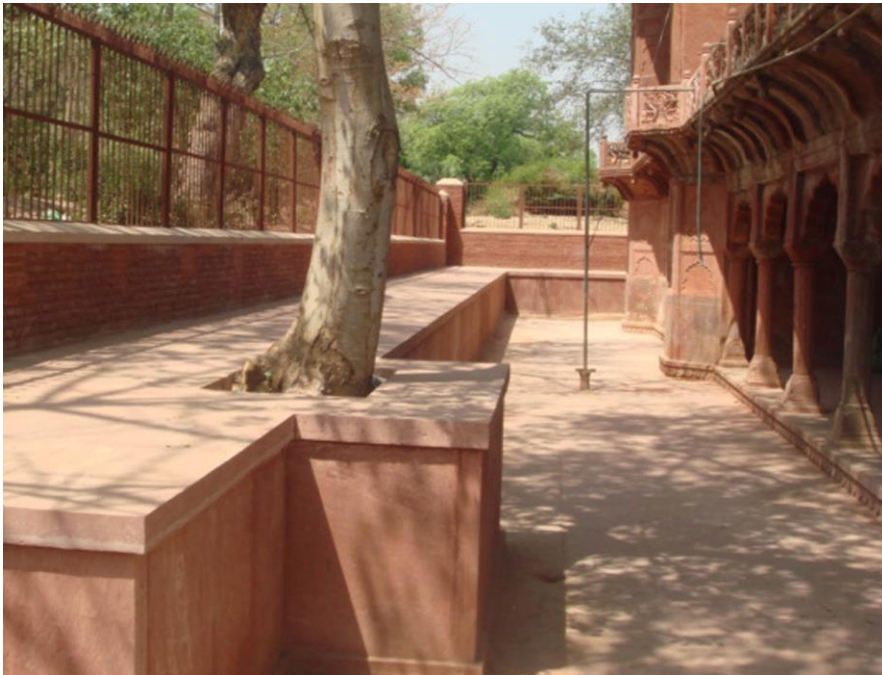
Plate 87

Taj Mahal, Agra: before and after conservation of southern side of the Fatehpuri mosque.

Old, damaged and worn out red sand stone veneer and *dasa* having floral design on front edge had been replaced with new ones as per original (Pl. 87). The work is in progress.
