# INDIAN ARCHAEOLOGY 2007-08

## - A REVIEW

# INDIAN ARCHAEOLOGY 2007-08 - A REVIEW

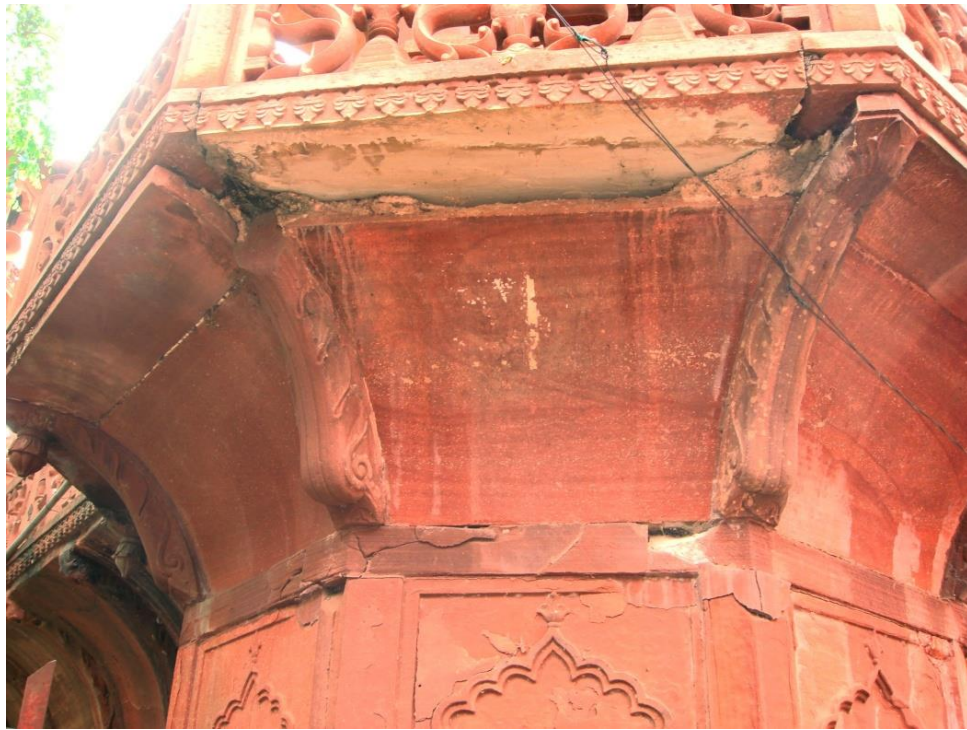
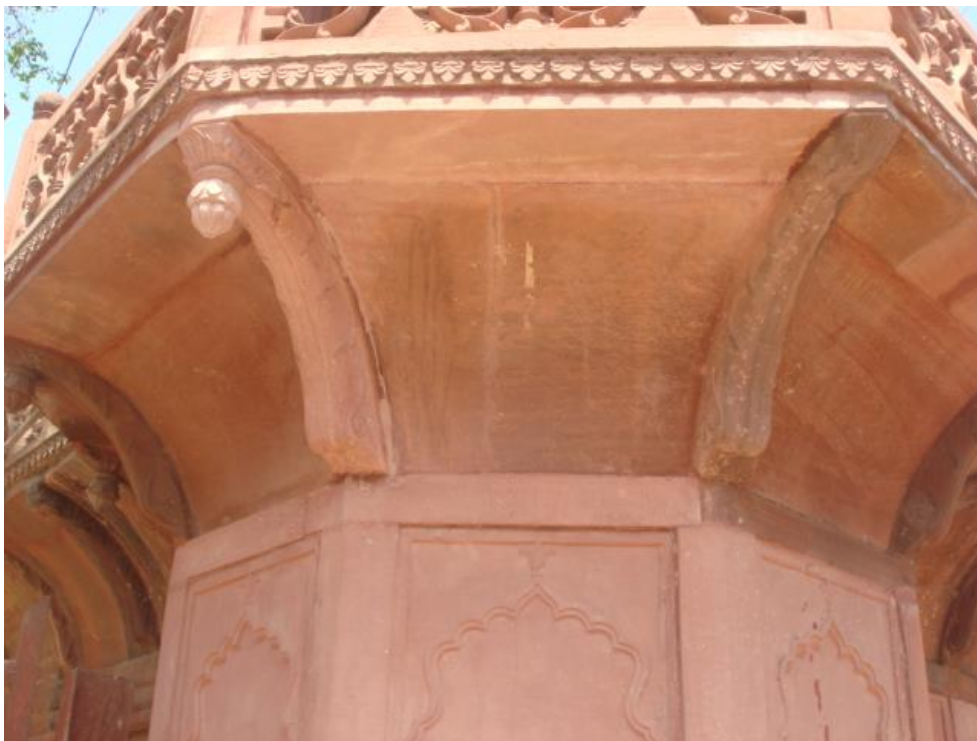
Taj Mahal, Agra: before and after conservation of Fatehpuri mosque, broken and decayed stones,

Fatehpuri Mosque was also taken for conservation. The southern side of the mosque was damaged and full of debris all around it. Retaining walls have been provided on two sides. Old, damaged, worn out red sand stone members at the dab, quid, veneer panels, *jali*, *mutakka* were replaced as per original (Pl. 88). Pinnacles of white marble and red sand stone were restored wherever missing as per the original (Pl. 89). Grill fencing has also been provided over brick tile wall all around the mosque after removal of debris.

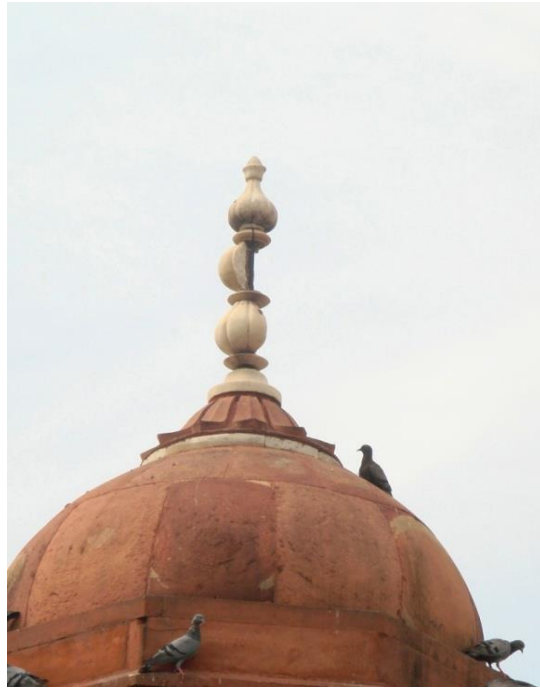
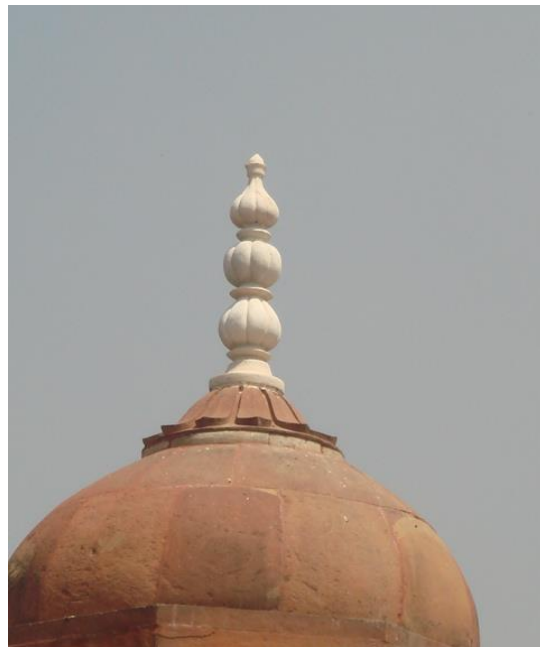
Plate 89

Taj Mahal, Agra: before and after conservation of Fatehpuri mosque, broken pinnacles.

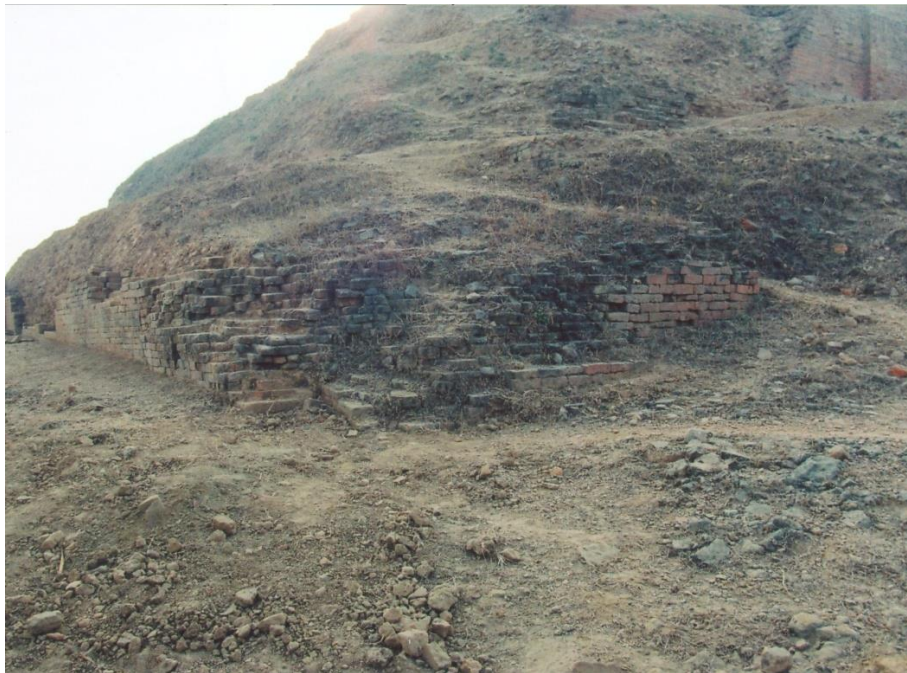
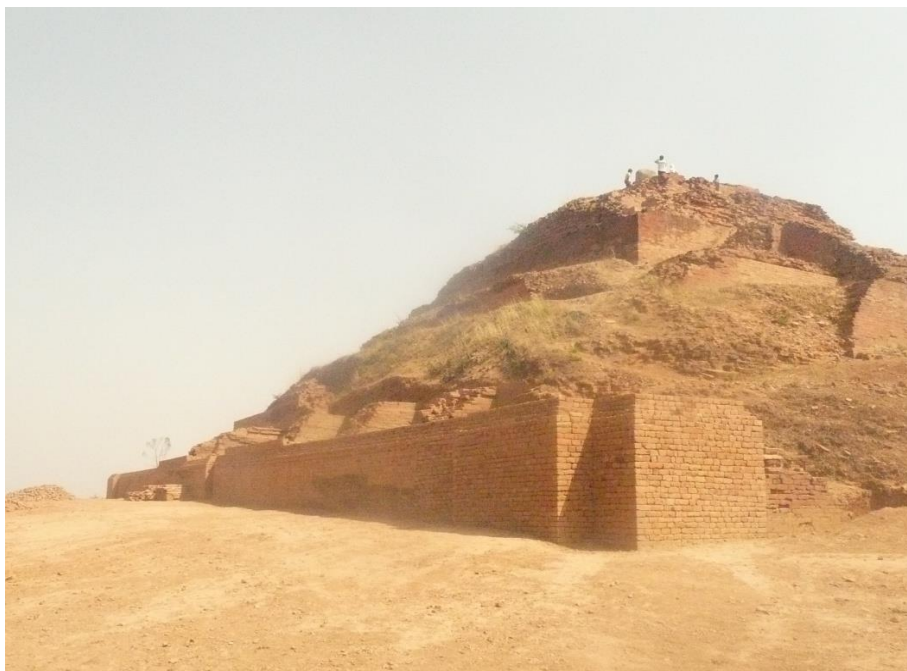
Ahichchhatra: before and after conservation of Temple-1.

The excavated dilapidated temple site was covered with vegetation; brick walls of terraces at several locations had either collapsed or bulged out. The vegetation was removed from all around the structure. The bulged walls at different location were repaired by using the available material. The outer brick wall and the boxes were full of fallen debris and out of plumb. The debris was removed and the out of plumb wall taken out and reset again using the same material (Pl. 90). The fallen debris within

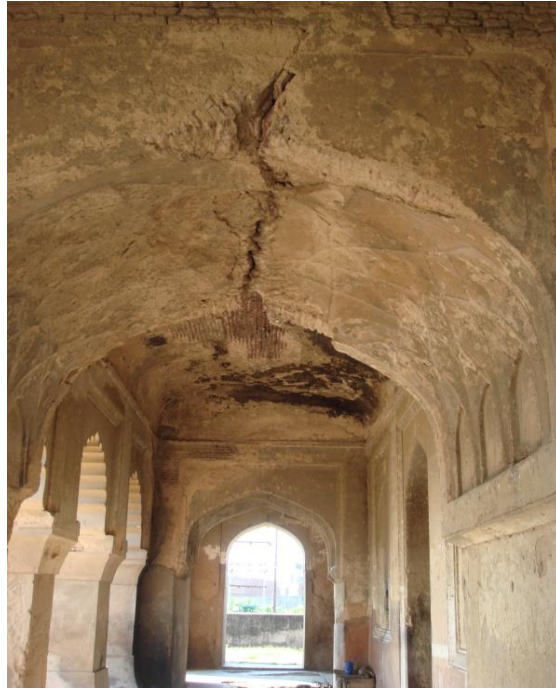
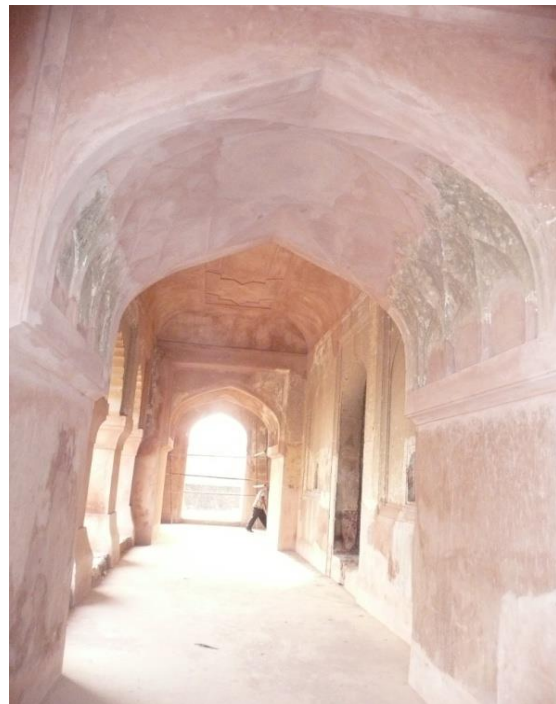
Plate 91

Tomb of Iklas Khan, Badaun: before and after conservation of cracked ceiling.

The cracks of the roof and ceiling were repaired by using traditional mortar. The decayed plaster of the wall were removed and re-plastered. The interior of the tomb was restored to its original level by removing the accumulated earth and then was re-laid in lime concrete. The boundary wall of the tomb was also repaired at different places (Pl. 91).

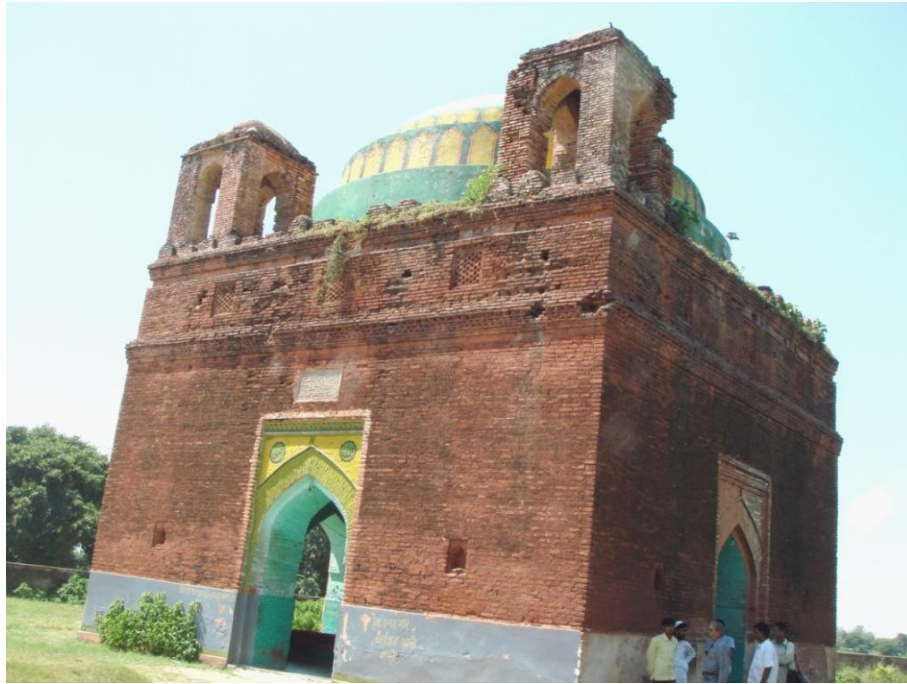
Badaun: before and after conservation of tomb of Imadul Mulk alias Pisan Hari-Ka-gumbaz.

Locally known as Panch peer, the dead plaster of the wall of this tomb was removed and the exposed *lakhauri* brick wall has been pointed with traditional mortar. The minarets were also repaired (Pl. 92). The modern paint on the dome has now been removed and its original colour was restored.

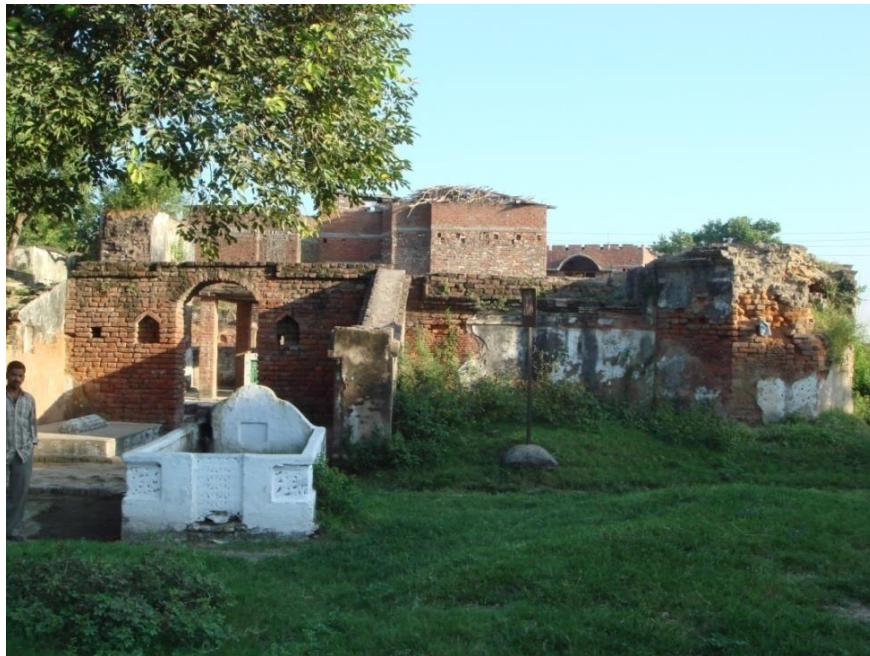
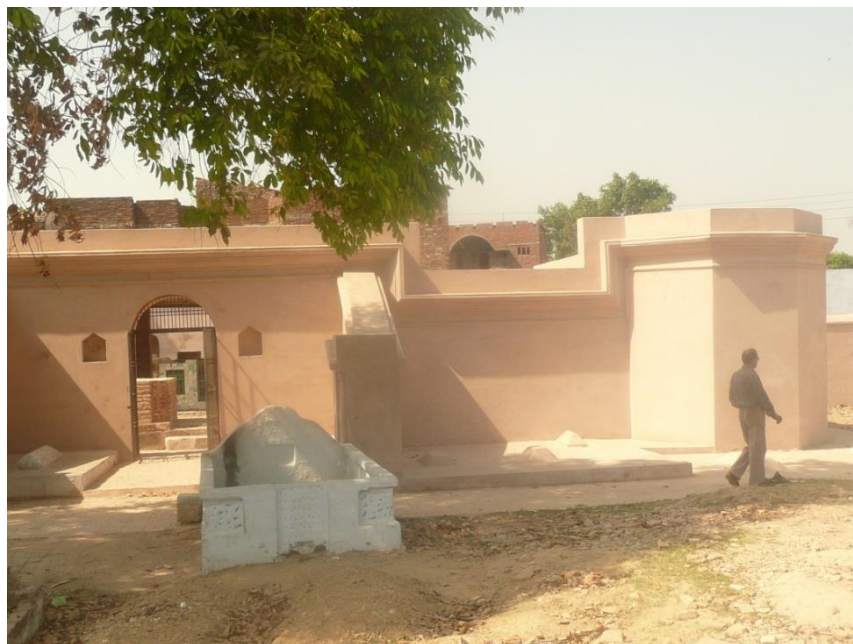
Bareilly: before and after conservation of tomb of Hafiz-ul-Mulk Rahmet Khan, the Rohilla Chief.

dilapidated condition and on the verge of collapse. In 1<sup>st</sup> phase the compound wall, the subsidiary graves and sunken area and the remaining original structure of main tomb including the entrance was repaired (Pl. 93). An approach brick pathway from main road to the monument has been provided (Pl. 94). It has been proposed to restore the original dome and remove the R.C. roof in future in order to bring the monument to its original shape.

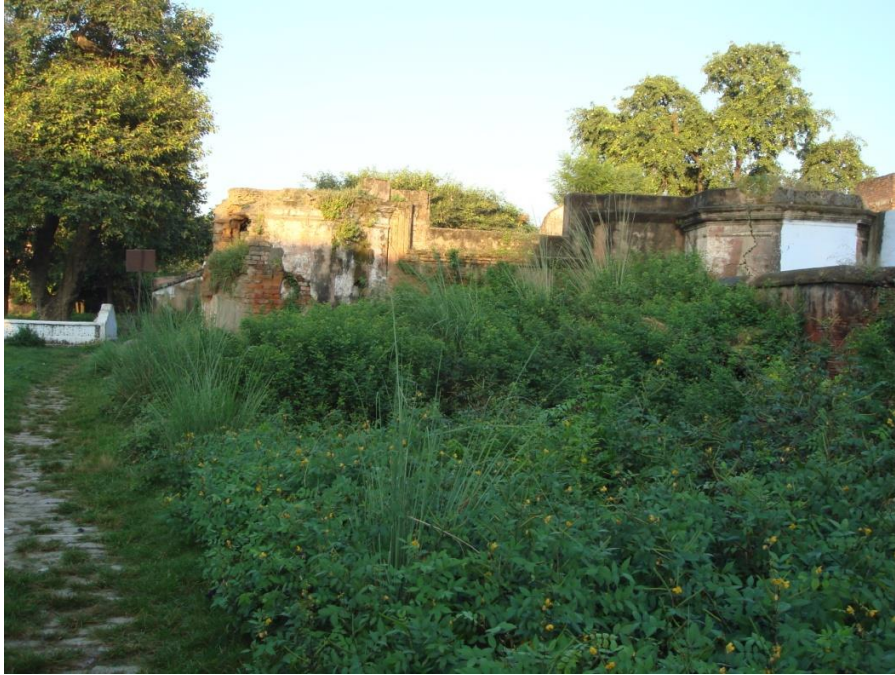
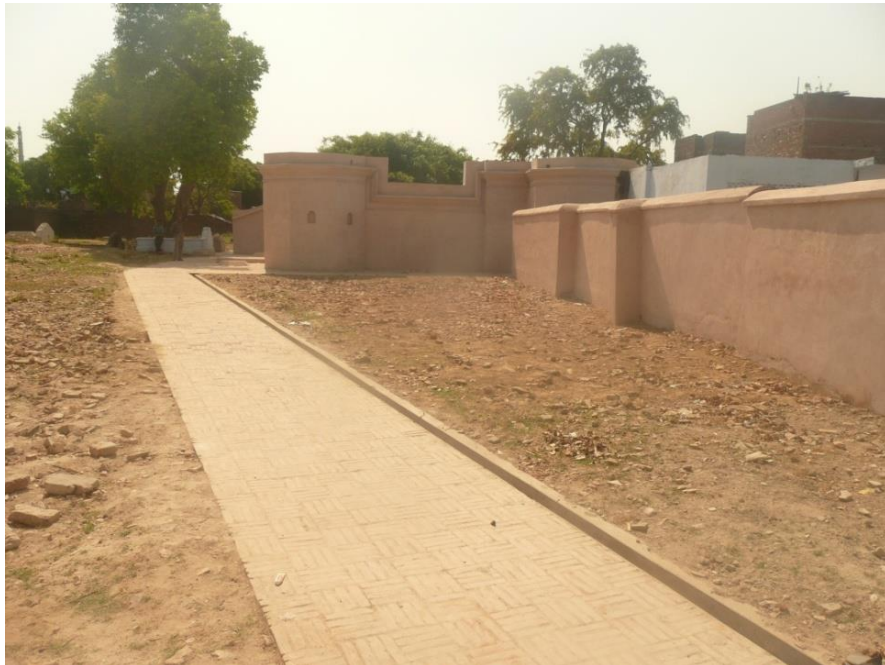
Plate 94

Baraaidly: before and after conservation of tomb of Hafiz-ul-Mulk Rahmet Khan.

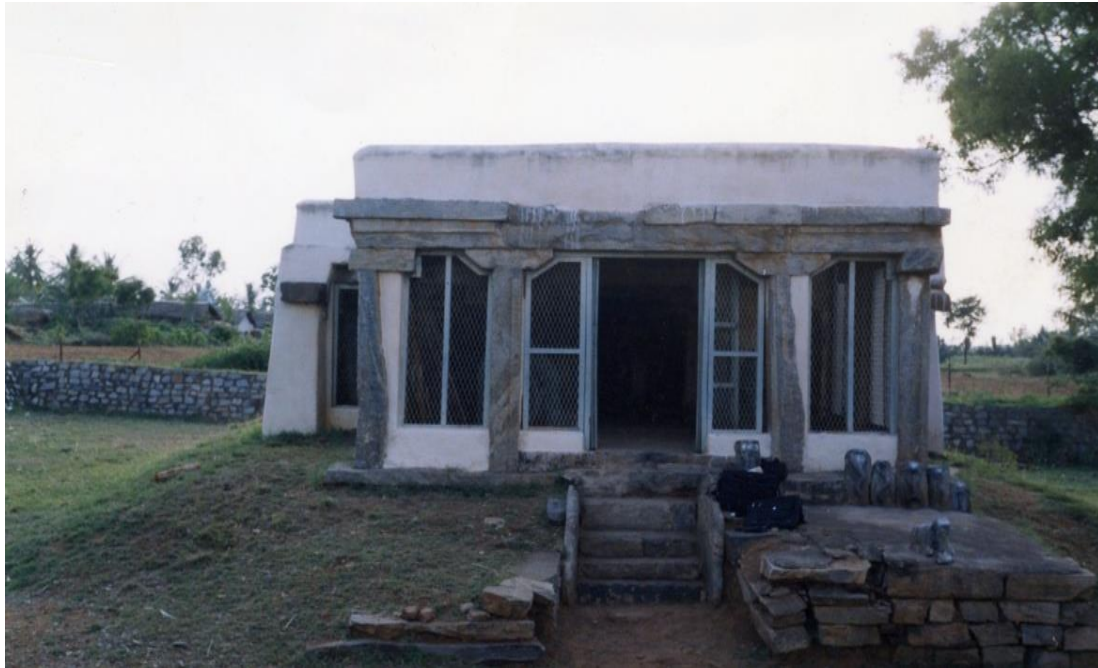
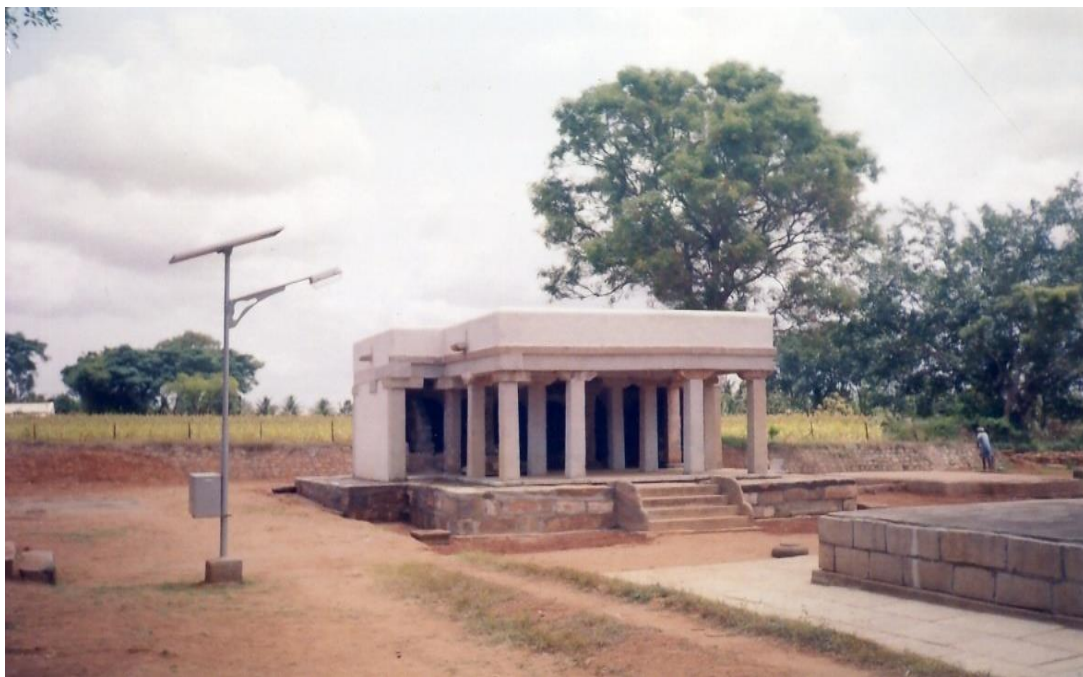
Narasamangala: before and after conservation of Rameshwara temple.

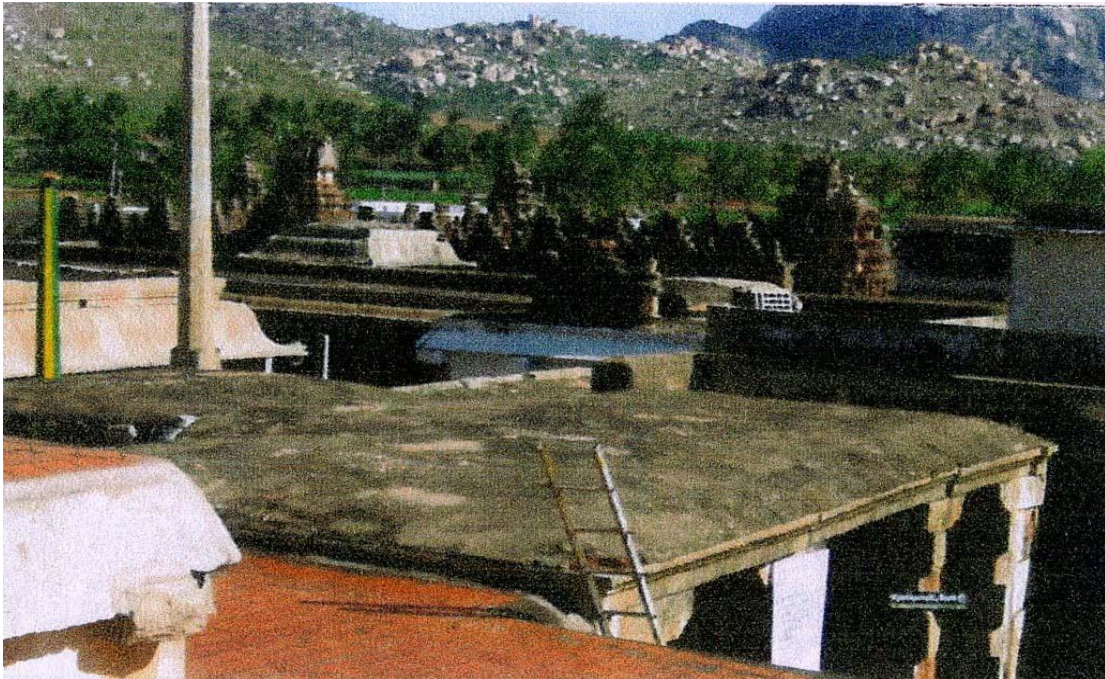
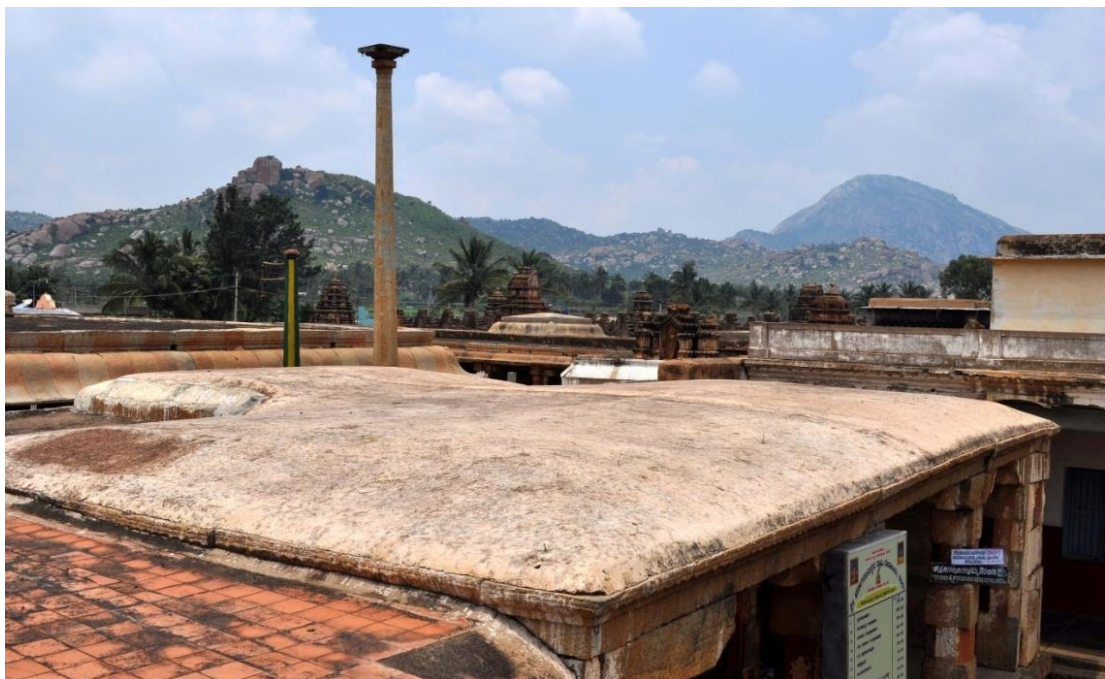
Plate 96

Nandi: before and after conservation of Bhoganandeshvara temple.

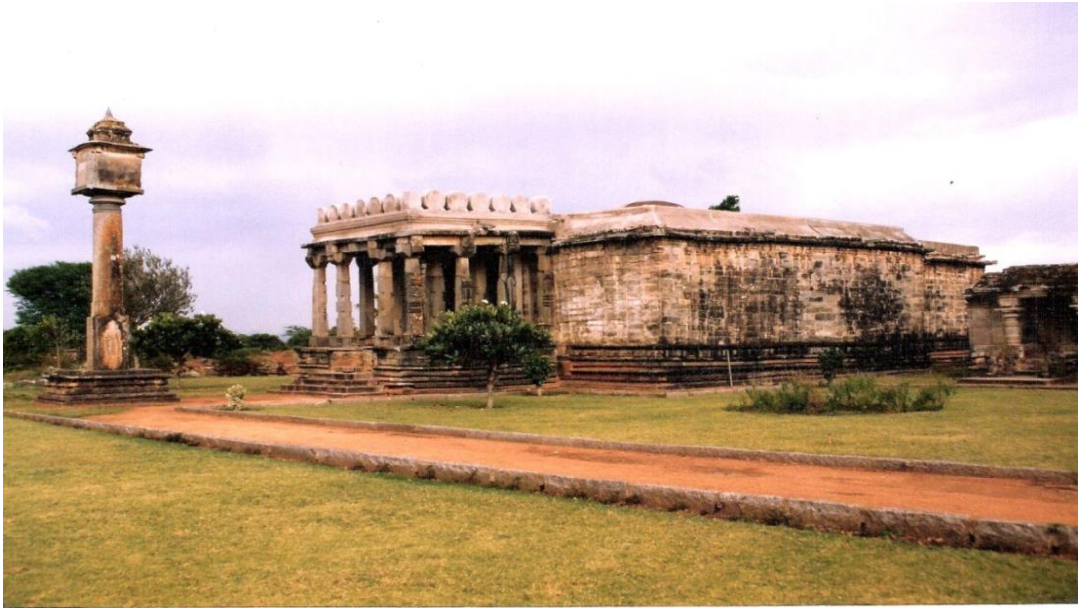
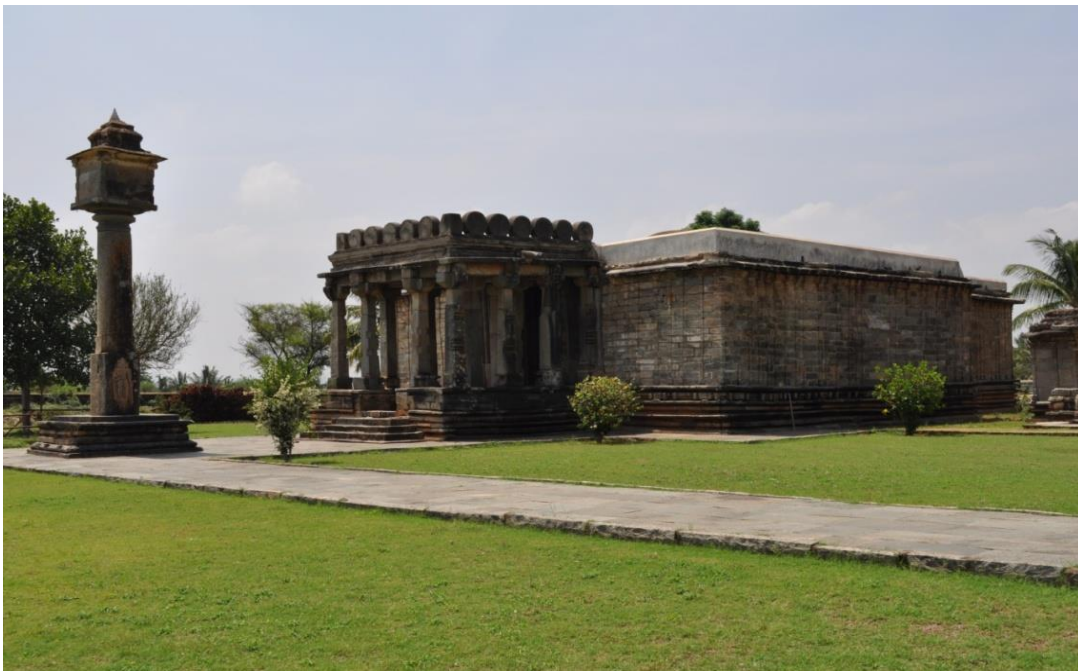
Halebid: before and after conservation of Parsvanatha Basadi.

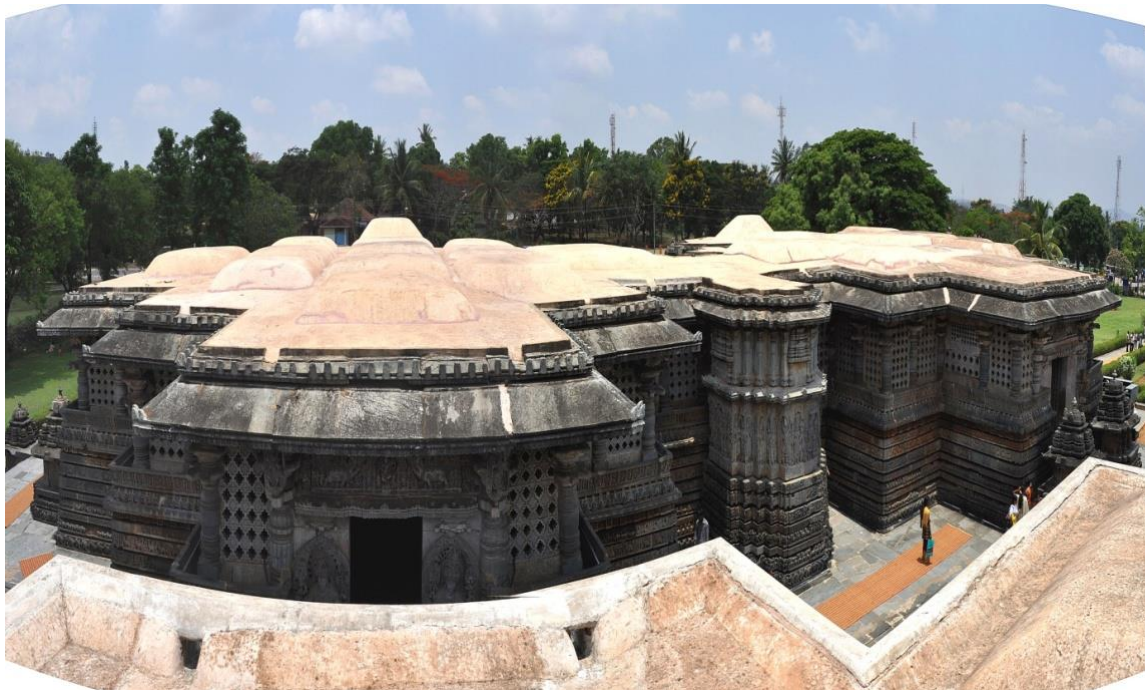
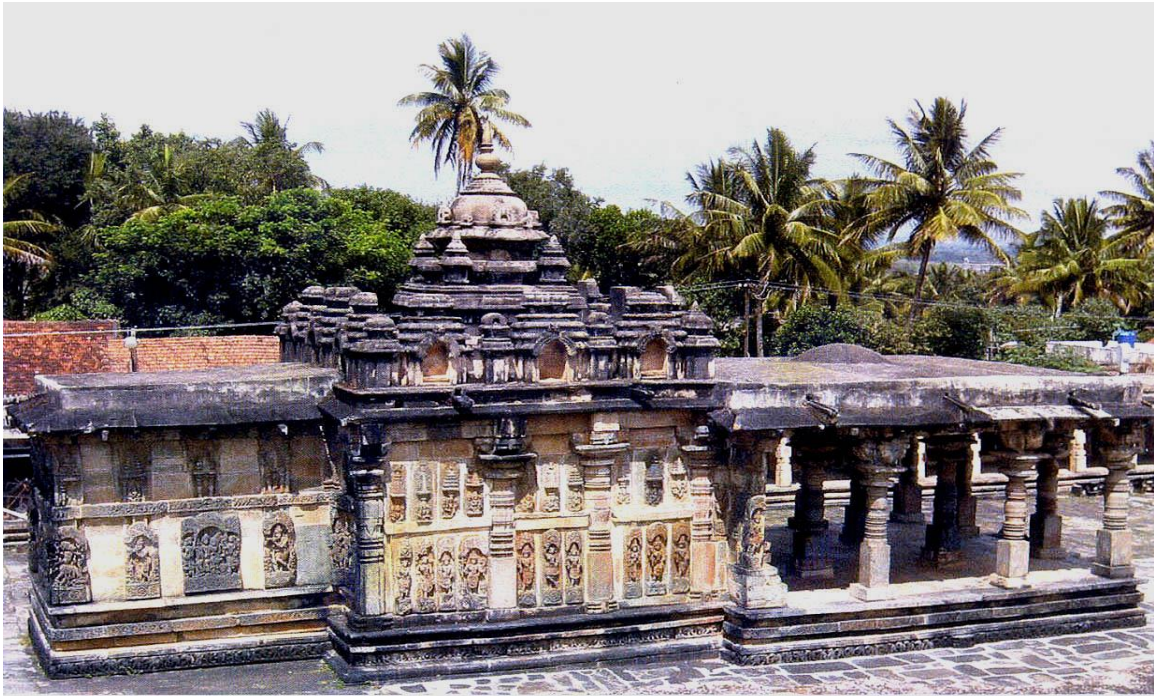
Halebid: before and after conservation of Hoysaleswara temple.

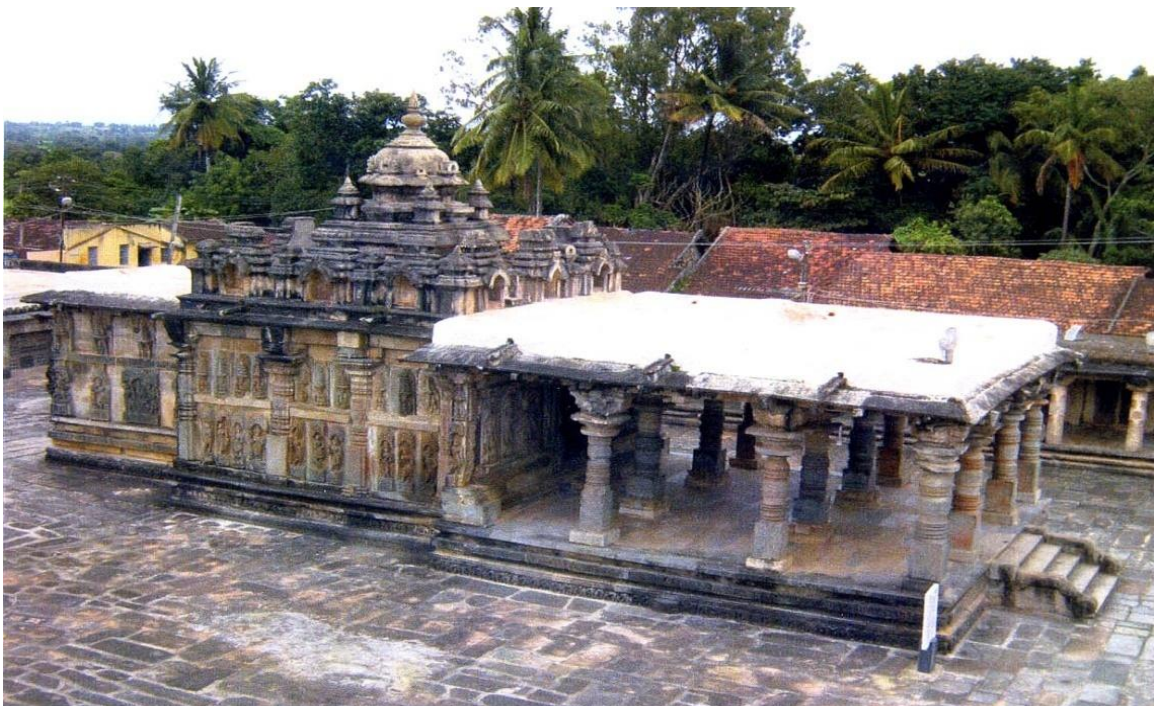
Belur: before and after conservation of Rangnayaki Amman shrine, Kesava temple.

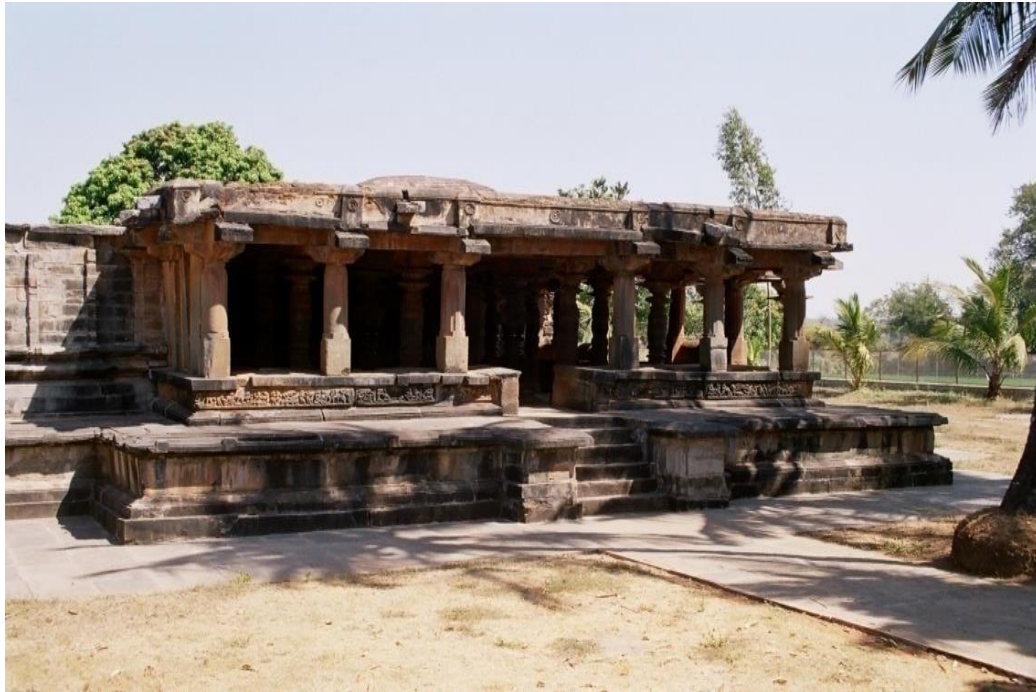
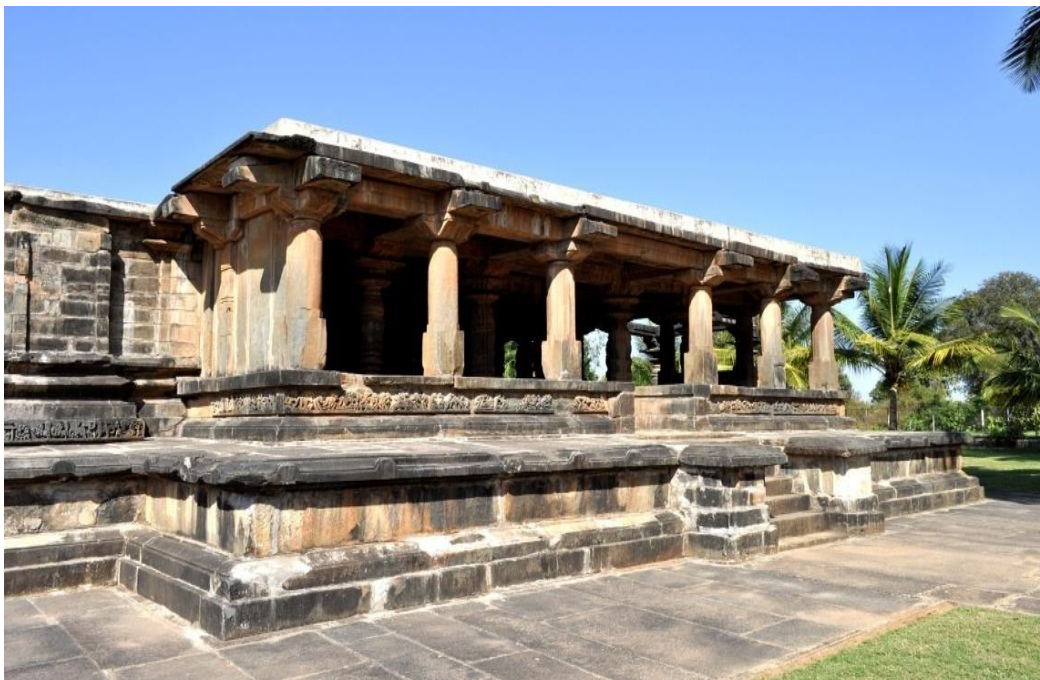
Plate 101

Belligavi: before and after conservation of Tripurantresvara temple.

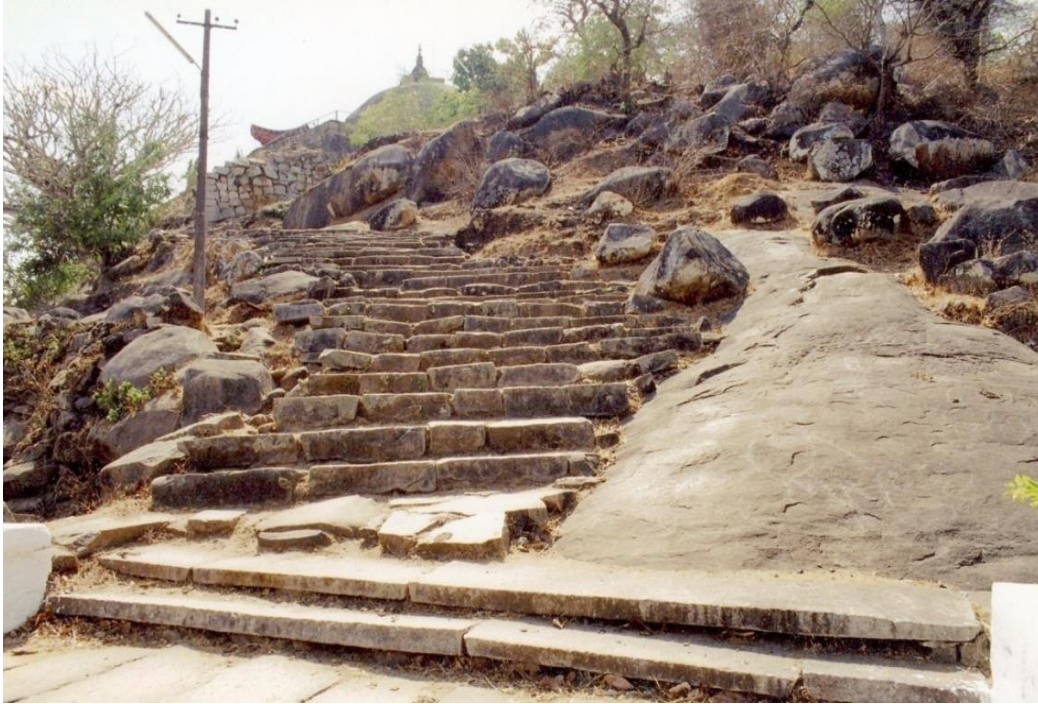
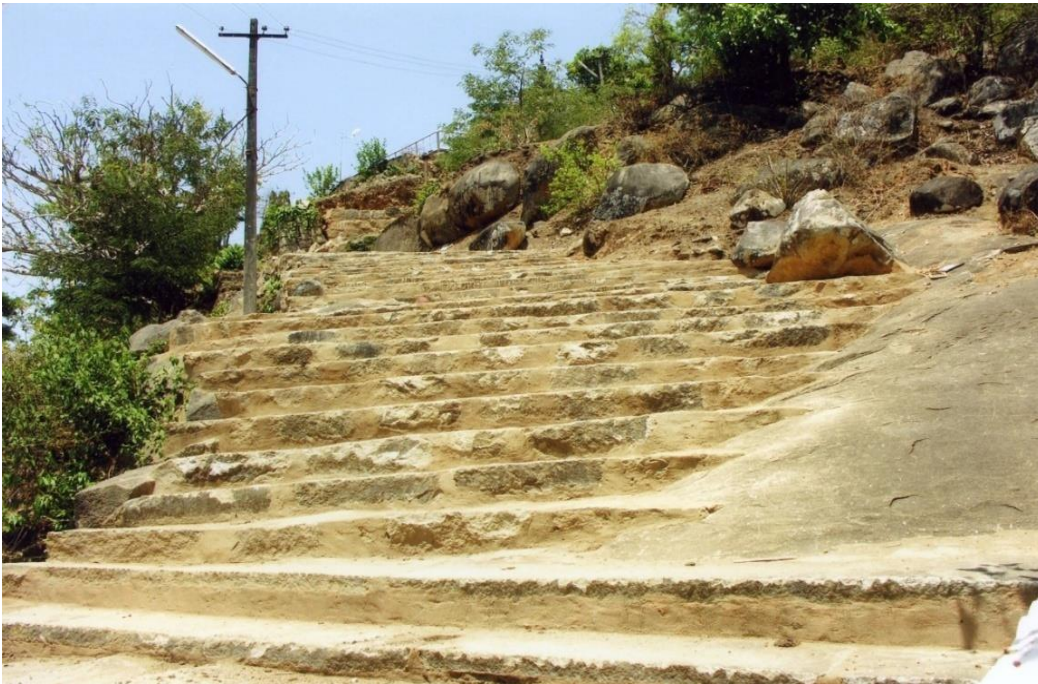
Chandragutti: before and after conservation of fortress and Renuka temple.

The entire monument was dismantled after removing the heavy growth of tree roots and other vegetation and after proper documentation the same was reconstructed same after strengthening the foundation. A retaining wall on northern side of the Ishwara temple has been constructed to arrest soil erosion and to prevent damage to the monument (Pl. 102).

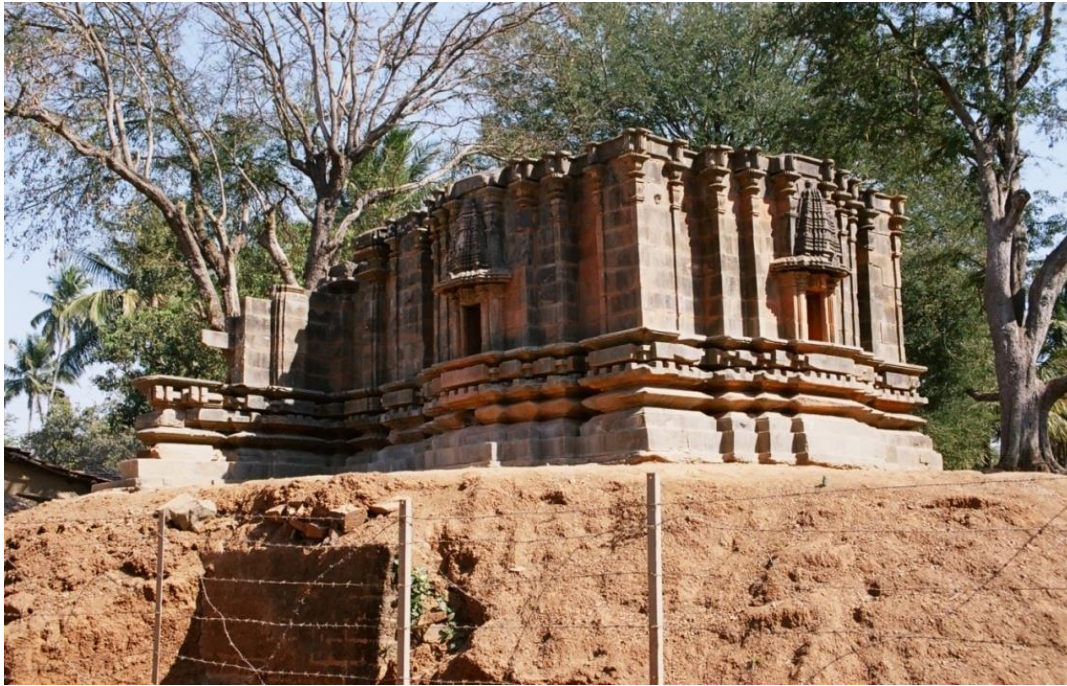
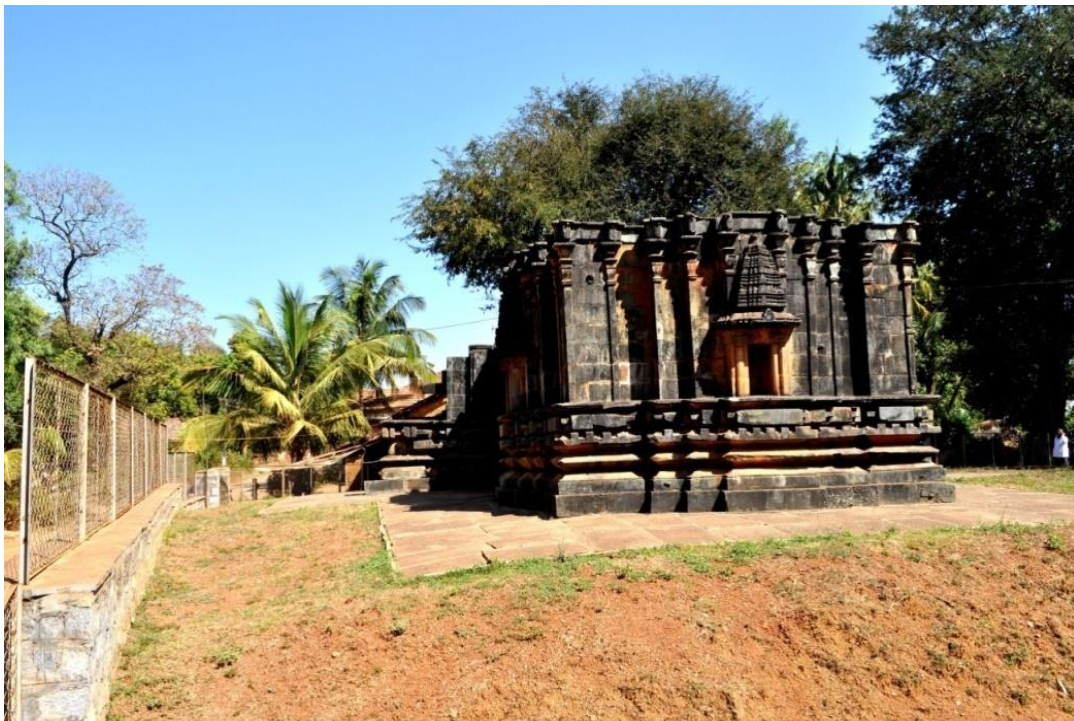
Plate 103

Udri: before and after conservation of temple and inscription.

In continuation of previous years work the restoration of missing and damaged platform on the north side on which the temples stand is in progress by way of replacing the damaged stone blocks with original fallen sand stones available at the site (Pl. 103).

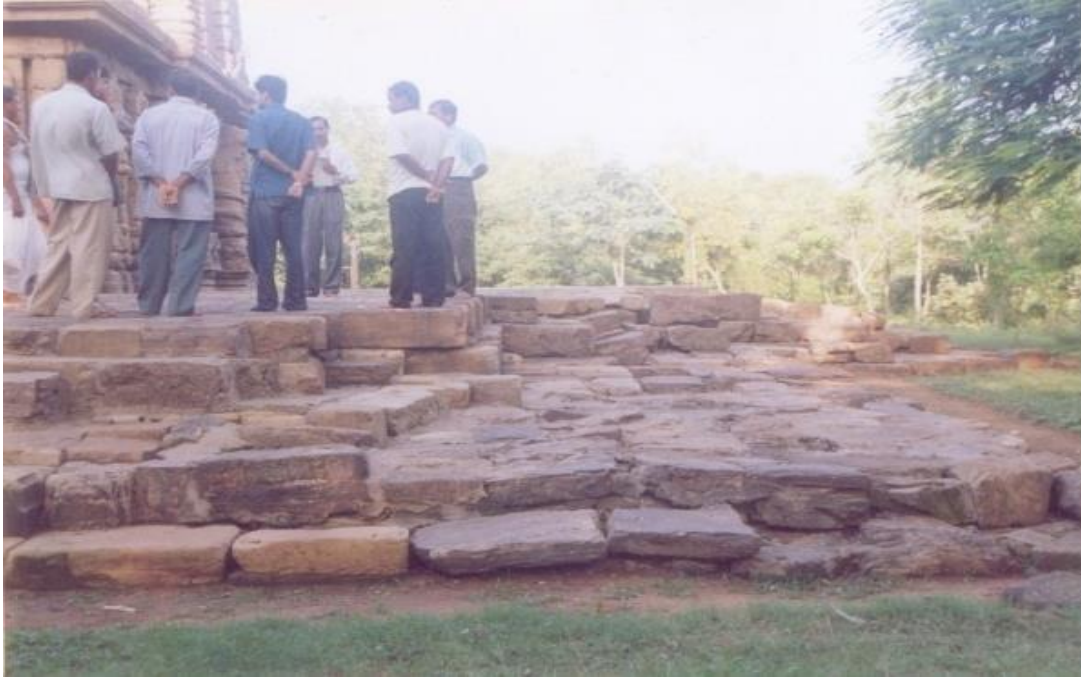
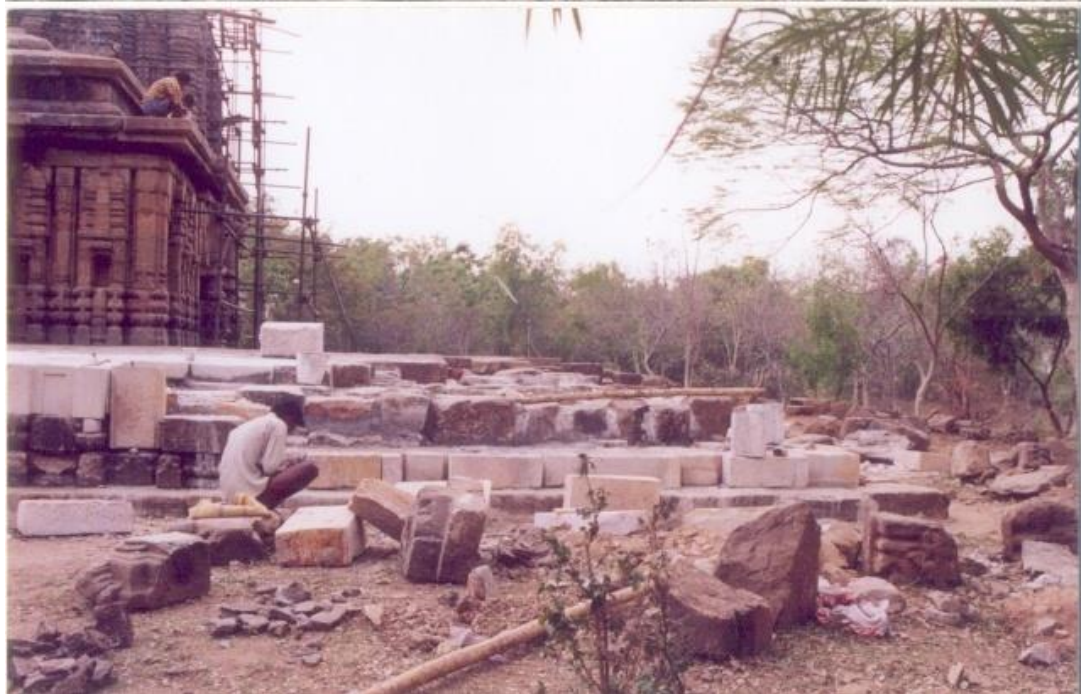
Gandharadhi: before and after conservation of Nilamadhava and Siddhesvara temples.

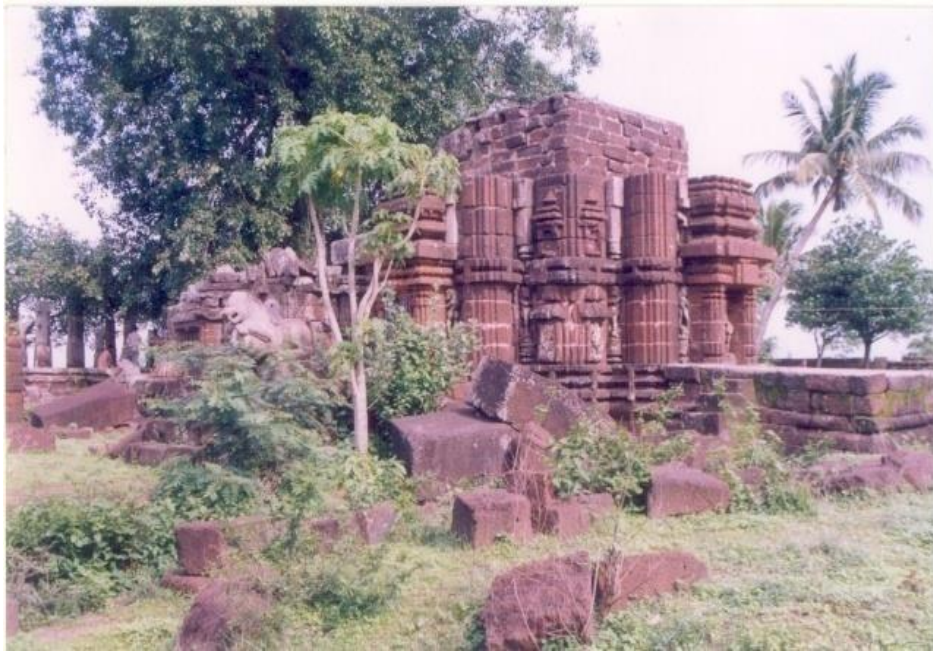
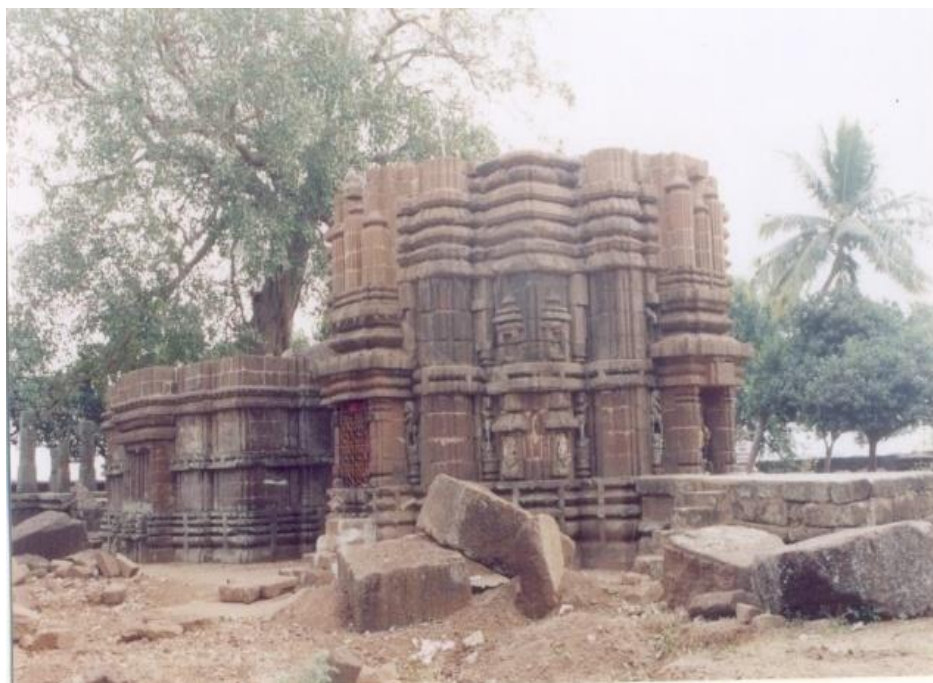
Choudwar fort, Badhi: before and after conservation of Kedaresvara Mahadeva temple.

In continuation of previous year's work, the structural repair to the main temple has been completed by way of removing the broken and damaged stone members from the top to the ground level and re-fixing the collected stone blocks from the site with traditional combined lime mortar as per original (Pl. 104).
