# INDIAN ARCHAEOLOGY 2007-08

## - A REVIEW

# INDIAN ARCHAEOLOGY 2007-08 - A REVIEW

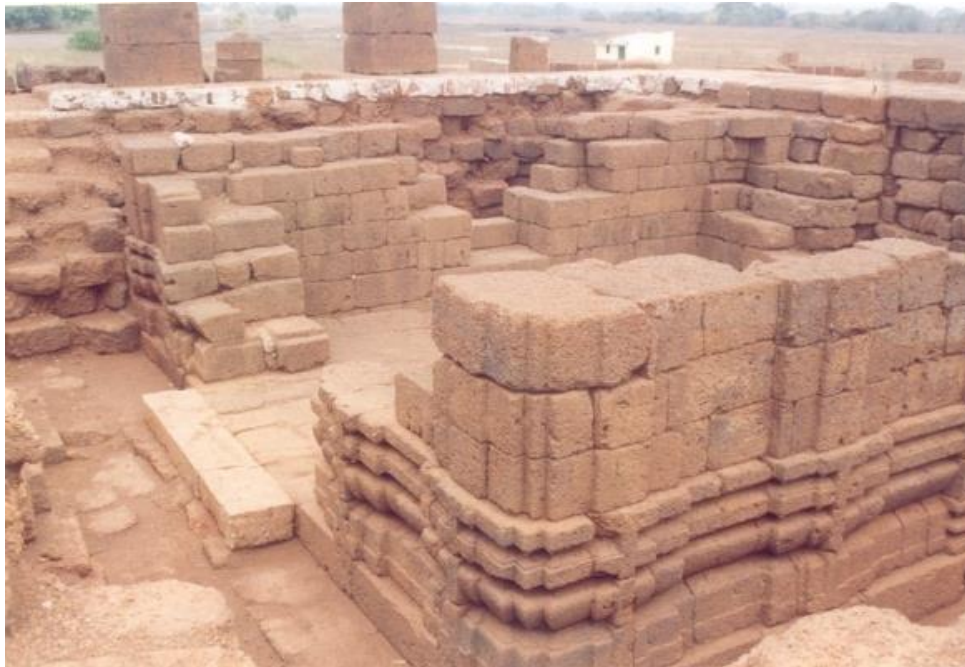
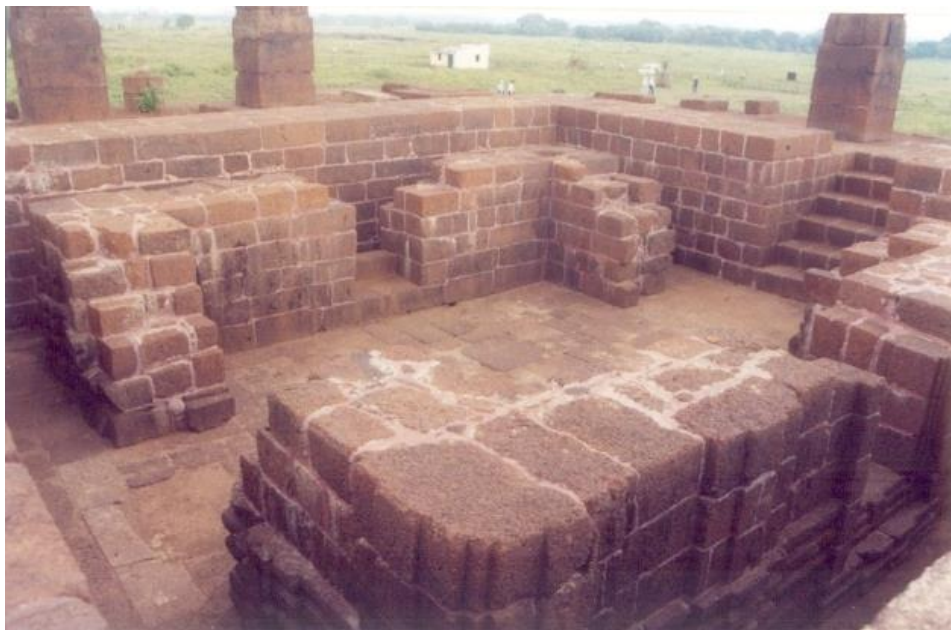
Choudwar fort, Badhi: before and after conservation of excavated temple remains.

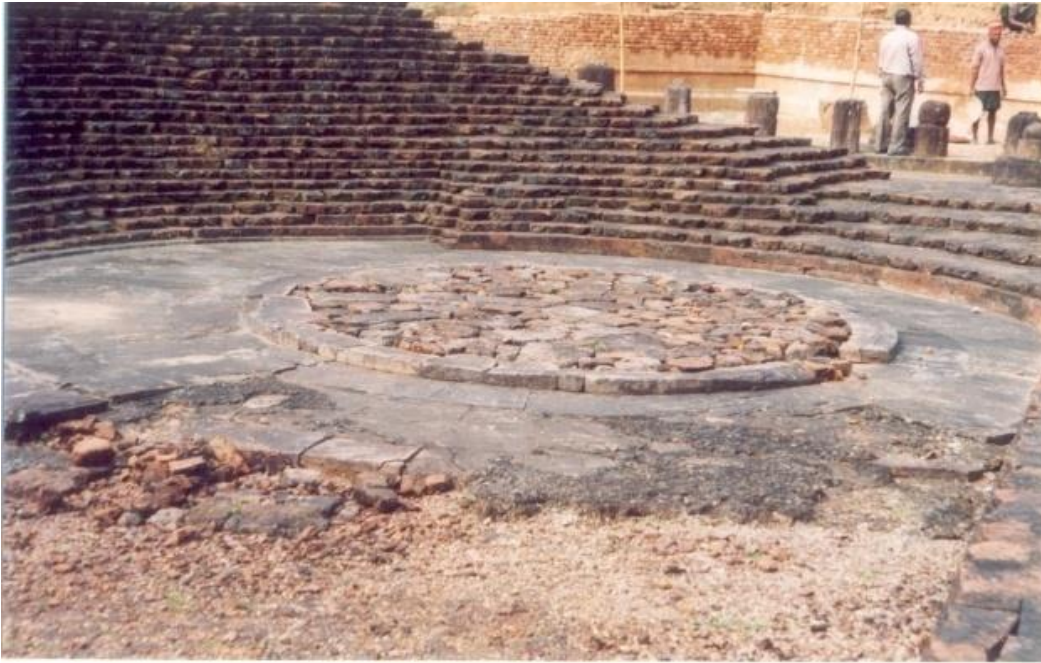
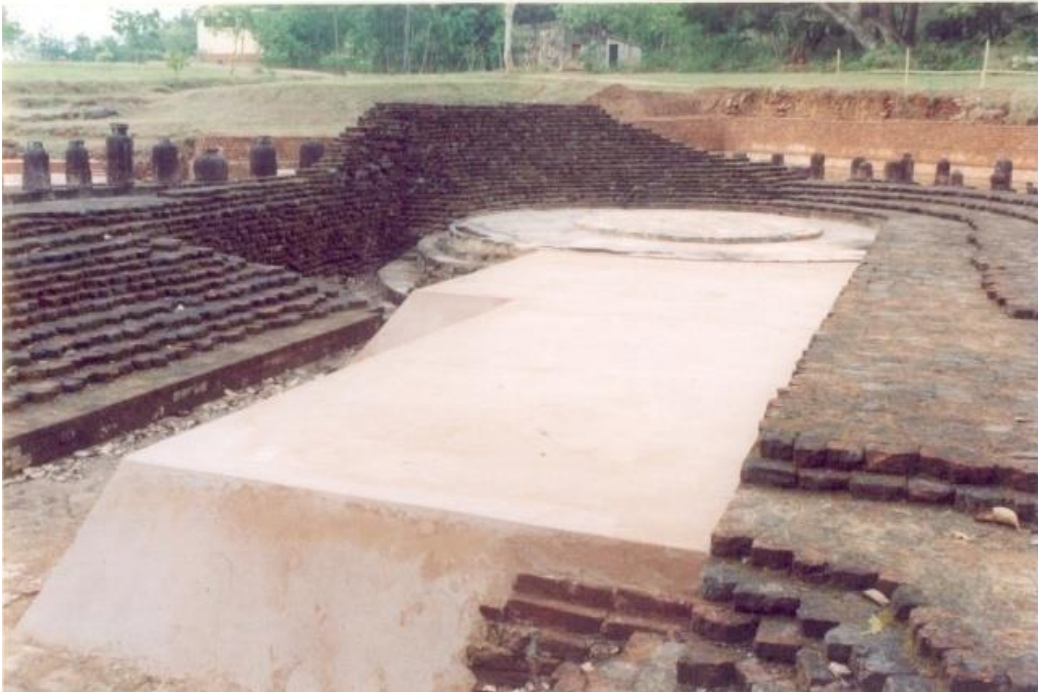
Lalitagiri: before and after conservation of *Chaityagriha*.

The conservation work of the excavated votive stupas in the proximity of the *chaityagriha* has been taken up by way of re-fixing the dislodged architectural members in their original position with traditional combined lime mortar and the work is in progress. Water tightening to the *chaityagriha* has been completed by way of pointing, joint sealing and plastering with traditional lime mortar. Repair to the enclosure wall of the *chaityagriha* has also been undertaken by way of resetting the out of plumb bricks to their original position with traditional lime mortar and the work is in progress (Pl. 106).

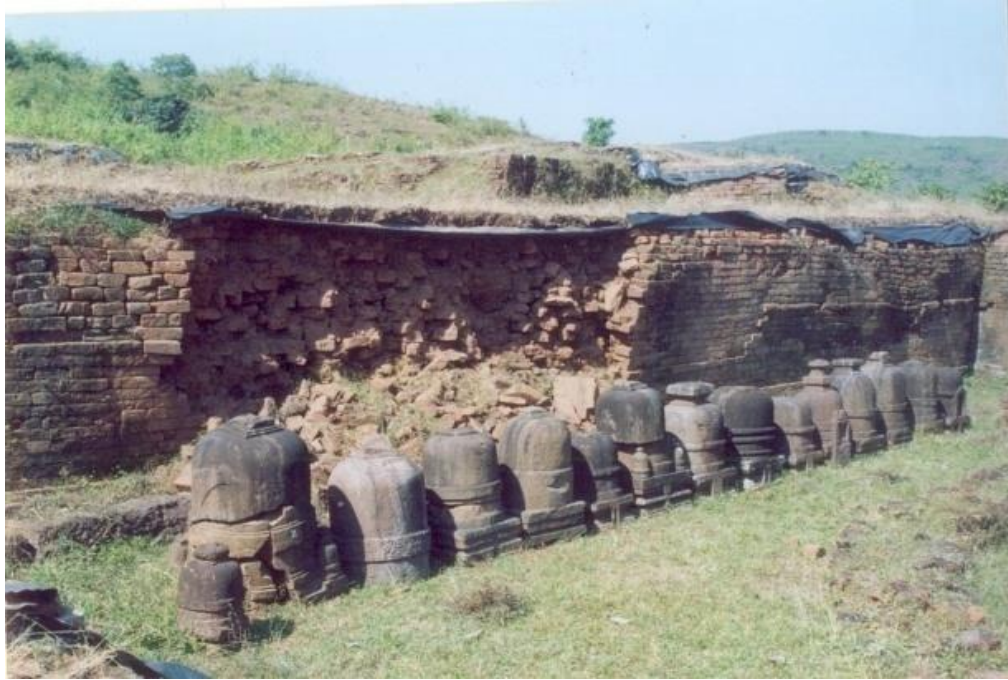
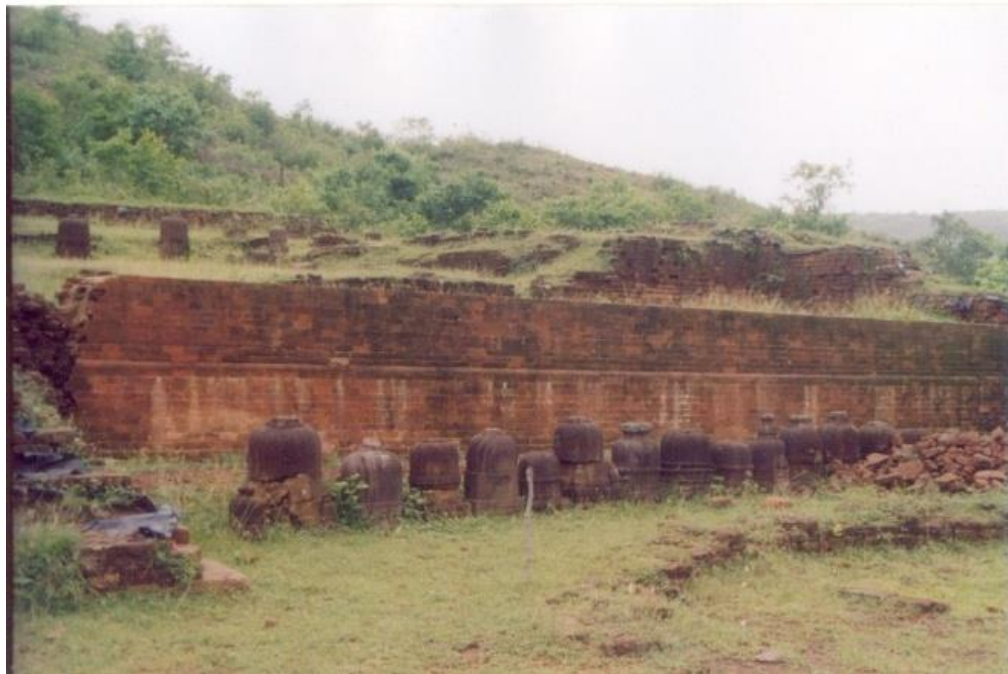
Plate 107

Udayagiri – 2: before and after conservation.

The conservation work of Monastery 2 has been completed by way of resetting the damaged and out of plumb walls to their original position with traditional lime mortar. The conservation work of the shrine complex has been undertaken by way of resetting the damaged out of plumb walls to their original position with traditional lime mortar. Resetting of the excavated brick structures of shrine complex is also in progress (Pl. 107).

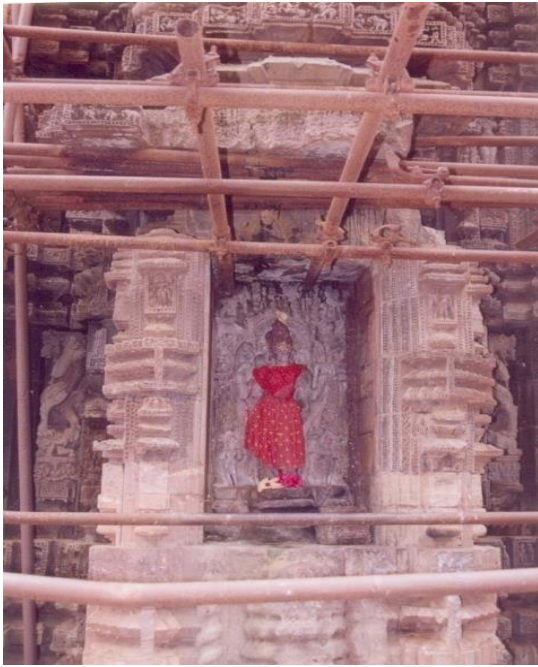
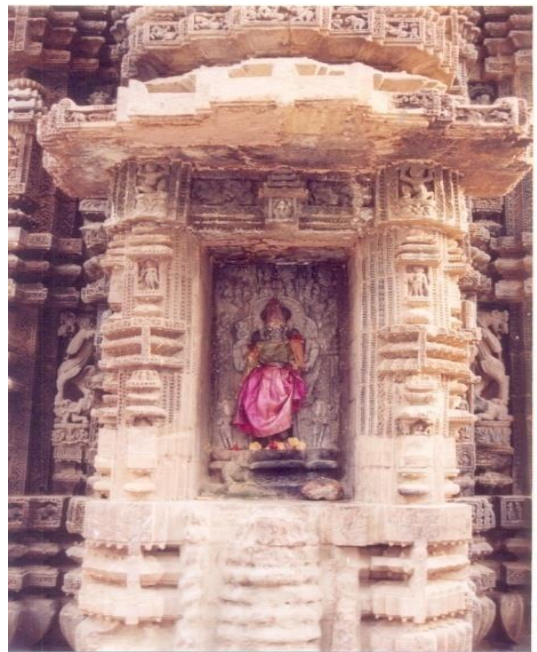
Plate 108

Banapur: before and after conservation of *Parsvadevata* niche, Dakshyaprajapati temple.

Resetting of the fallen/damaged architectural members to the north and south side *parvadevata* niches has been completed by way of dressing *khondalite* stone blocks. Besides, repair to *rosaghara* and boundary wall has also been completed (Pl. 108).

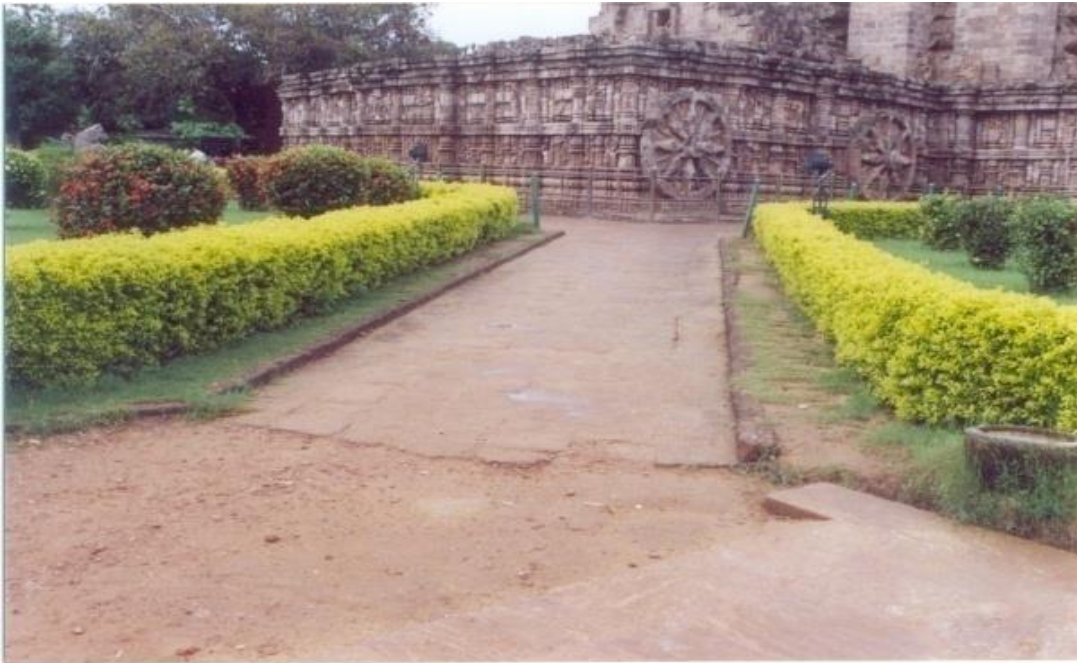
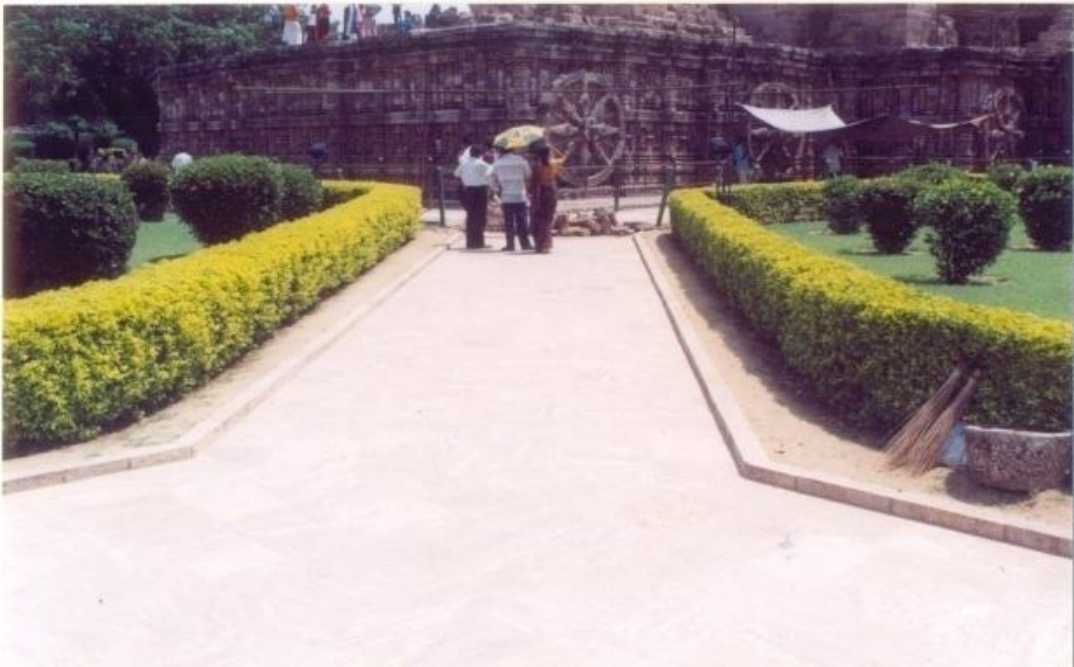
Plate 109

Sun temple, Konark: before and after conservation of the damaged floor on the northern side.

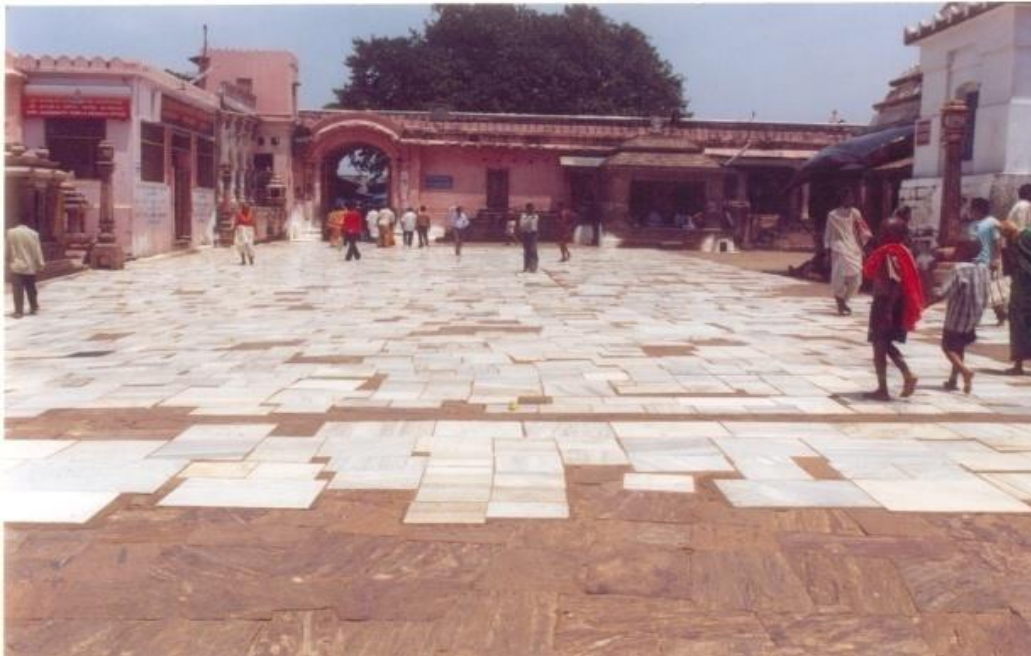
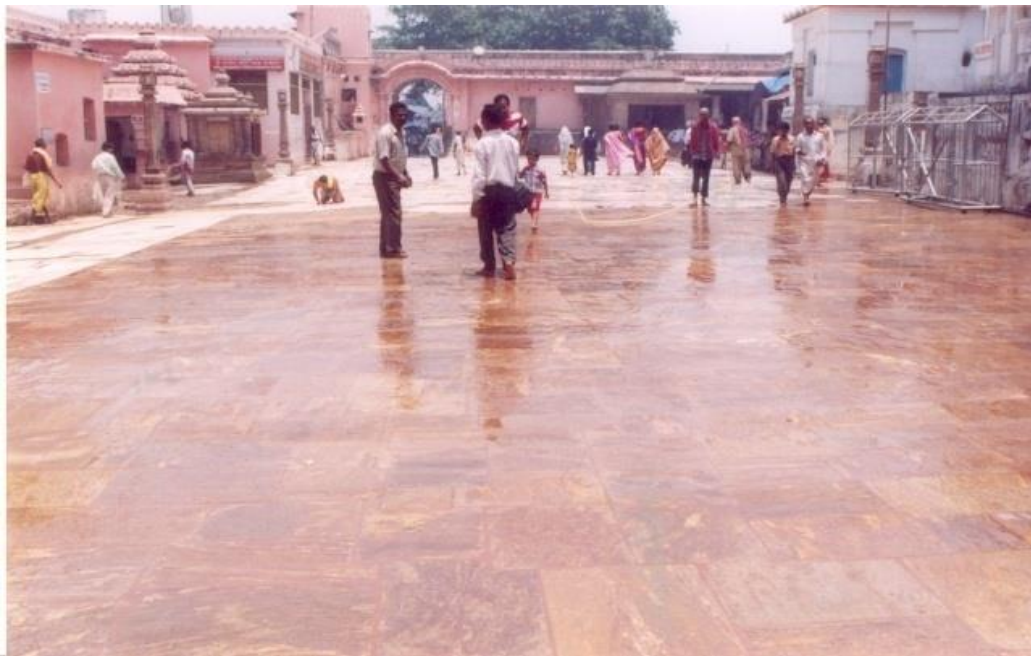
Puri: before and after conservation of Jagannatha temple complex.

In continuation of earlier year's work, structural repair to the Jagannatha temple is resumed by way of resetting the bricks, core filling, pointing to the joints with traditional

combined lime mortar as per original. The restoration work of the missing *sikhara* of the temple and laying of brick apron around Rasikraya temple has been completed. Restoration and consolidation to the excavated structures within the complex is in progress with the help of special size brick, tile and traditional lime mortar.

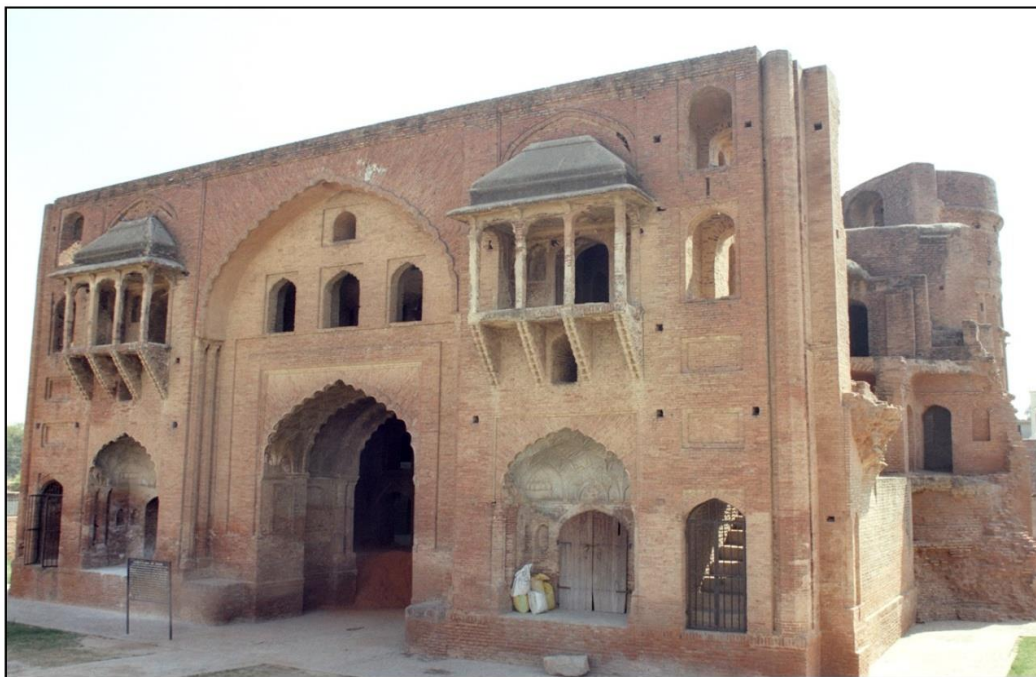
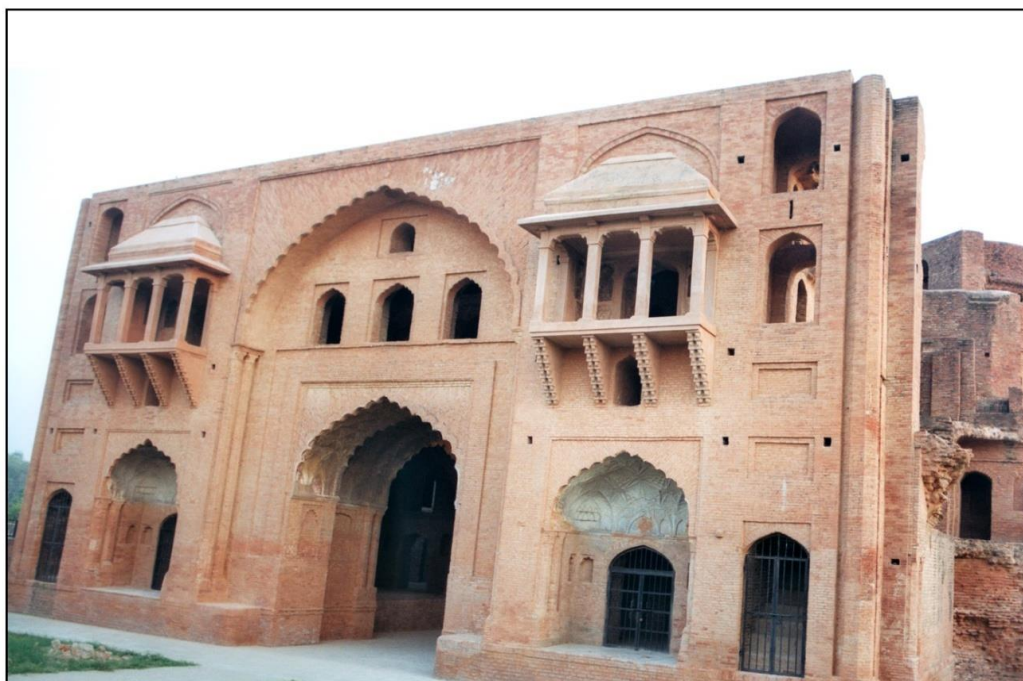
Gharunda: before and after conservation of gateway of old Mughal sarai.

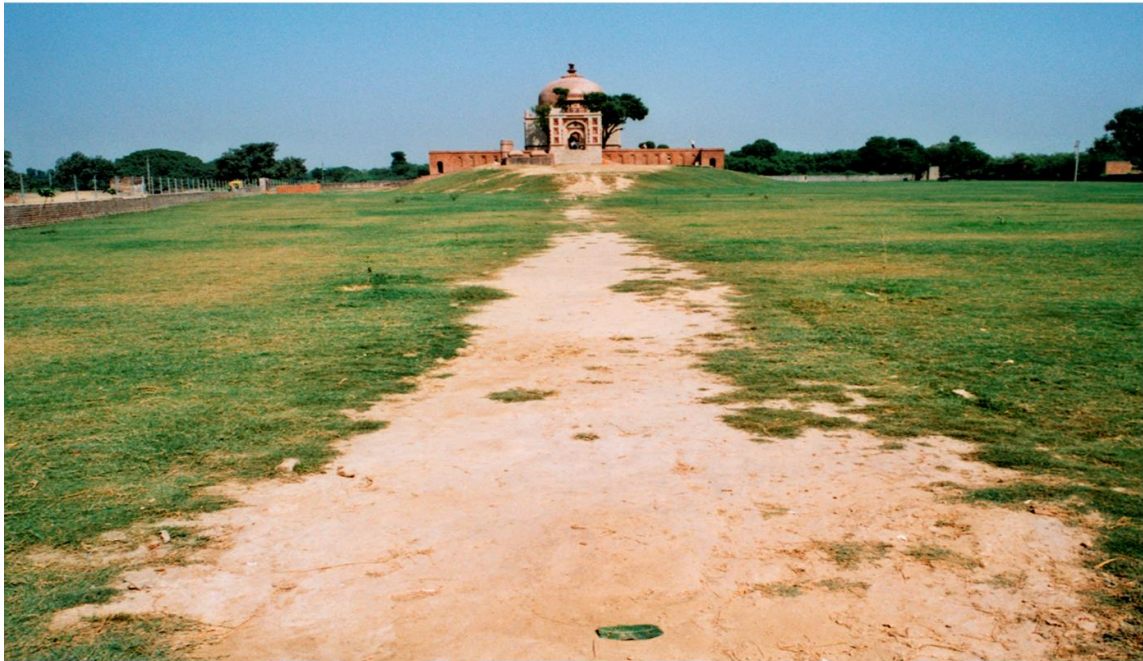
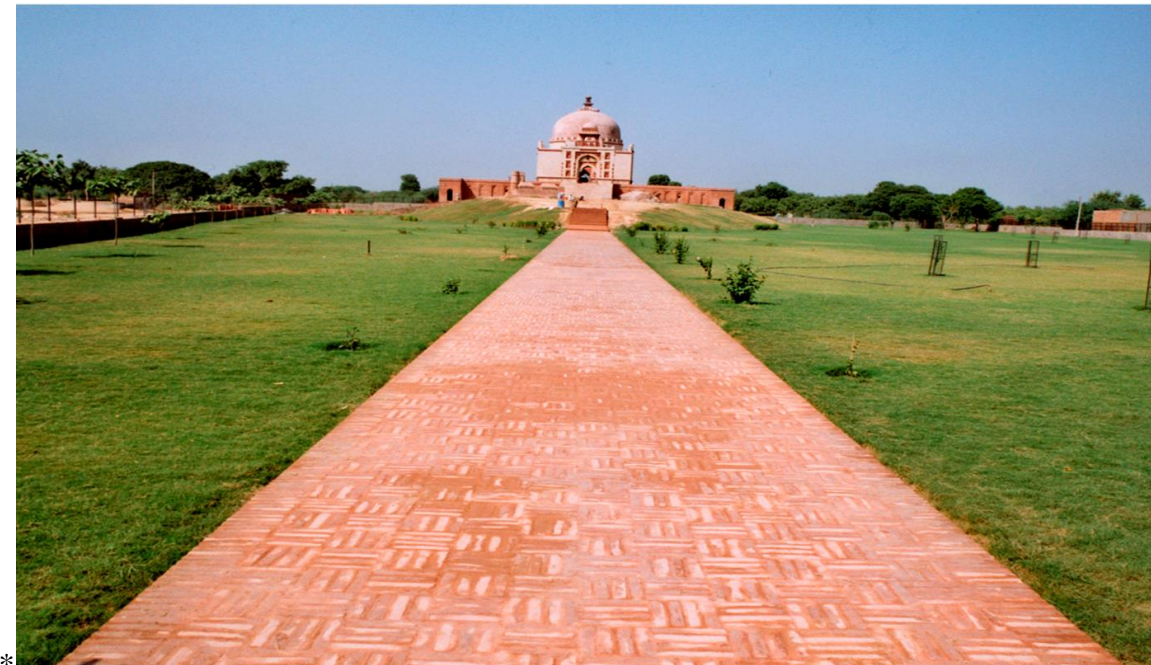
Plate 112

Sonepat: before and after conservation of Khawaja Khizir tomb.

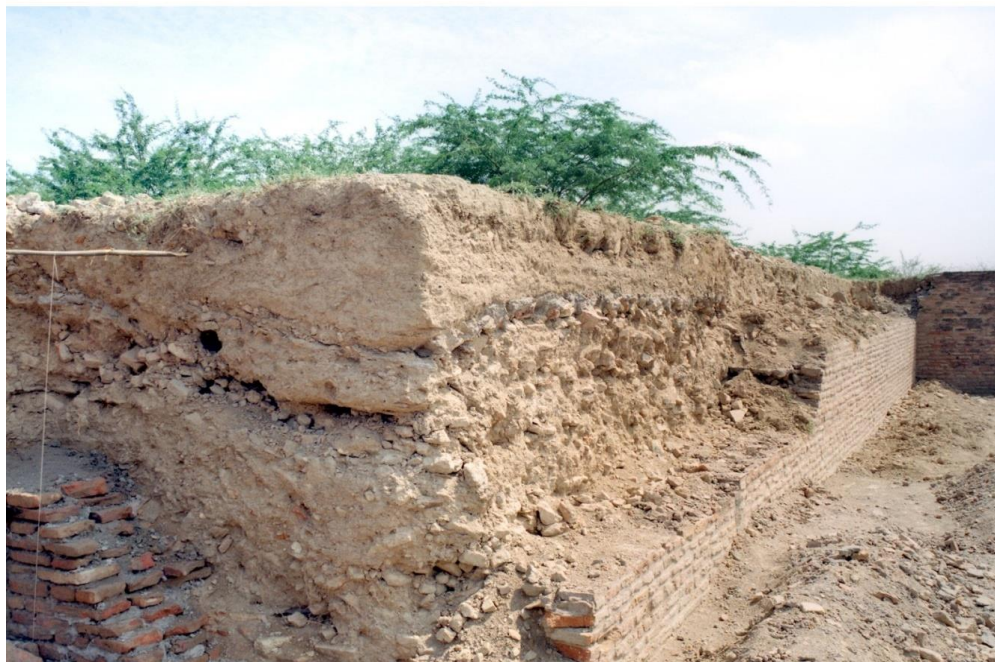
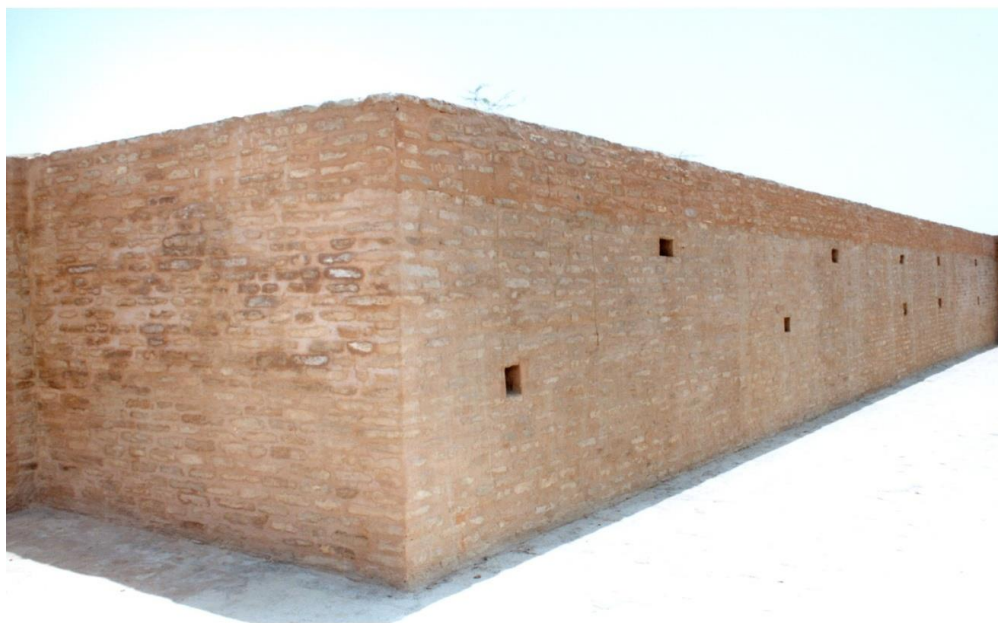
Agroha: before and after conservation of Buddhist stupa.

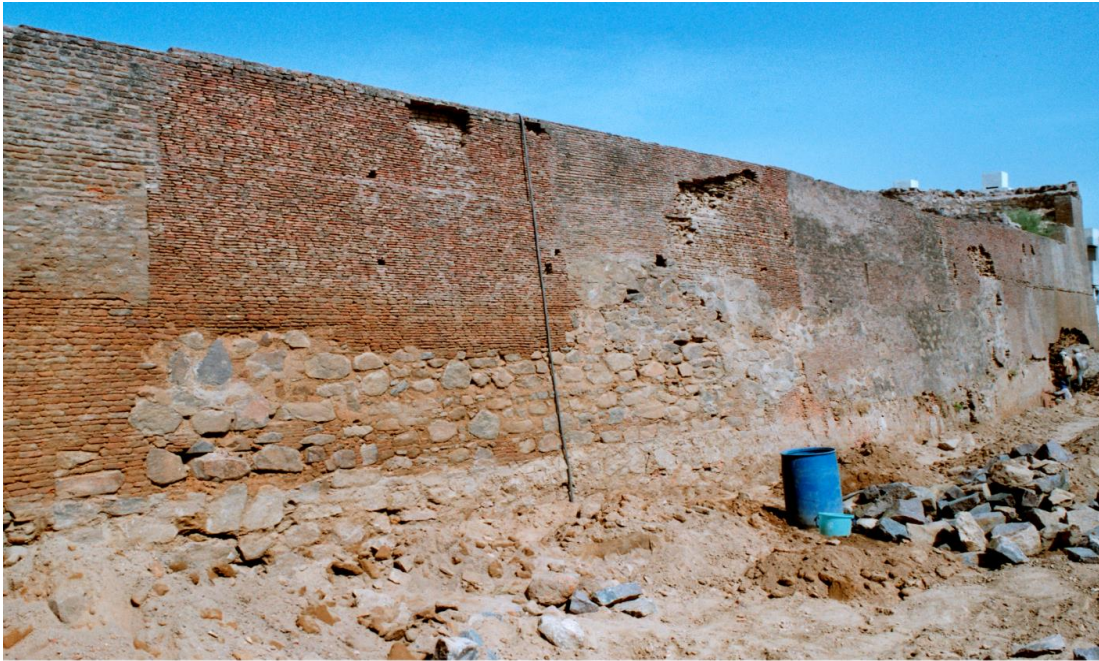
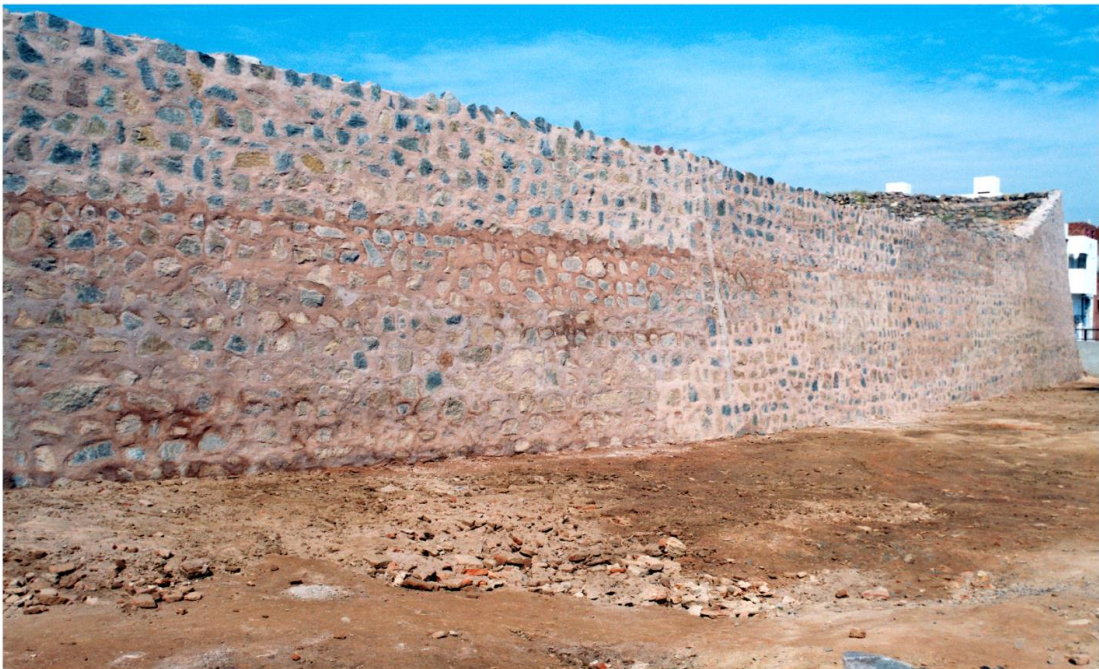
Plate 114

Hissar: before and after conservation of Ferozshah palace.

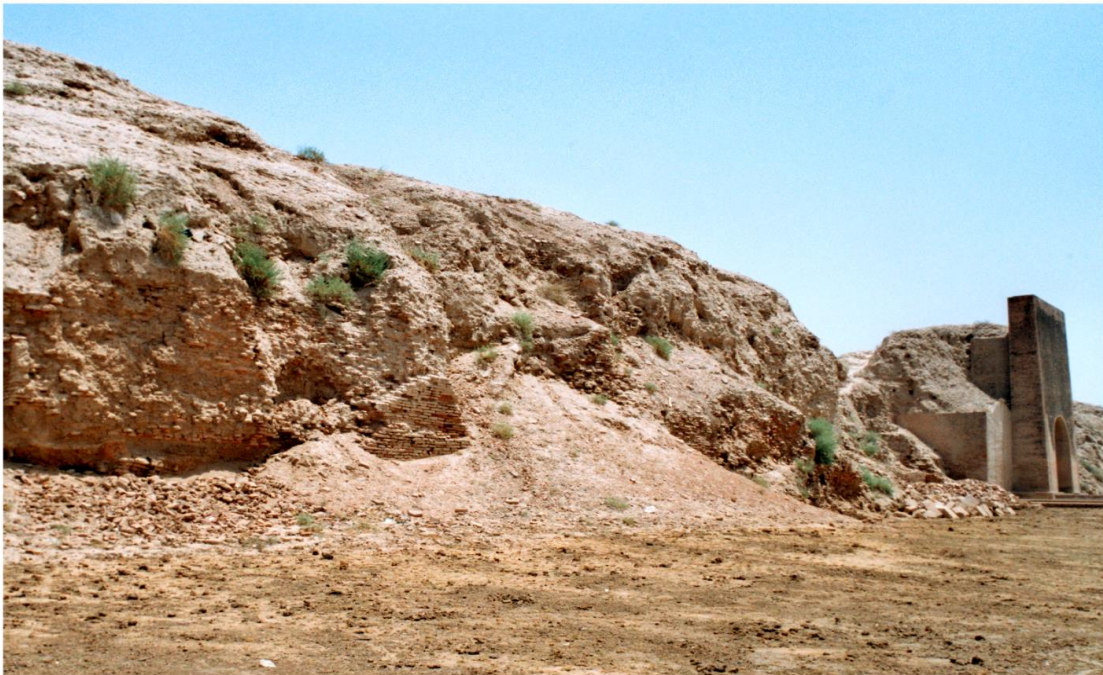
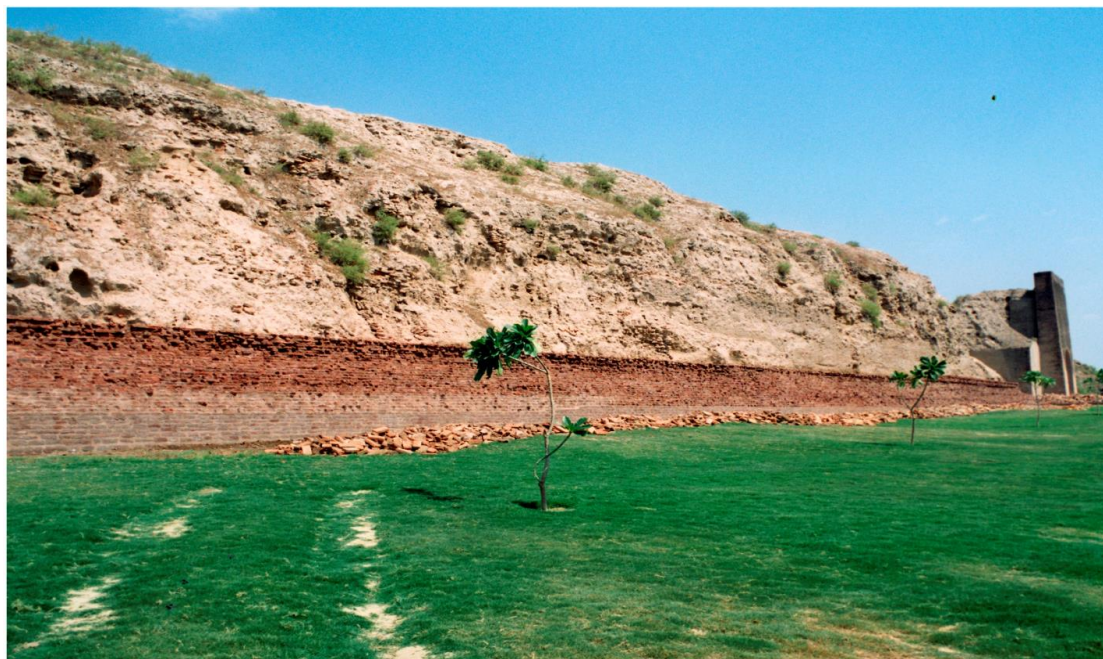
Hansi: before and after conservation of Prithviraj Chauhan fort.

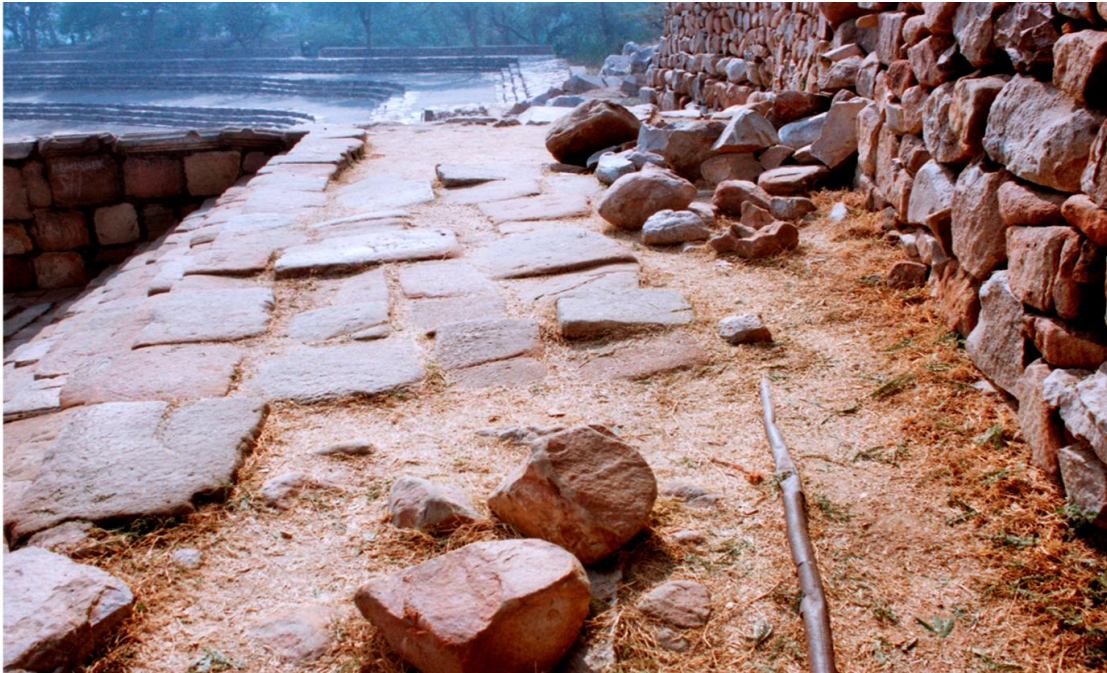
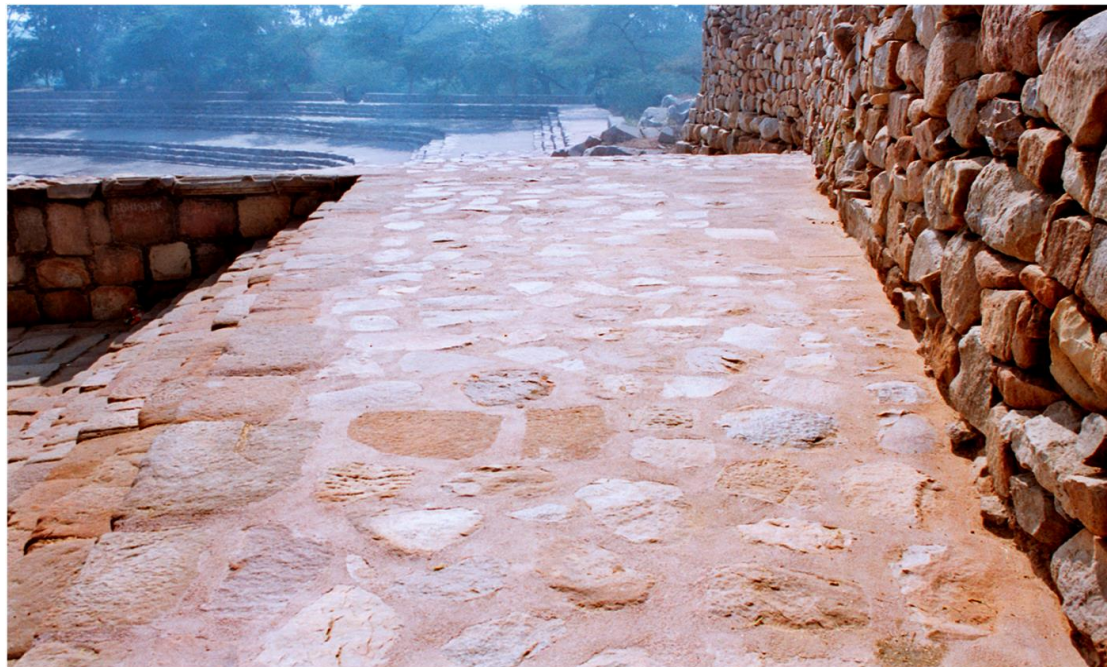
Faridabad: before and after conservation of Surajkund.

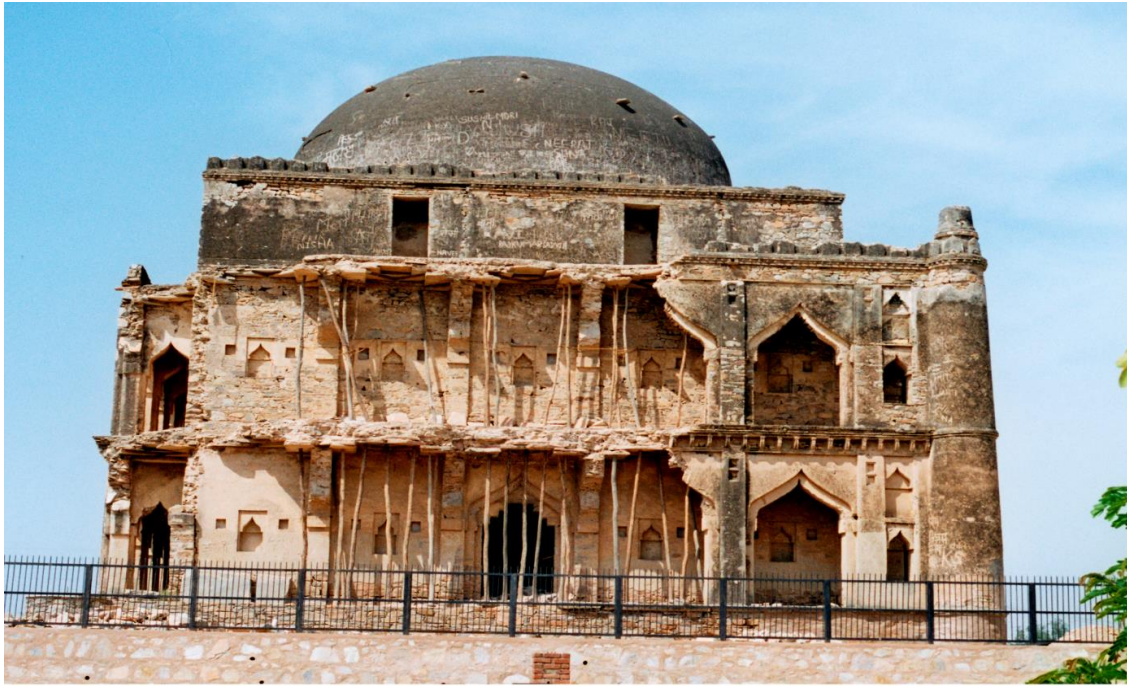
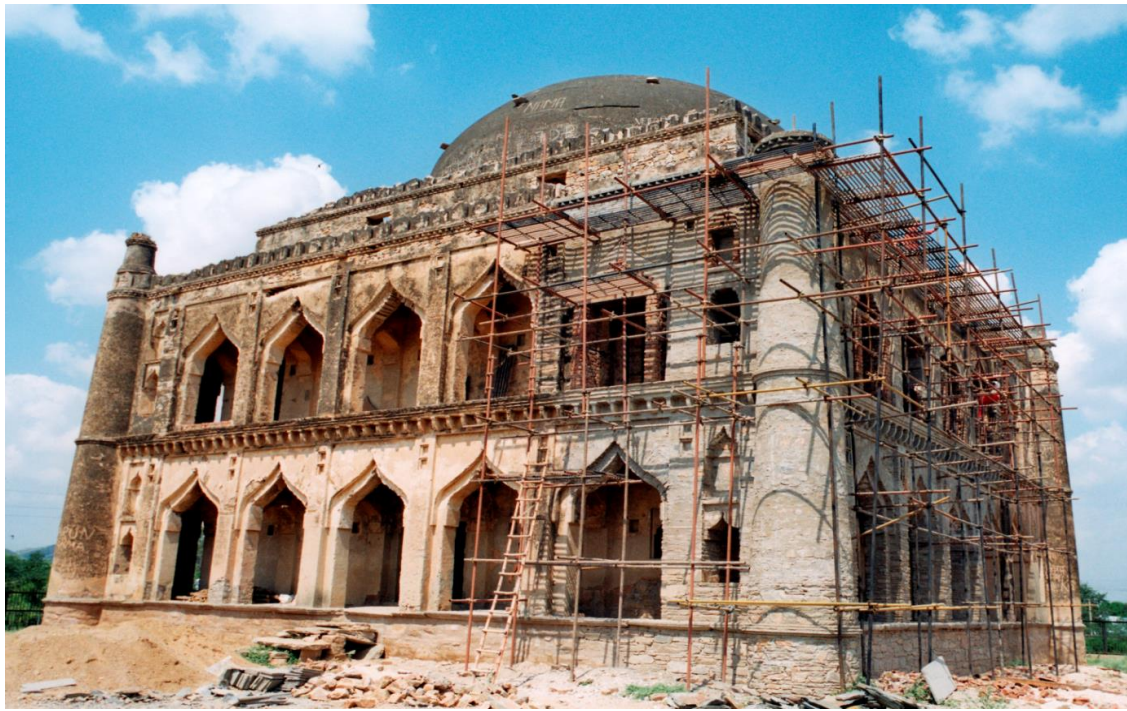
Plate 117

Narnaul: during conservation of Chor gumbad.

The fallen brick masonry of outer and inner facade of the monument was restored and plastering in lime *surkhi* mortar as per original is in progress (Pl. 117).

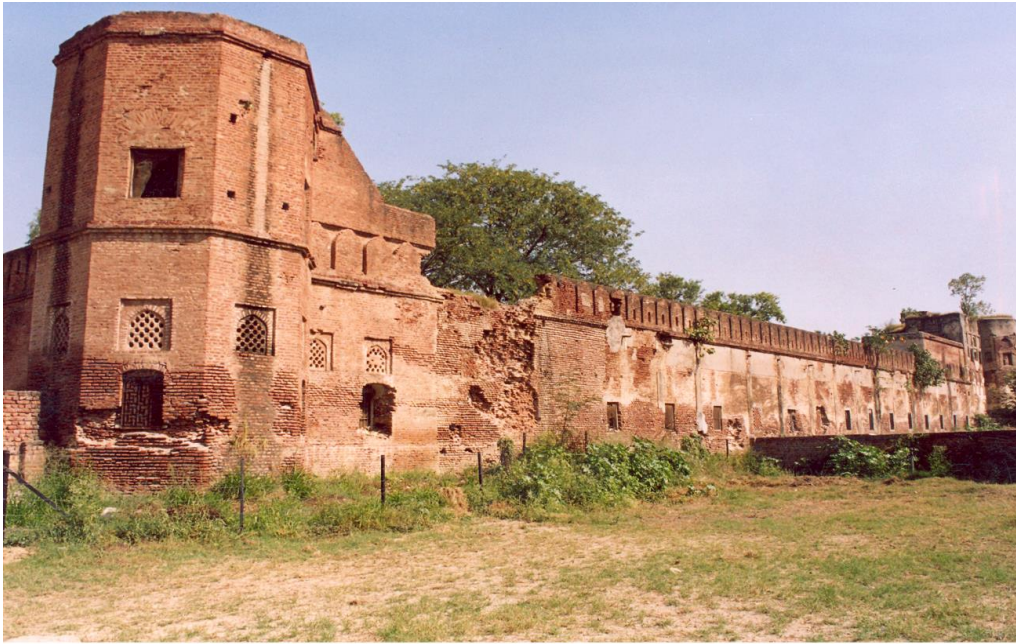
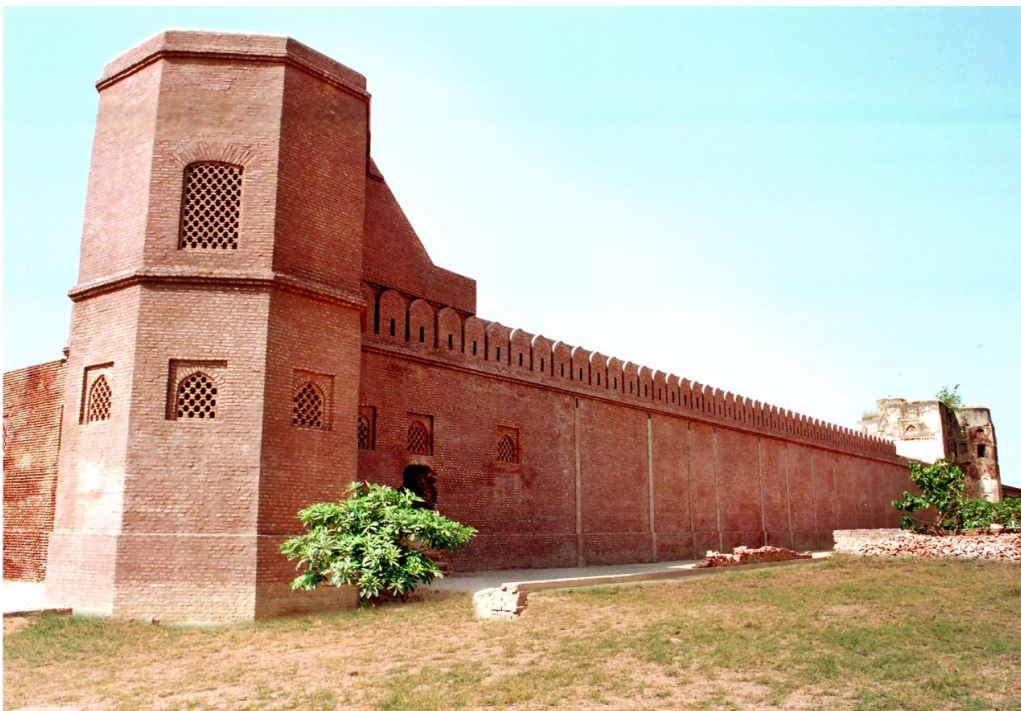
Noormahal: before and after conservation of Noormahal sarai.

The damaged bastion, located in the south-west corner of the fort was taken up for restoration and completed (Pl. 123).

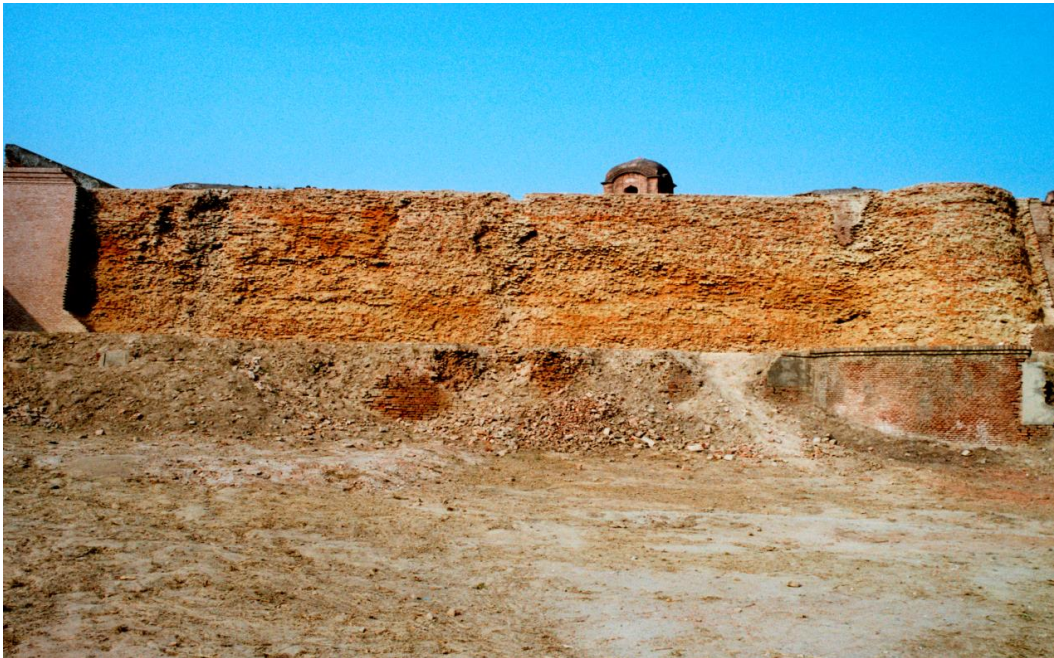
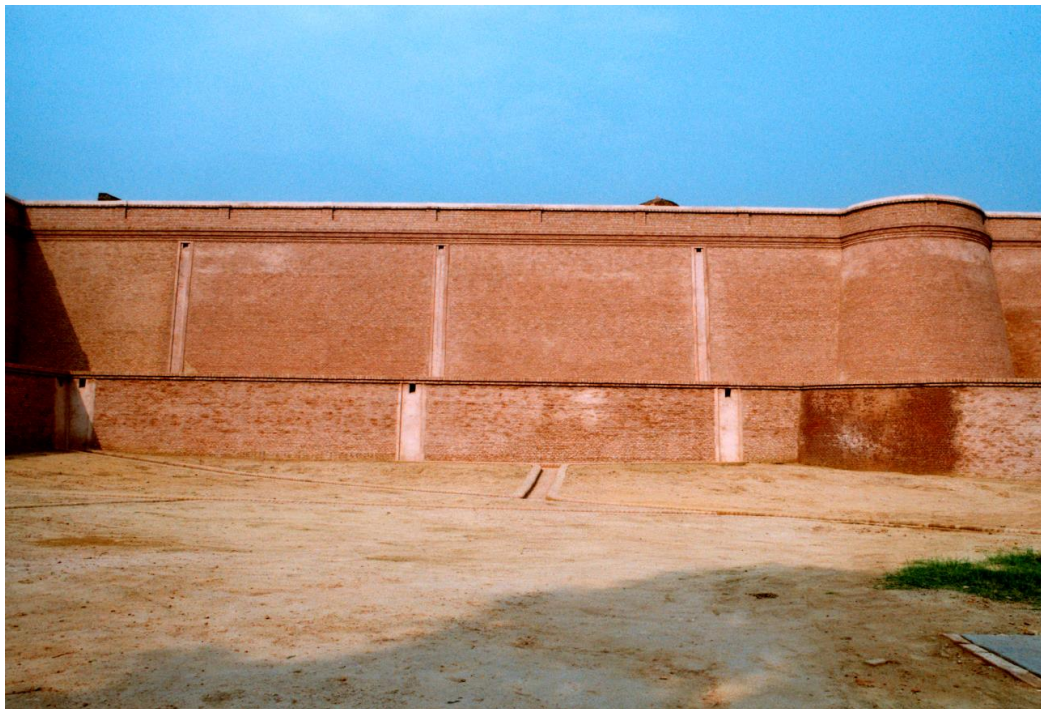
Plate 123

Bhatinda: before and after conservation of Bhatinda fort.

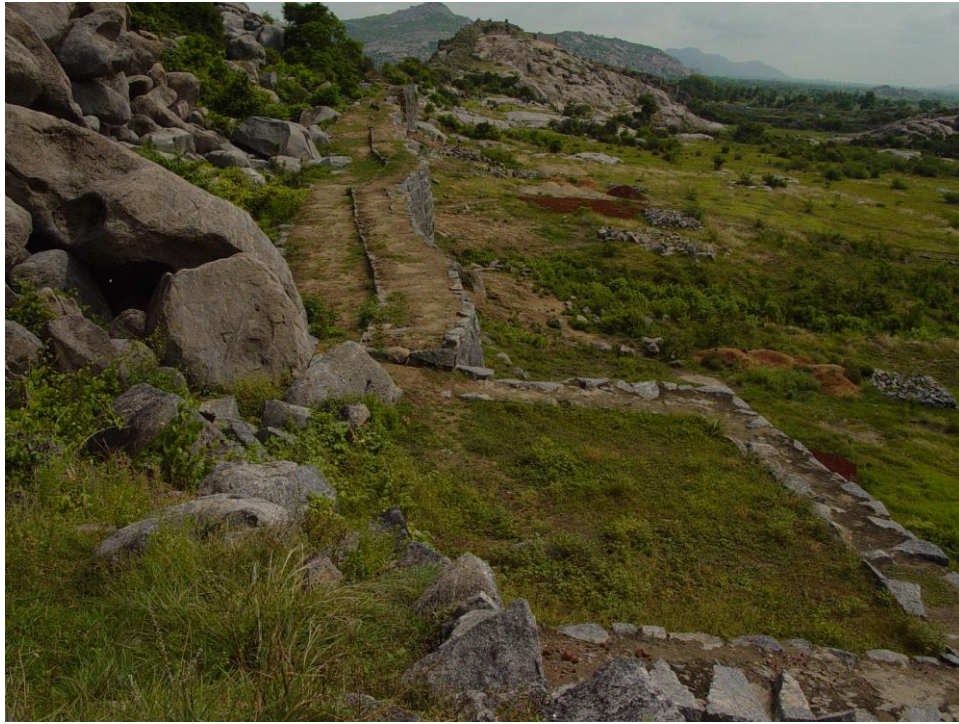
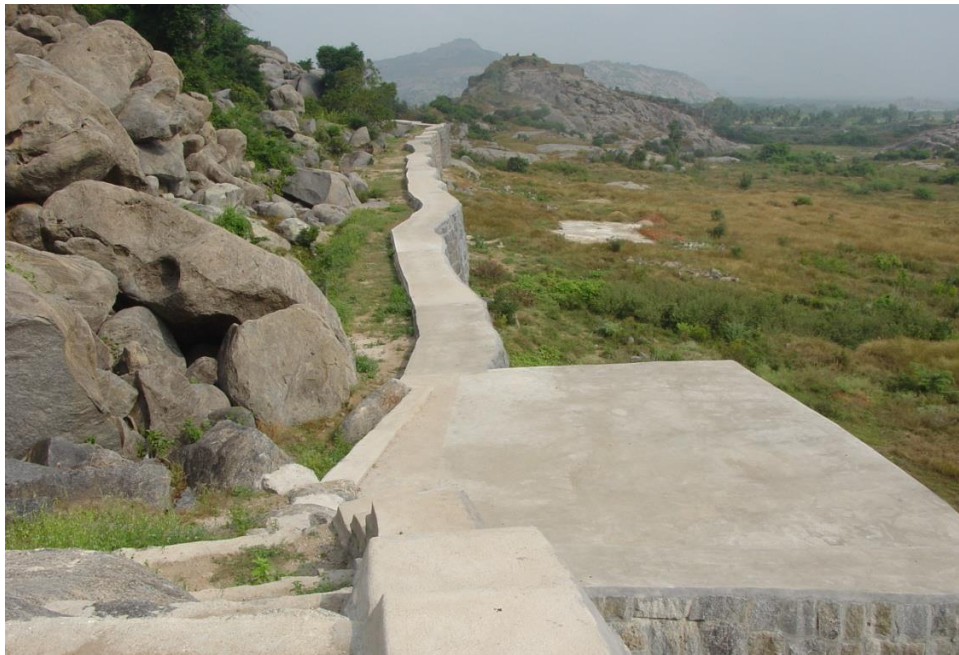
Plate 124

Fort Gingee: before and after conservation of eastern fortification wall.
