# INDIAN ARCHAEOLOGY 2007-08

## - A REVIEW

# INDIAN ARCHAEOLOGY 2007-08 - A REVIEW

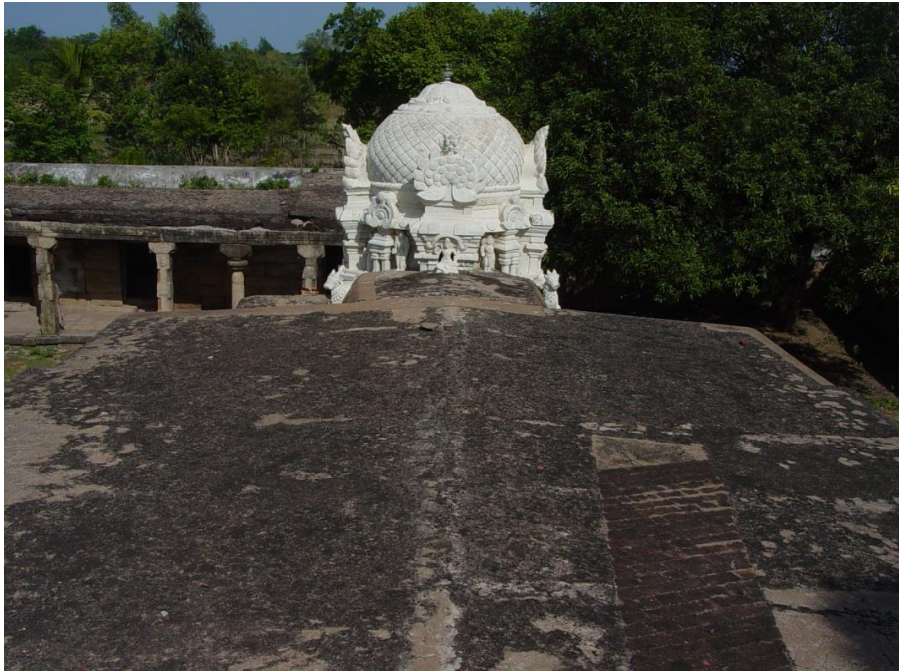
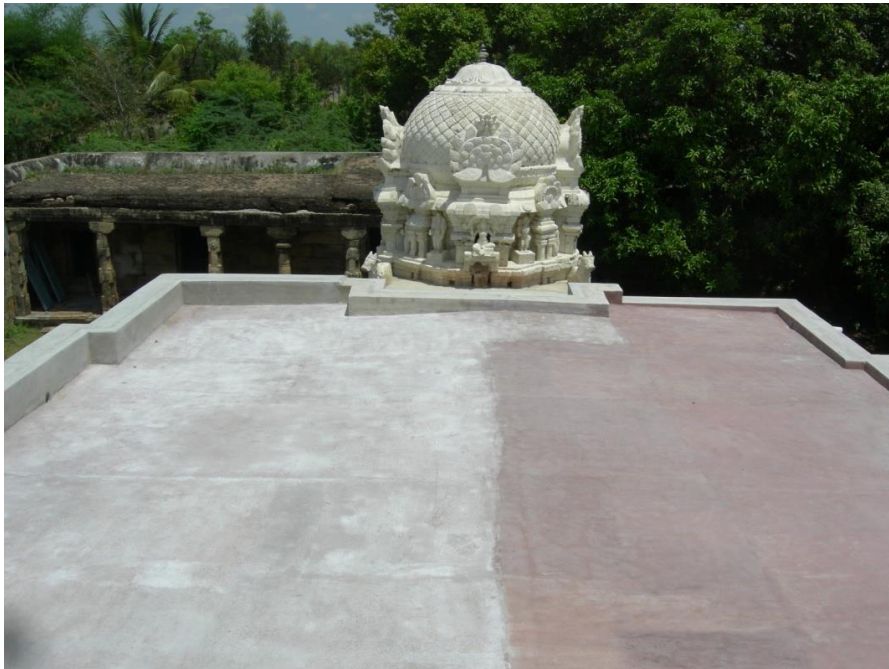
Agastisvara temple, Vellanur: before and after conservation of terrace of Amman shrine.

Water tightening the leaky terrace of *Amman* shrine and conserving the undulated old stone flooring of the open pillared *mandapa*, *ardhamandapa*, *madapalli* has been completed. Removing of accretionary brick wall around *Amman* shrine for exposing the original features of the pillars and conserving the broken beams, ceiling slabs and undulated stone flooring of the main shrine, *mukhamandapa* and *garbha griha* have been completed (Pl. 126).

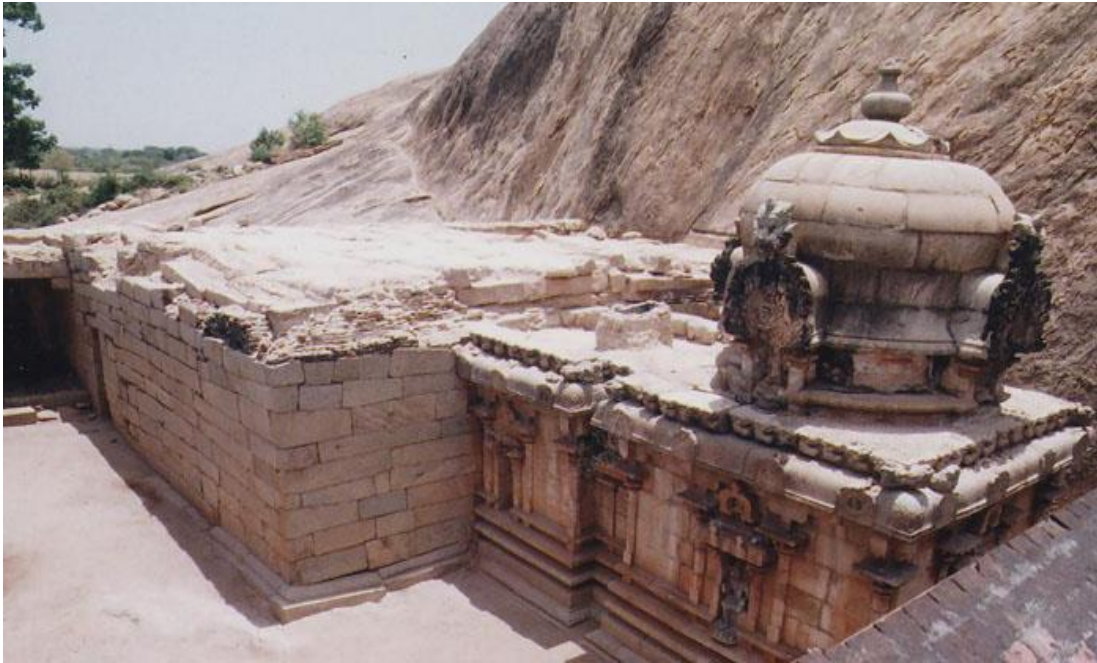
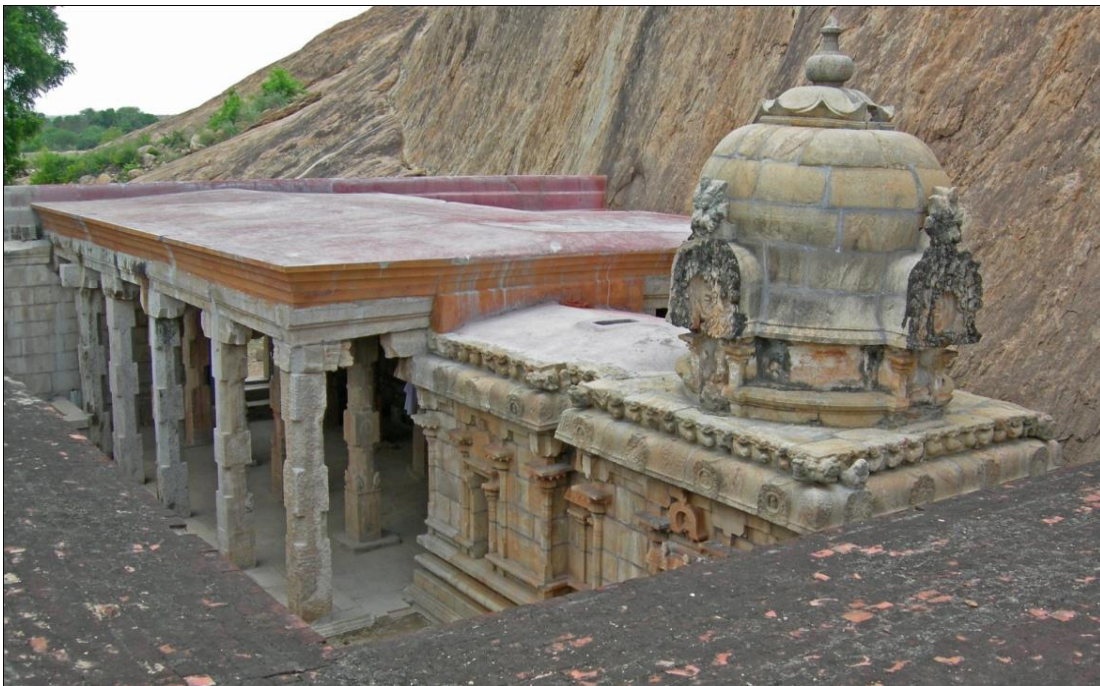
Plate 127

Narthamalai: before and after conservation of terrace, Rock cut Cave.

The work of water tightening the leaky terrace of the Main shrine, *mukhamandapa* and *Amman* shrine has been completed. Conserving the undulated stone flooring near sub shrines has been completed (Pl. 127).

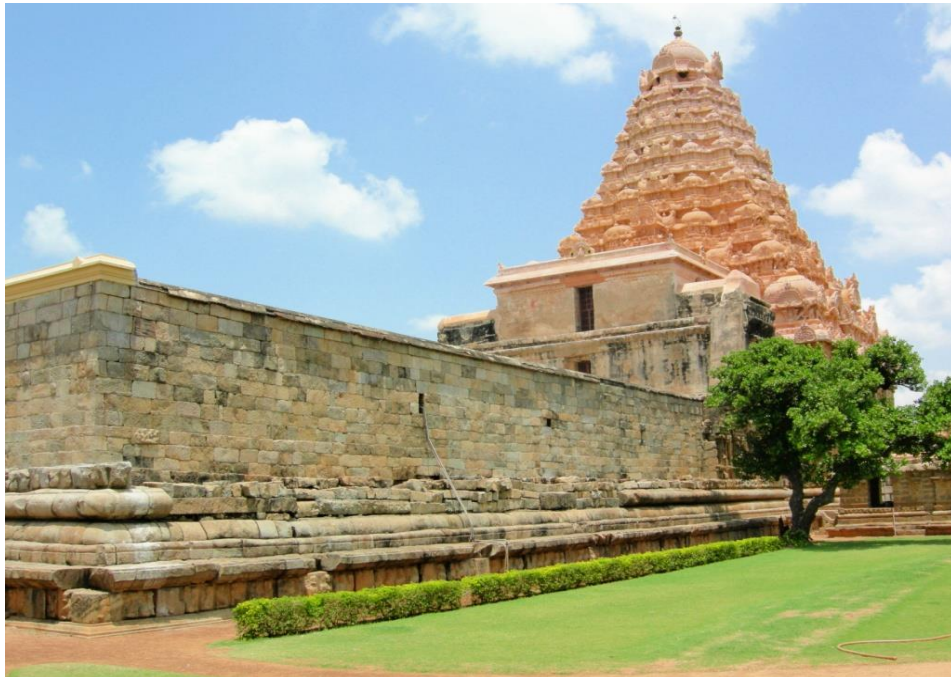
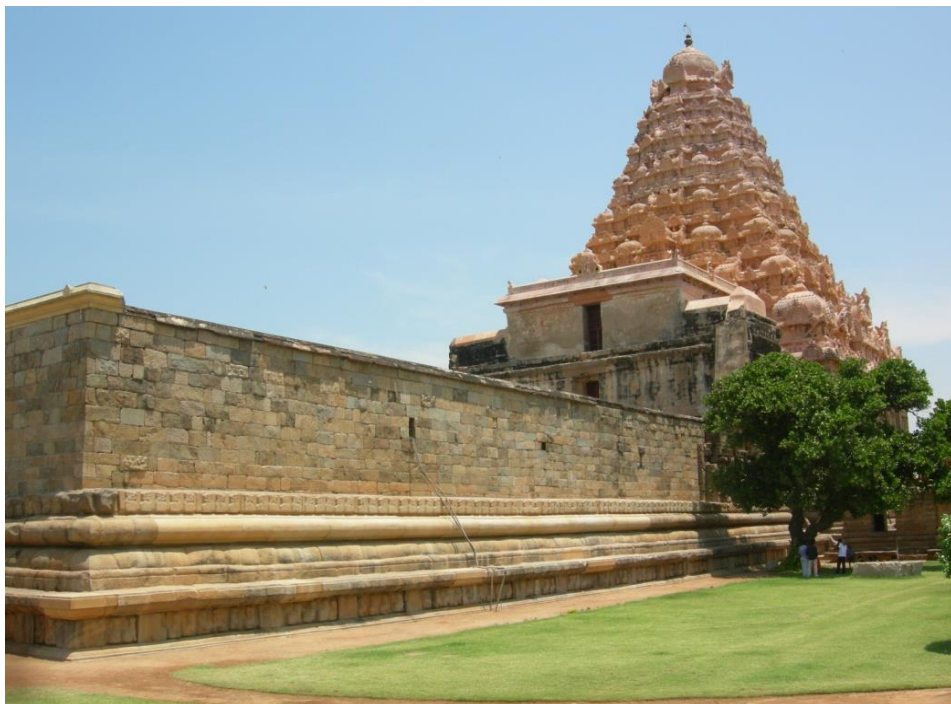
Brihadisvara temple, Gangaikondacholapuram: before and after conservation of adhisthana.

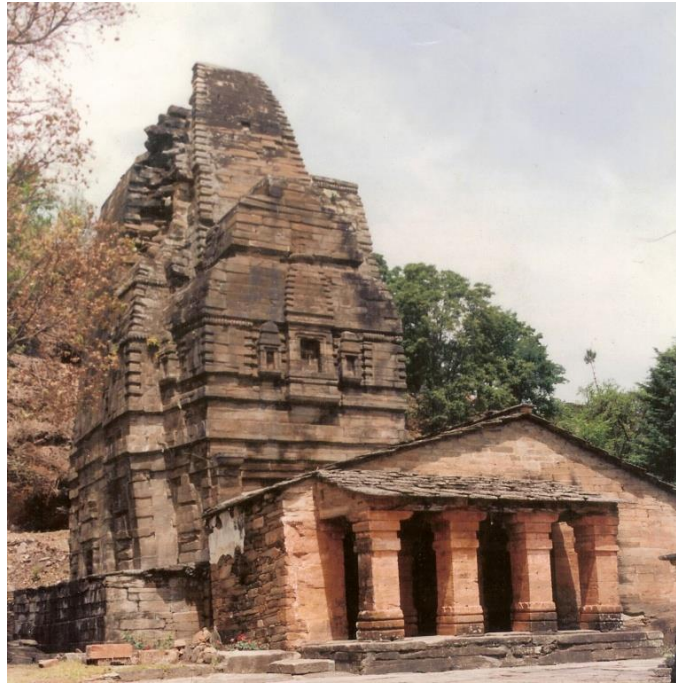
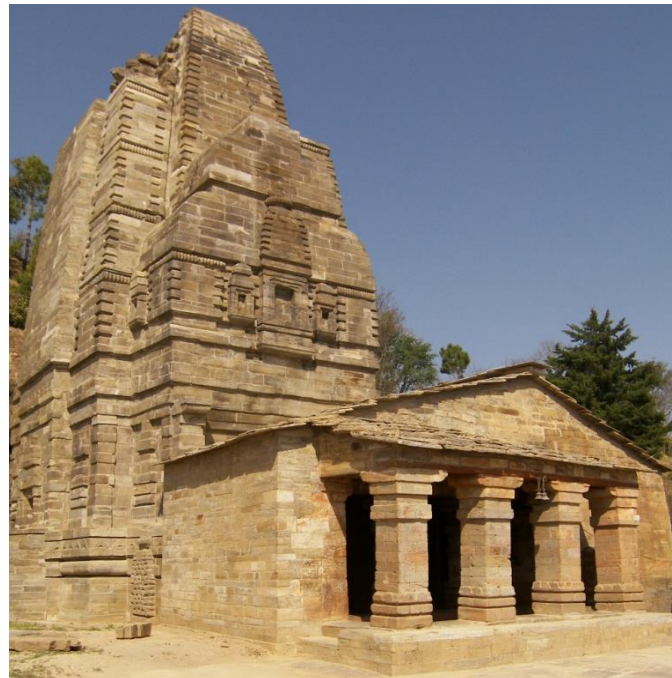
Plate 131

Sun temple, Katarmal: before and after conservation.

miniature shrines in front of the main shrine of the complex and *sukanasika* of the main shrine were dismantled and re-set as per the original after strengthening the foundation. The resetting work of southeast corner of the main shrine has been completed and copper dowels were also used in place of iron ones. The badly damaged walls of the *mandapa* have been restored and the wooden members have been replaced (pl. 131).

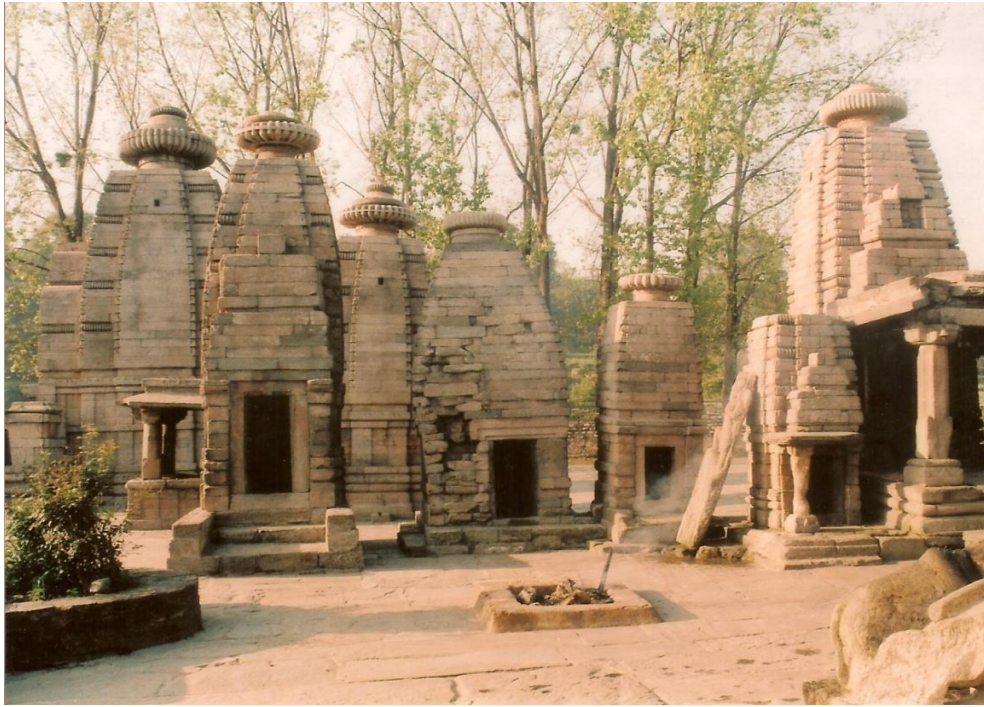
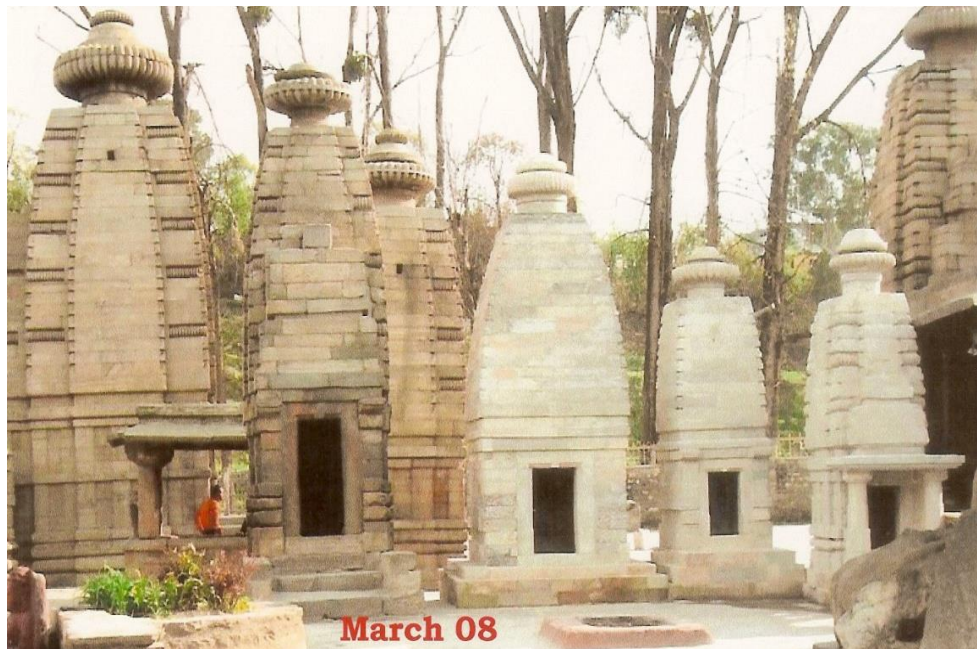
Plate 132

Group of Temples, Baijnath: before and after conservation.

Dismantling and re-setting of the out of plumb, damaged and weathered veneering stones of the three shrines near the main shrine of the complex have been restored as per the original, after strengthening the foundation. All the rusted Iron dowels were also replaced by copper (pl. 132).

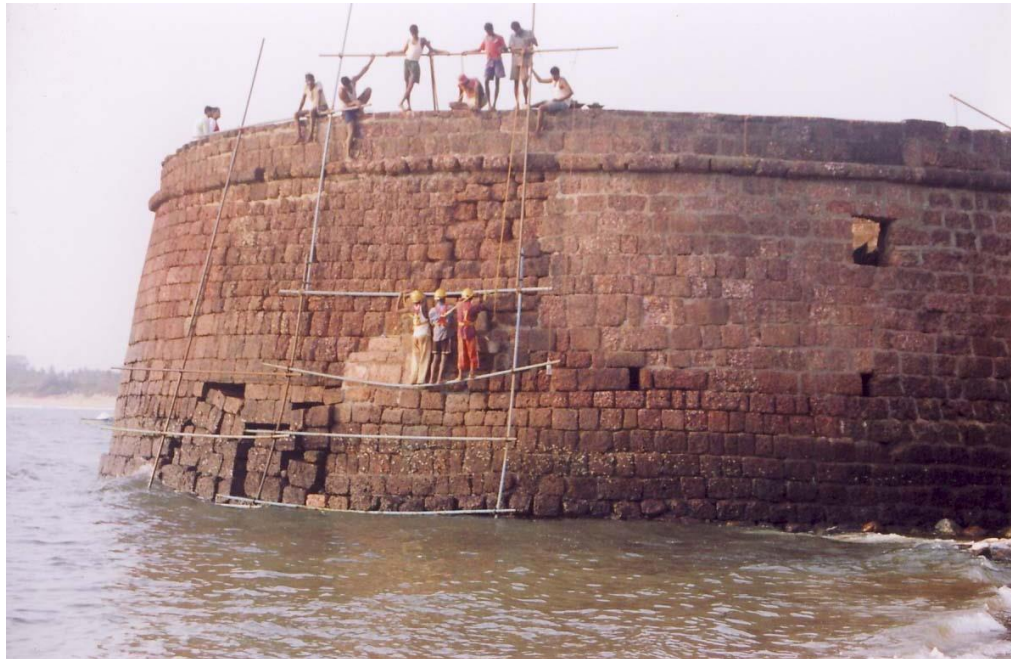
Lower Fort, Aguada: during strengthening and underpinning.

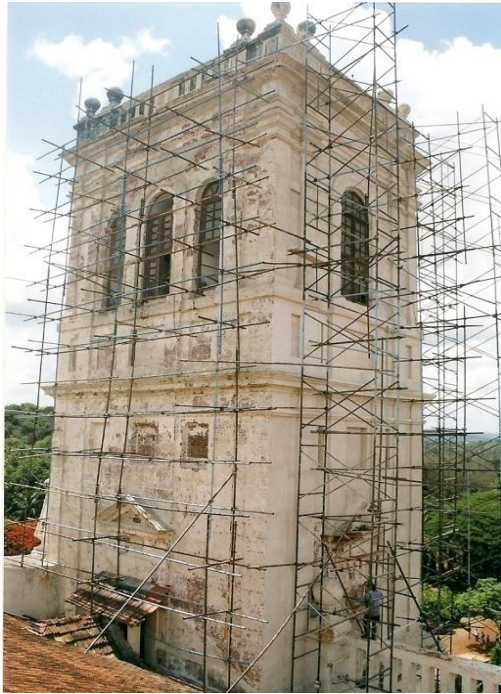
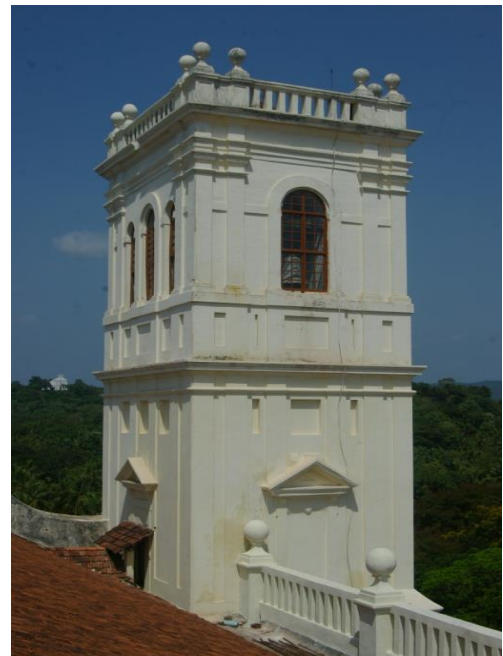
Se' Cathedral: during and after conservation of Bell tower.

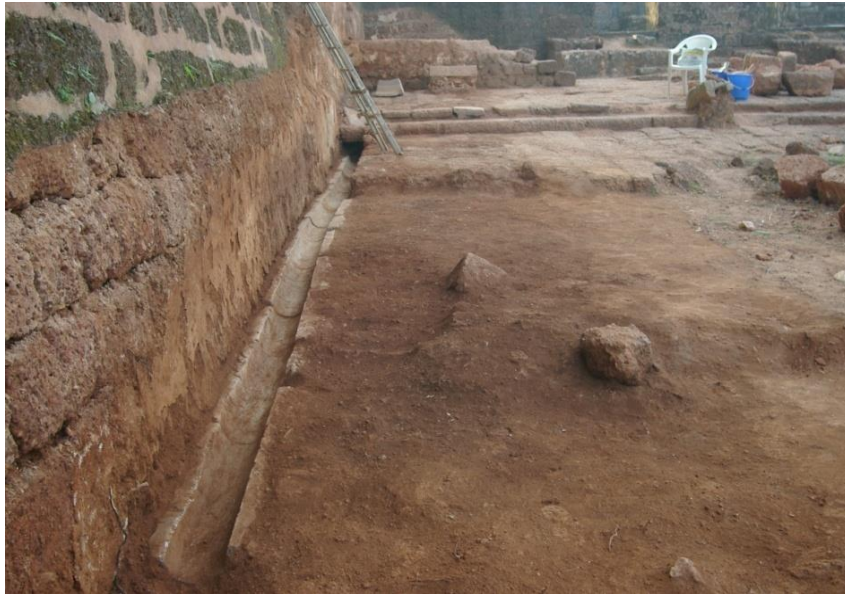
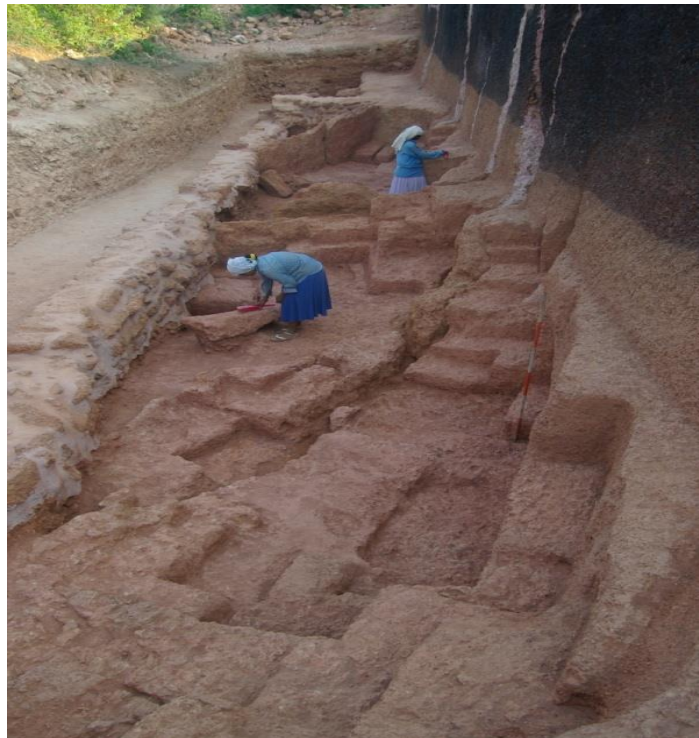
Old Goa: during clearance of St. Augustine complex.

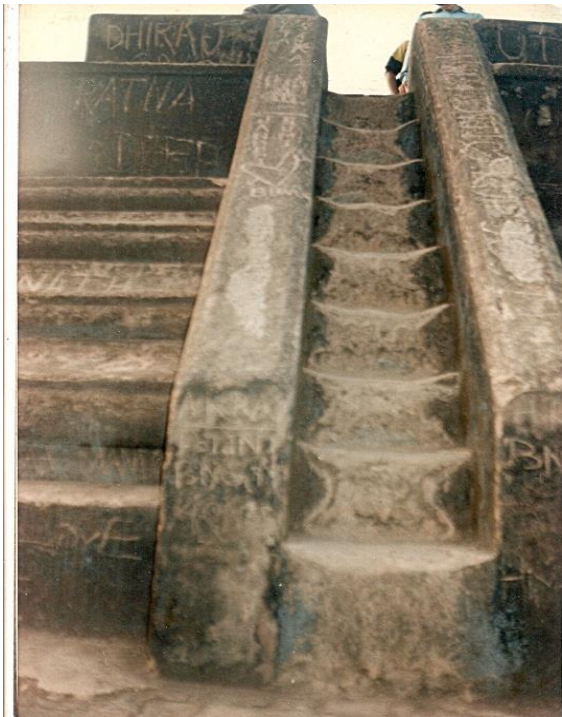
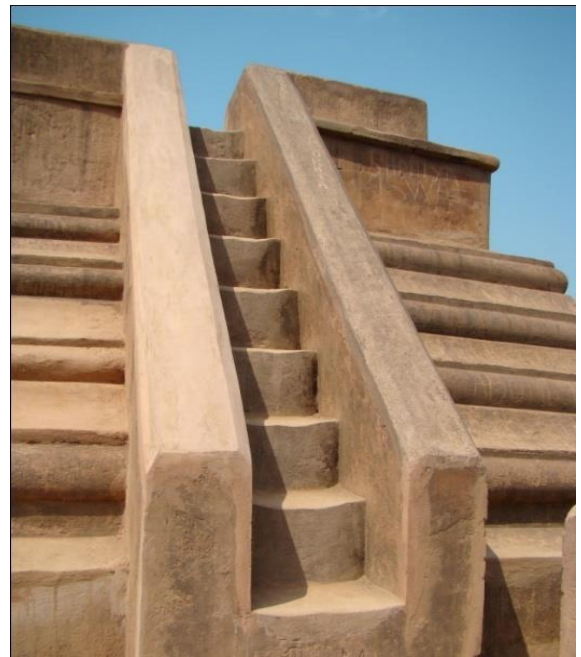
Plate 141

Garhgaon Raja's palace: before and after conservation

The relaying of the damaged floor with brick jelly and finished with lime-*surkhi*, providing brick-on-edge apron around the monument and pointing of the brick pathway have been completed. Conservation of the staircase was also attended to. Construction of a toilet block for the visitors is in progress (pl. 141).

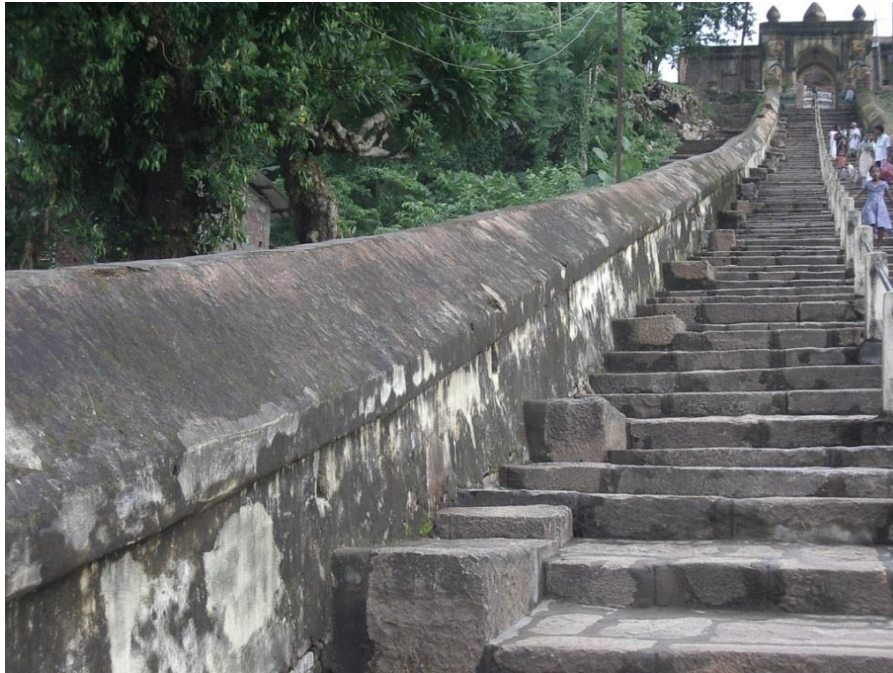
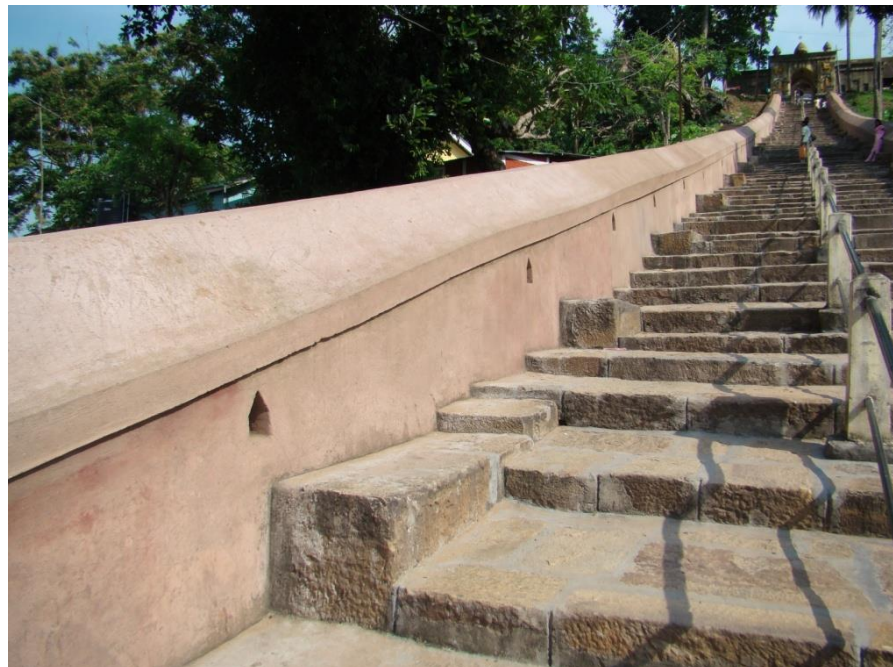
Plate 142

Hayagriva Madhava temple, H ajo: before and after conservation.

Pointing and sealing of the joints of the stone masonry of the main temple, pointing of the brick-on-edge apron around the monument and painting of the roof truss of the *mandapa* of the main temple have been completed. Repairing of the ancient boundary wall is in progress.

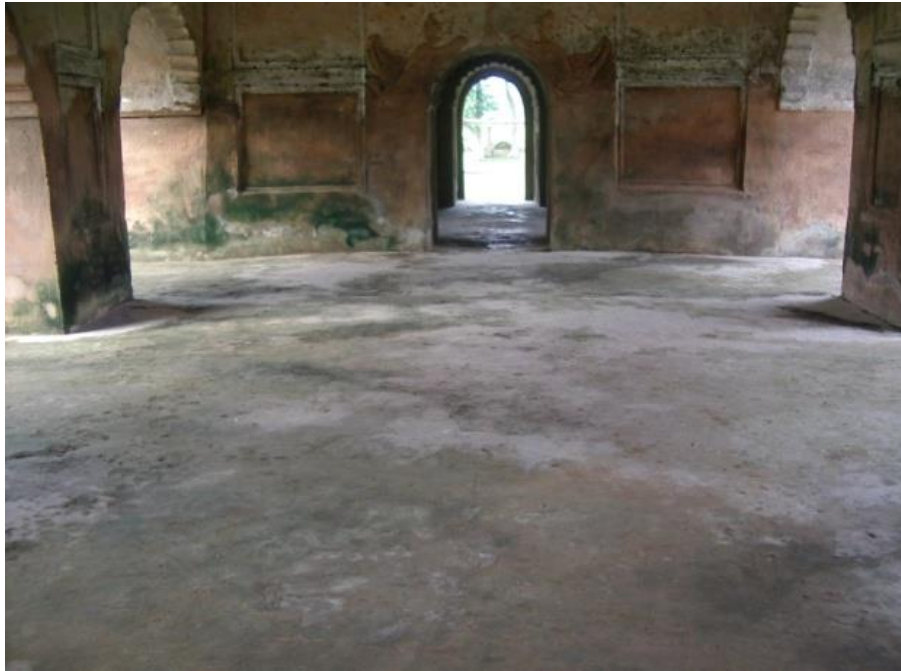
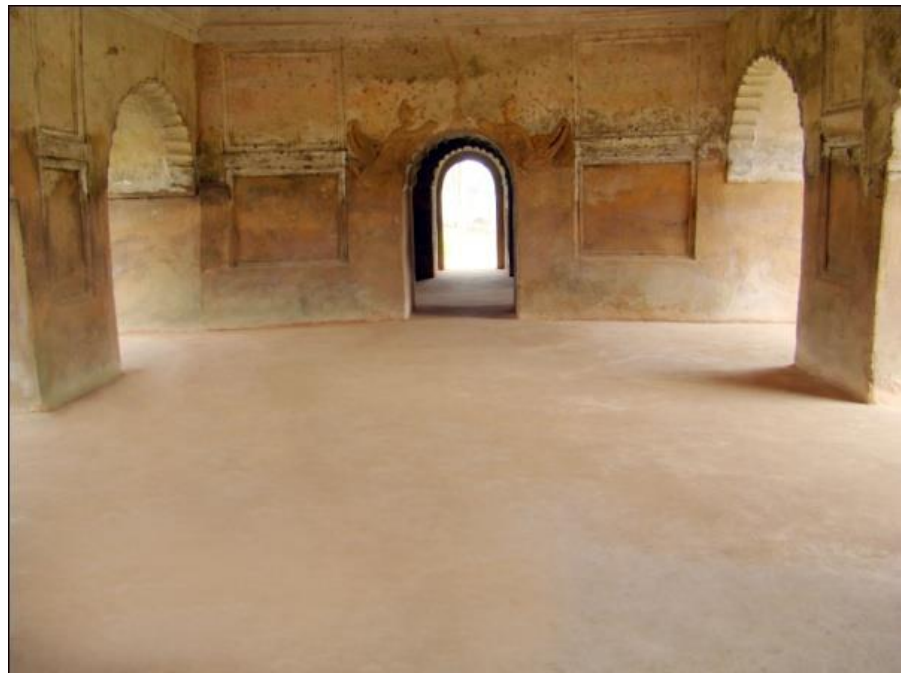
Ranghar Ruins, Joysagar: before and after repairs of the flooring.

Relaying of brick jelly flooring and new brick-on-edge apron after raking out the damaged concrete floor and removing the old apron was completed. Construction of toilet block for the visitors is in progress (pl. 143).

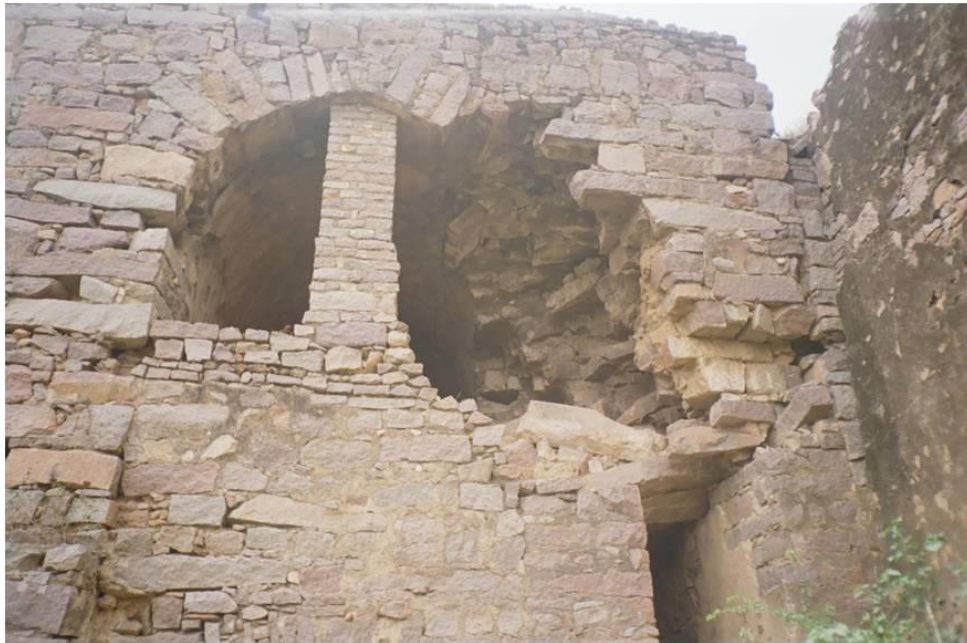
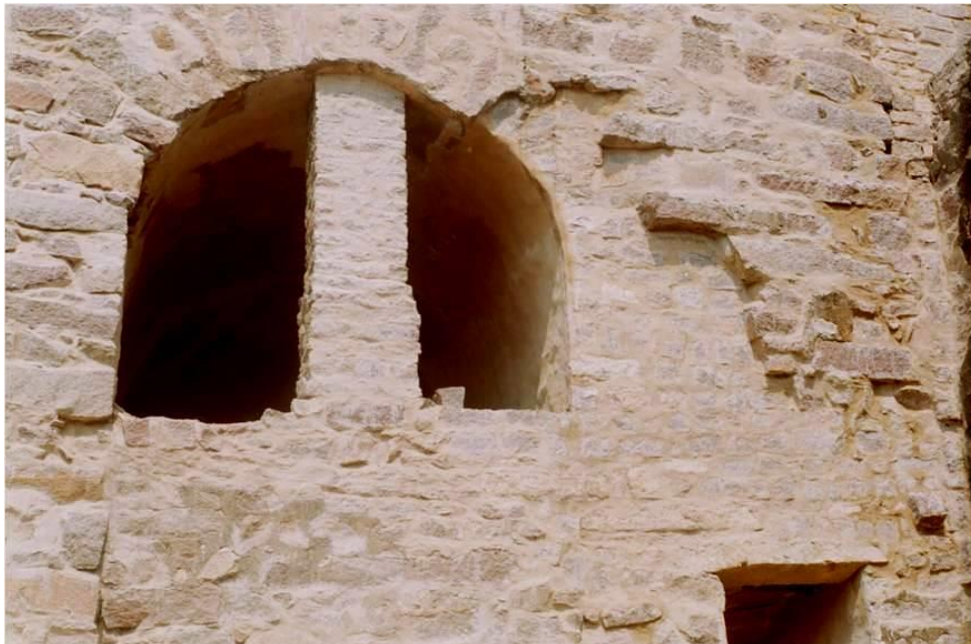
Dad Mahal, Fort, Golkonda: before and after conservation

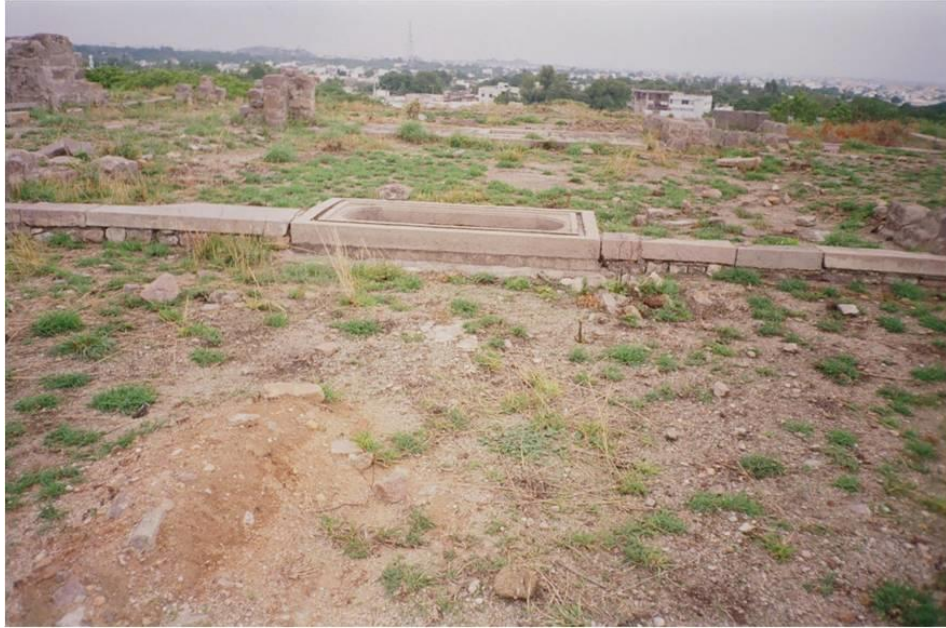
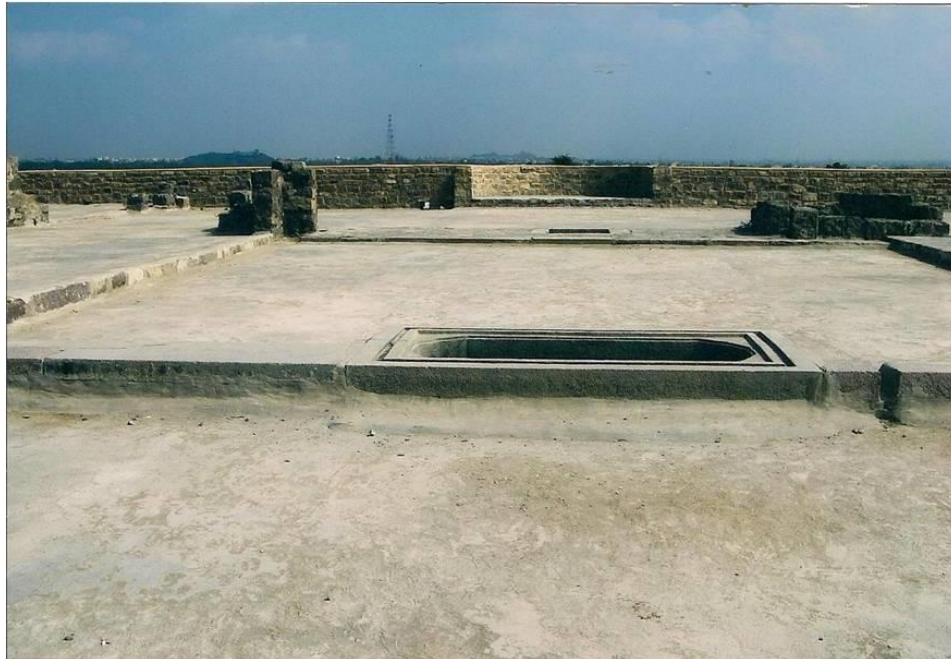
Plate 145

Rani Mahal, Fort, Golkonda: before and after conservation of terrace garden area.

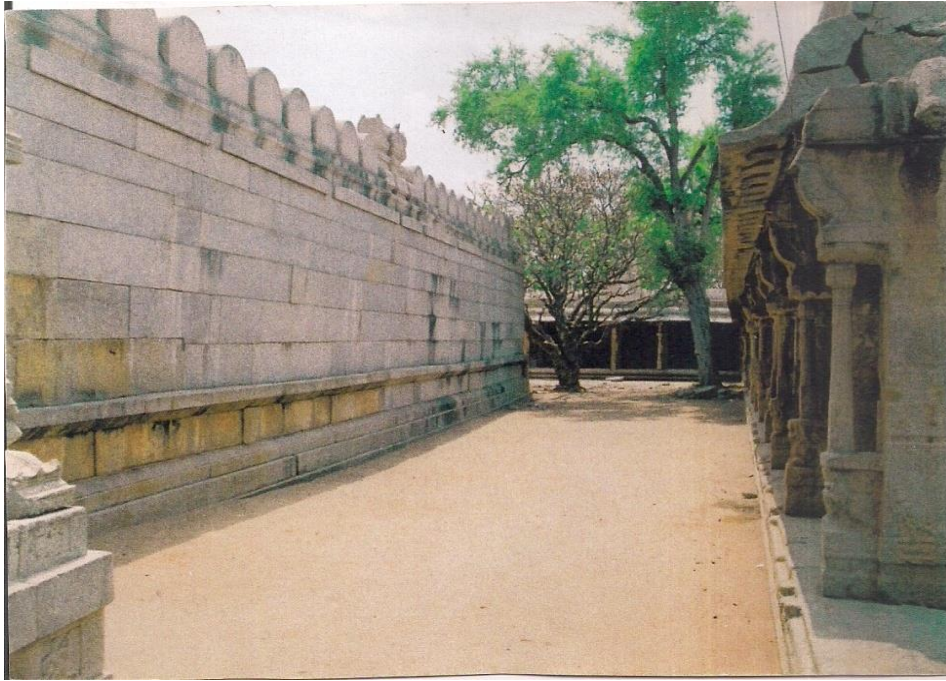
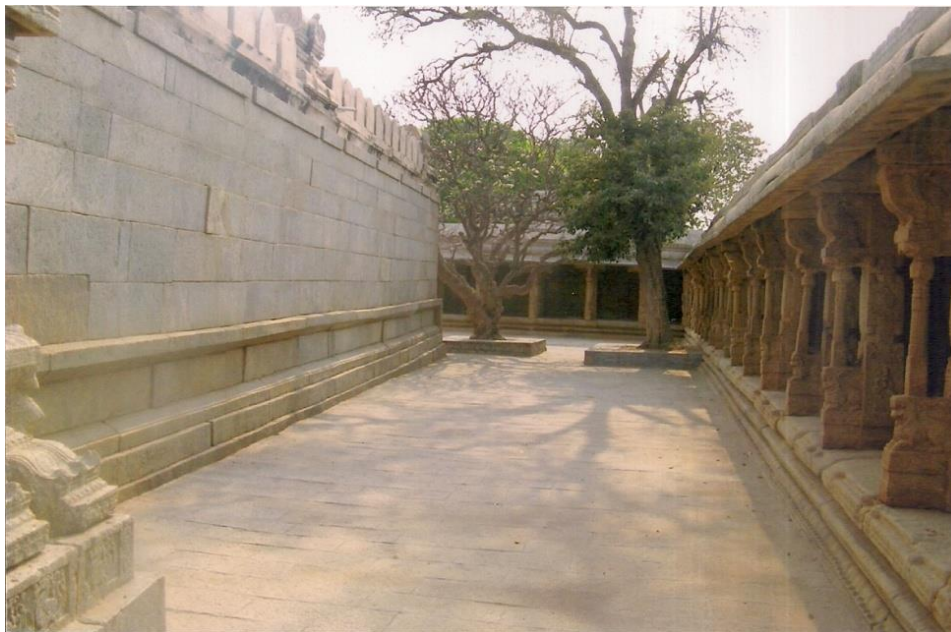
Veerabhadra swamy temple Lepakshi: before and after conservation of north-western corner.

The damaged and fallen portion of the outer *prakara* was strengthened and conserved using the original stone slabs. The damaged flooring around the temple was relaid with stone flooring. The damaged roof of *Yagnasala* and that of a small shrine located on the western side of the temple was repaired, consolidated, water tightened and conserved. The boundary of the temple complex on the western side was provided with fencing over a dwarf wall. The uneven earth floor around the monolithic bull was leveled and stone paved flooring was provided for the easy movement of the visitors (pls. 146-147).

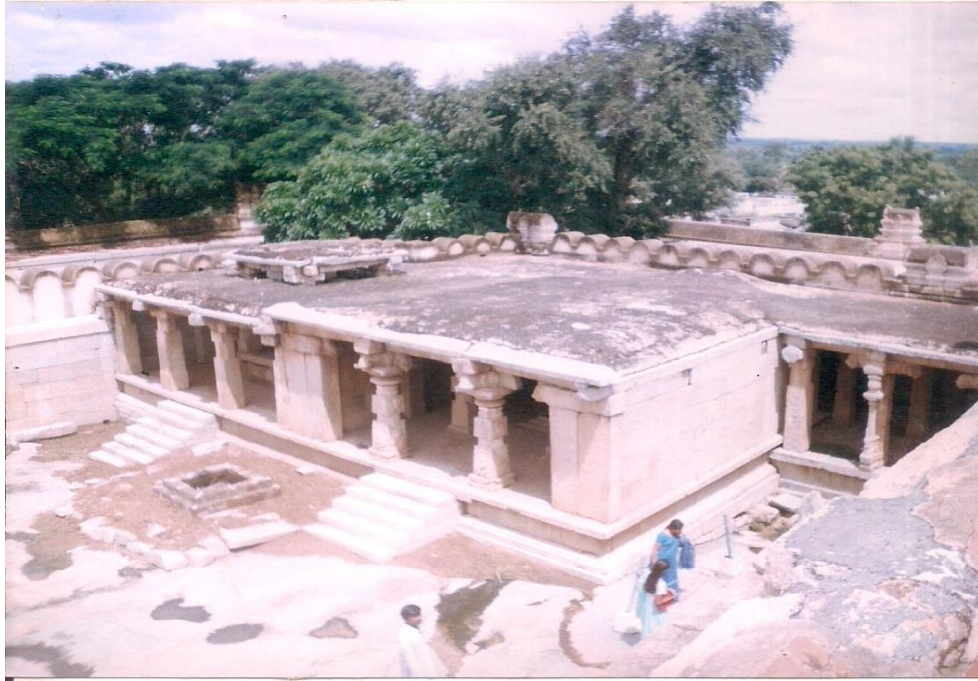
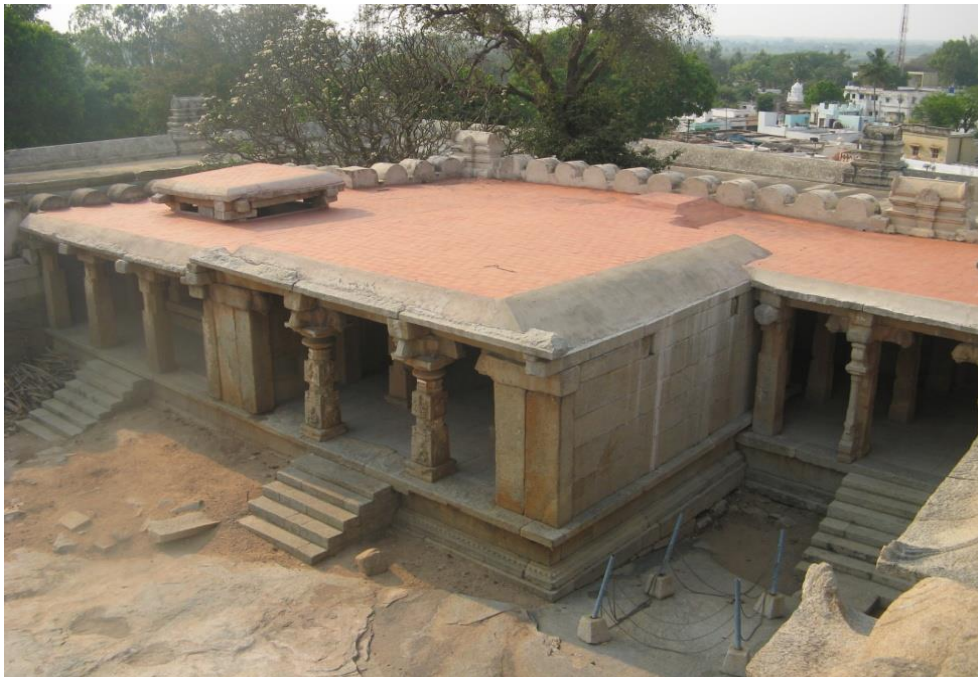
Plate 147

Veerabhadraswamy temple, Lepakshi: before and after conservation.

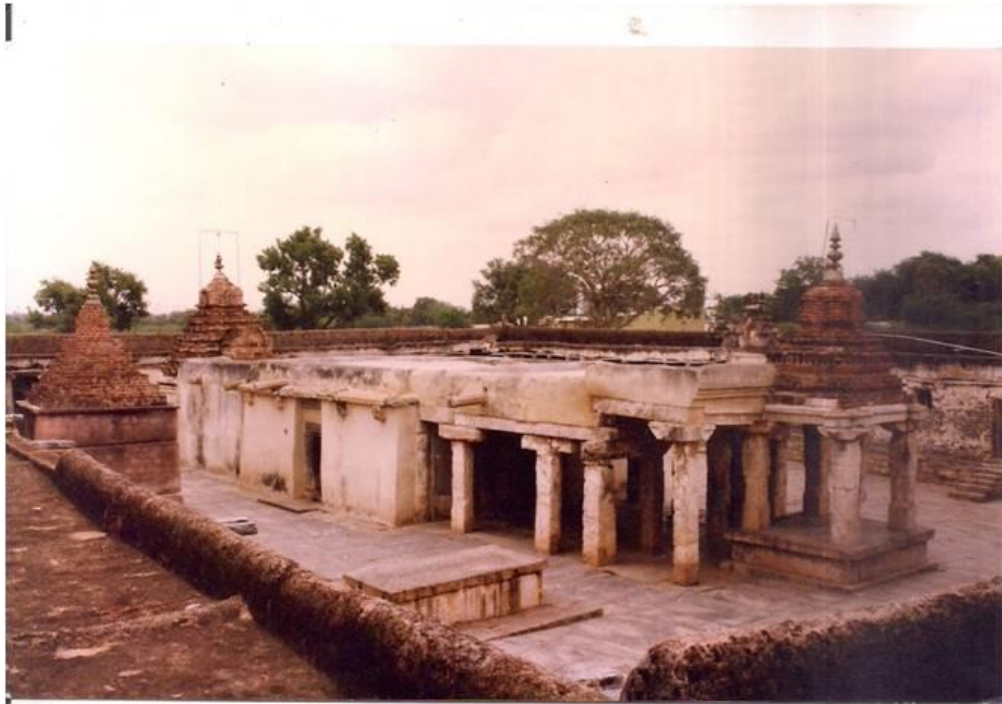
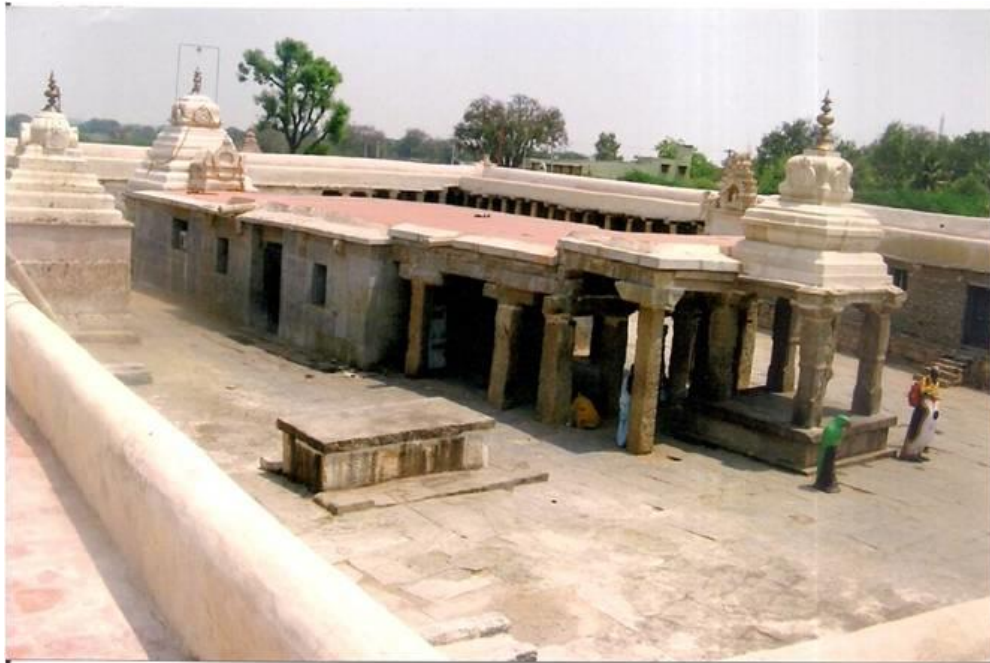
Plate 148

Siddheswara swamy temple, Hemavath: before and after conservation.

The broken beam of *mukhamandapa* was conserved by mending the broken beam using steel and epoxy resin. The temple

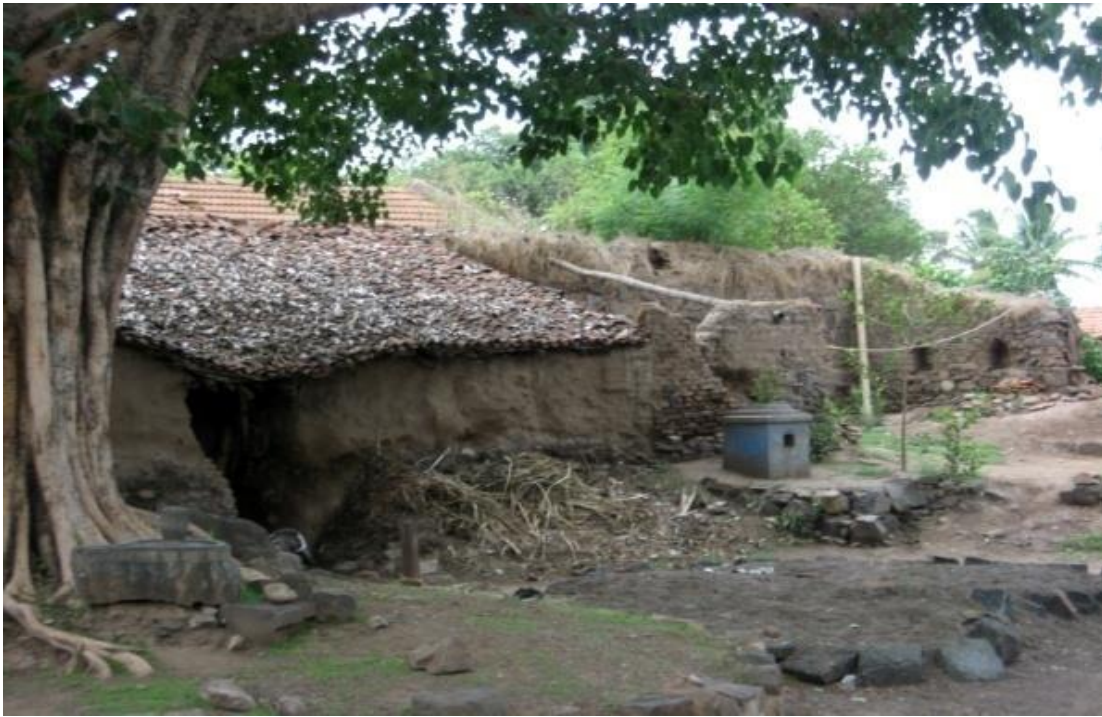
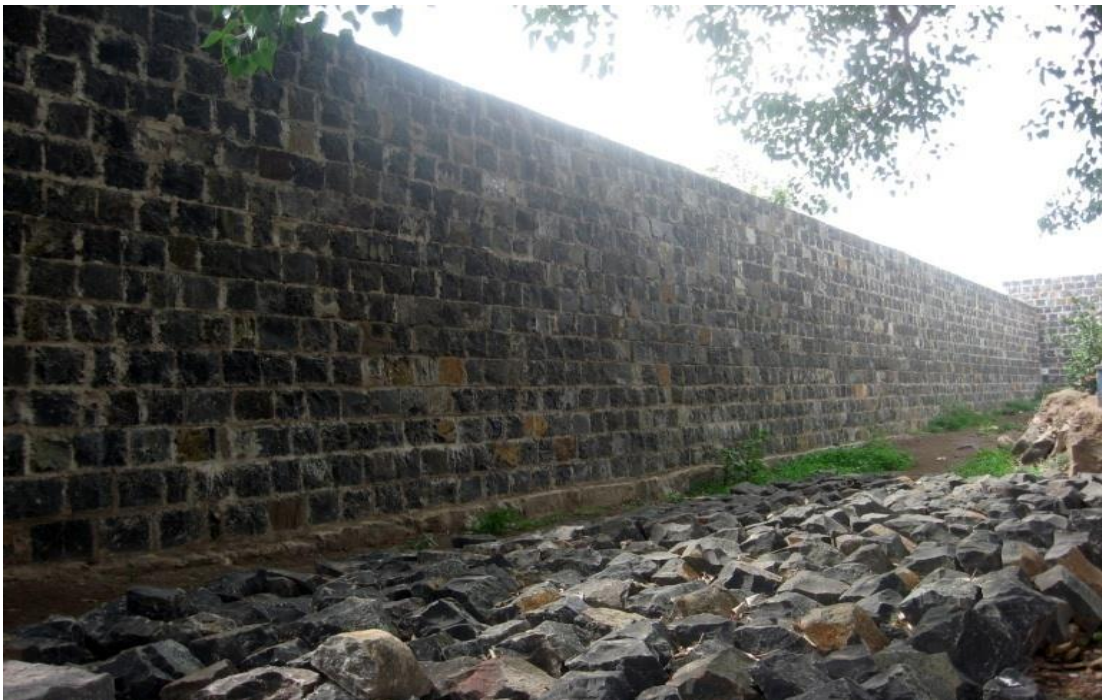
Khidrapur temple, Khidarpur: before and after construction of wall.

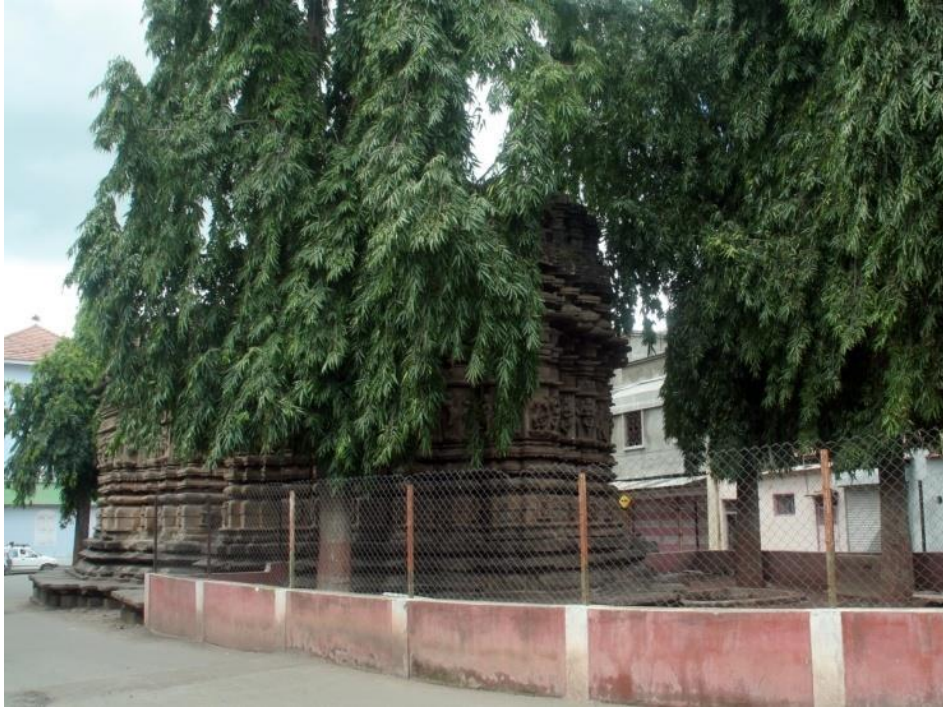
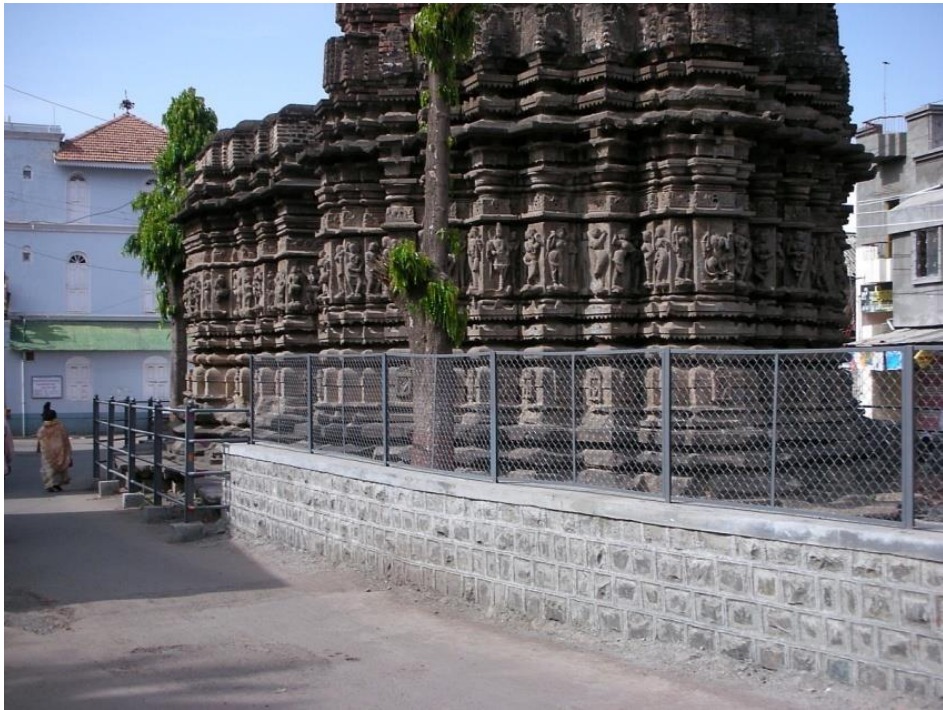
Plate 159

Jhabreshwar temple: before and after conservation .
