# INDIAN ARCHAEOLOGY 2007-08

## - A REVIEW

# INDIAN ARCHAEOLOGY 2007-08 - A REVIEW

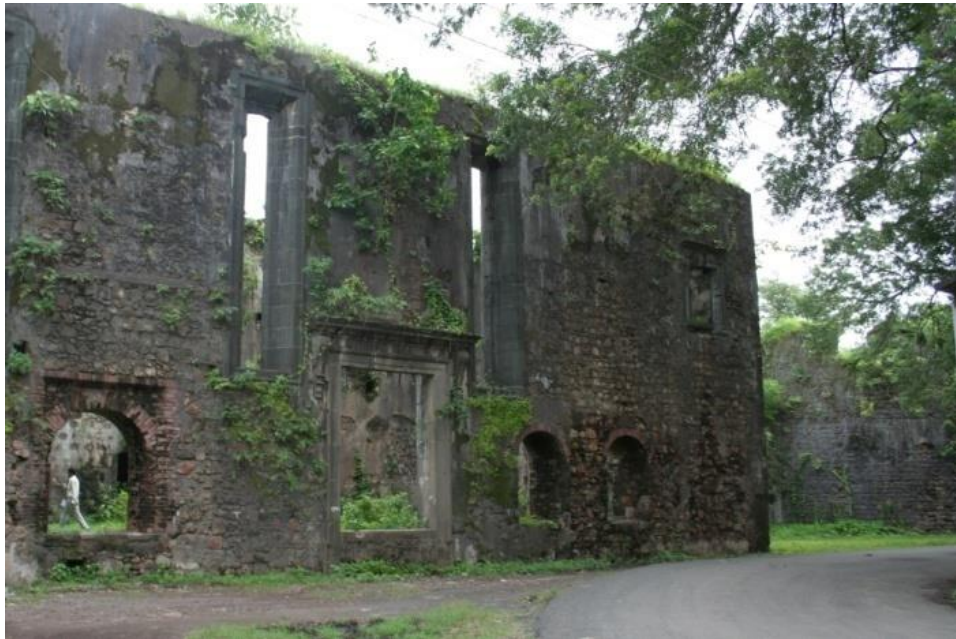
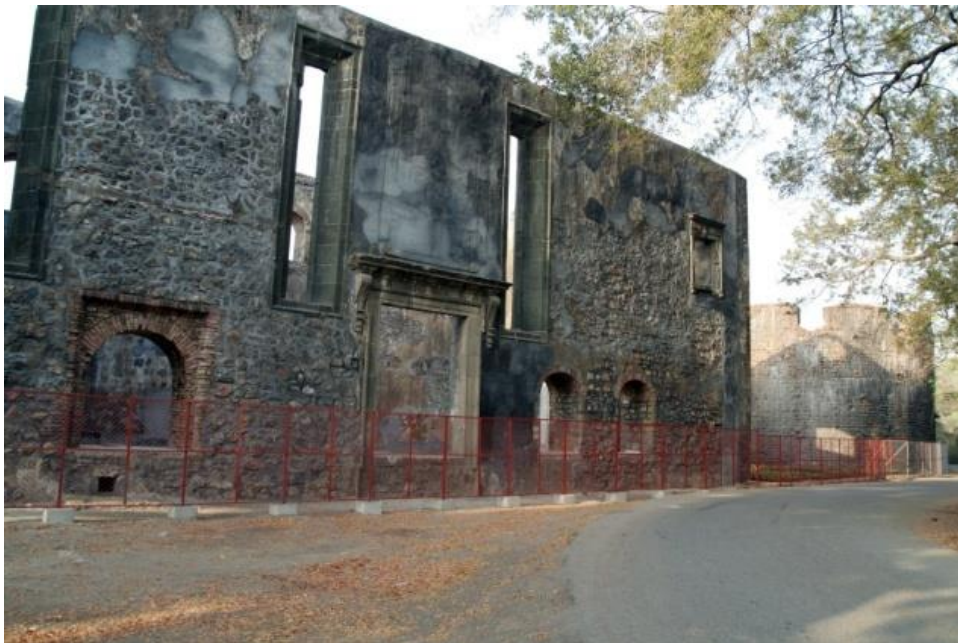
Plate 160

Bassien fort, Nossa Senhora: before and after conservation of Da Vida.

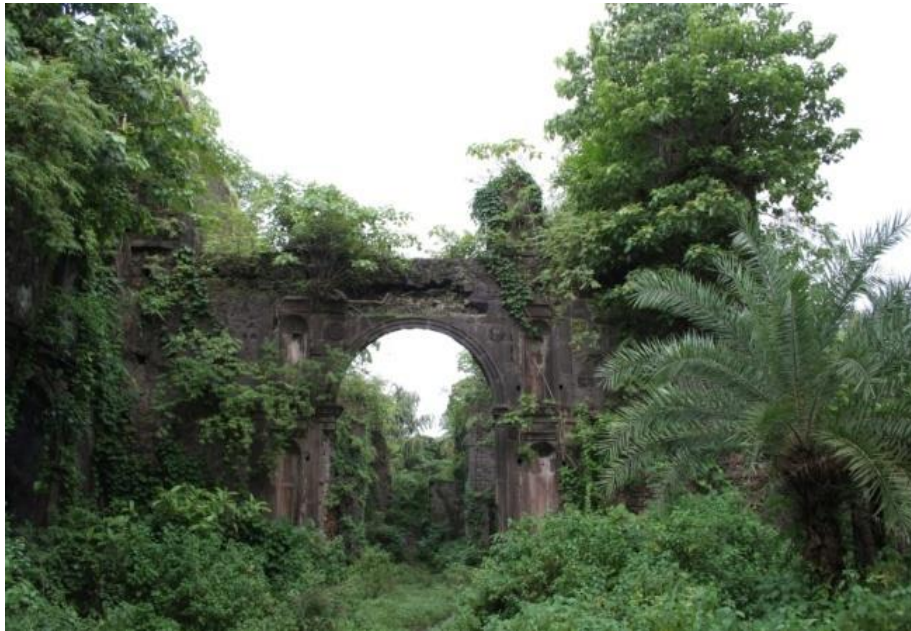
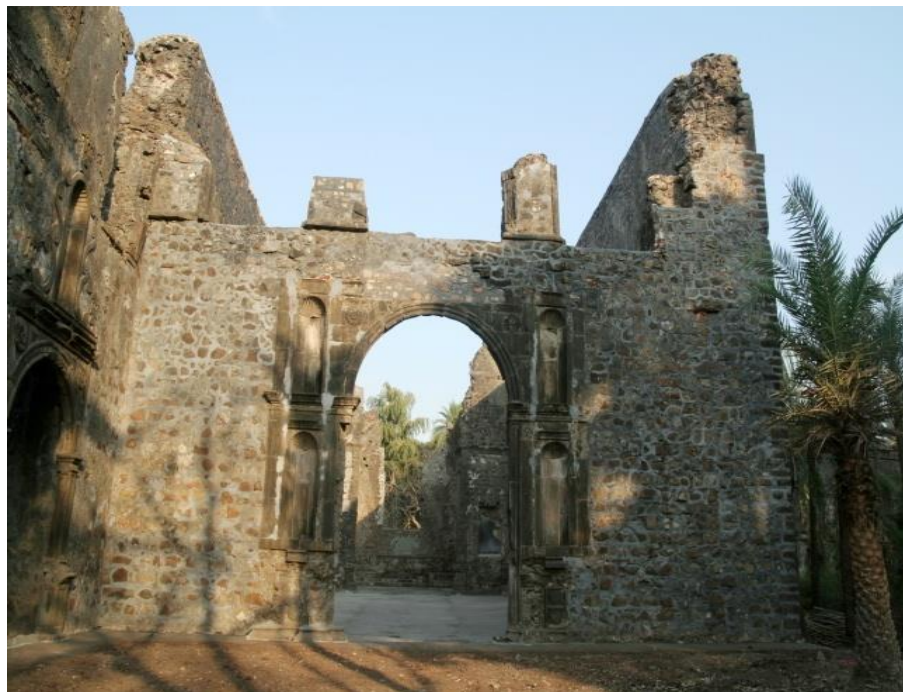
Dominican Church, Bassian fort: before and after conservation.

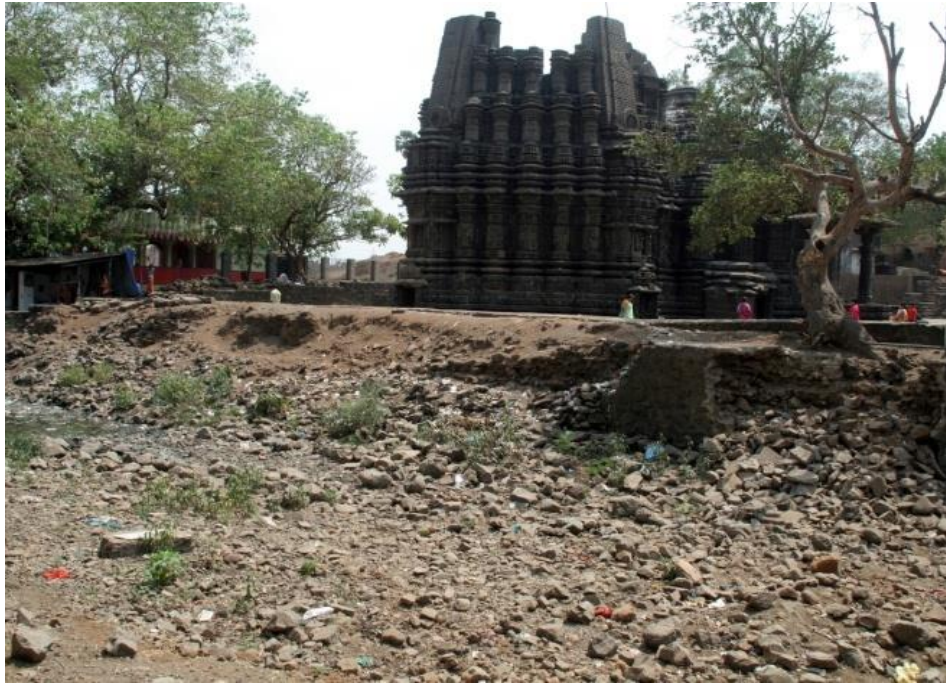
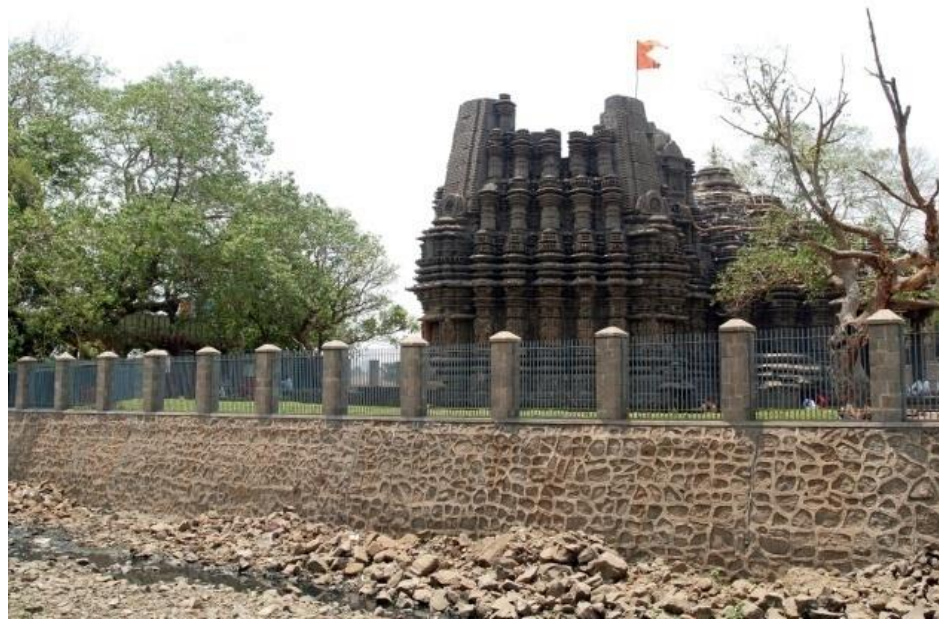
Plate 162

Temple of Ambarnath: before and after conservation.

In continuation to the earlier work, the replacement of the damaged barbed wire fencing with grill fencing over a stone masonry dwarf wall has been completed. The extension of the stone pavement in the outer courtyard of the temple on the northern, eastern and southern sides has been completed. The existing dilapidated store room in the south - western corner was removed and the work of re-erecting a shed to house the loose sculptures has also been completed. The reconstruction of the retaining wall on river side has been completed and the garden was laid on the northern and eastern side of the temple complex (pl. 162).

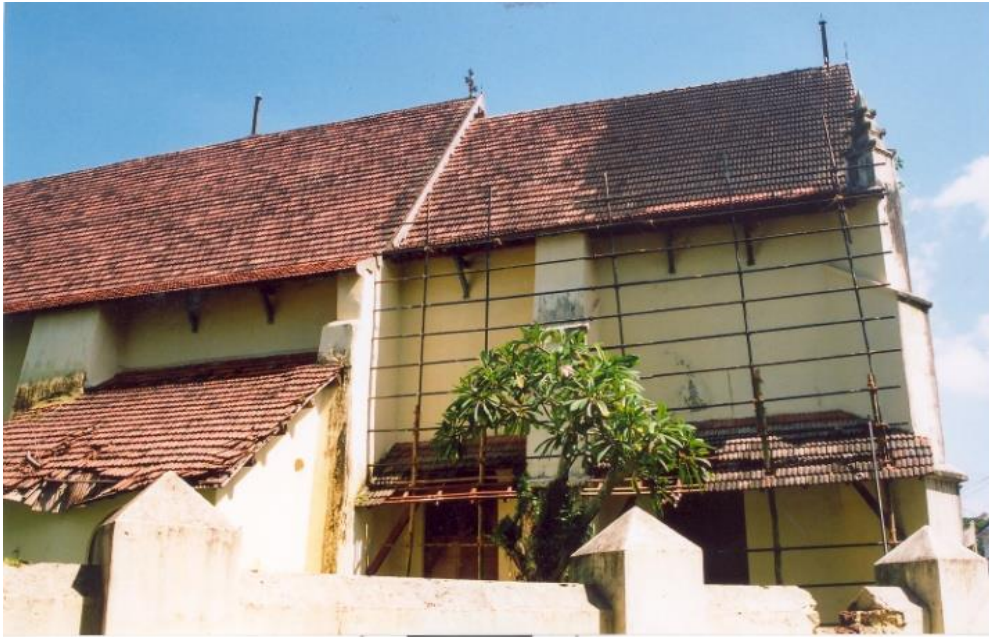
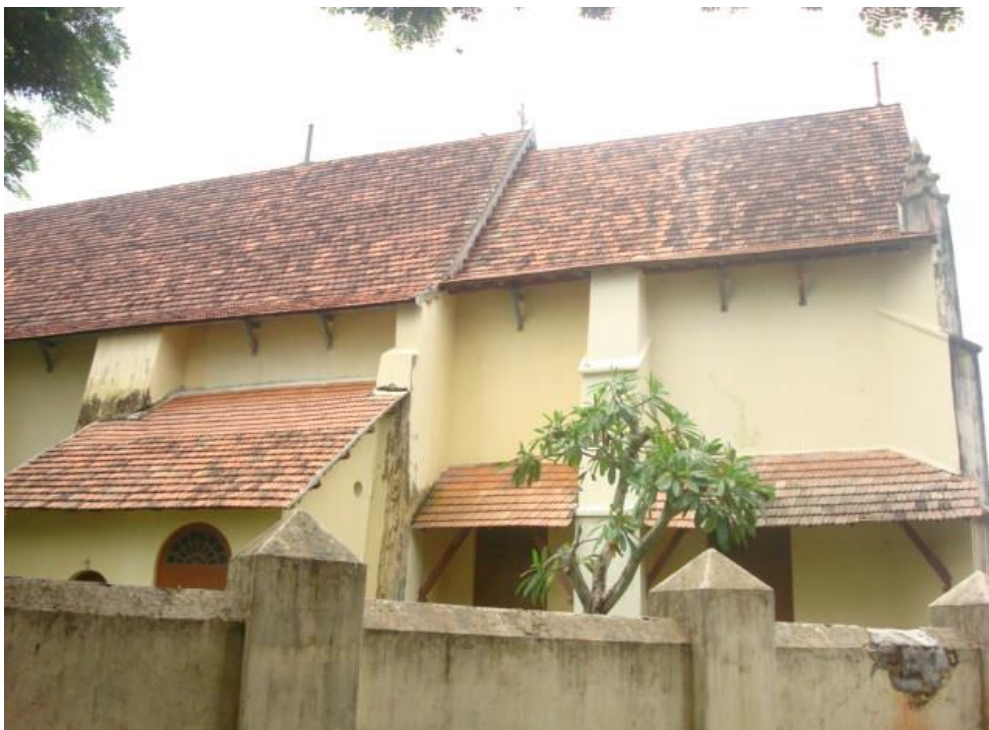
Plate 163

Kochi: before and after conservation of St. Francis Church.

The damaged old M.P tiles and reapers from the roof of the altar of the church were removed after thorough documentation. The old planks were repaired wherever possible and the totally damaged ones were replaced with new teak wood planks, and finally wood preservative oil was applied over the teak wood members. Over them ridge tiles were fixed (PI 163).

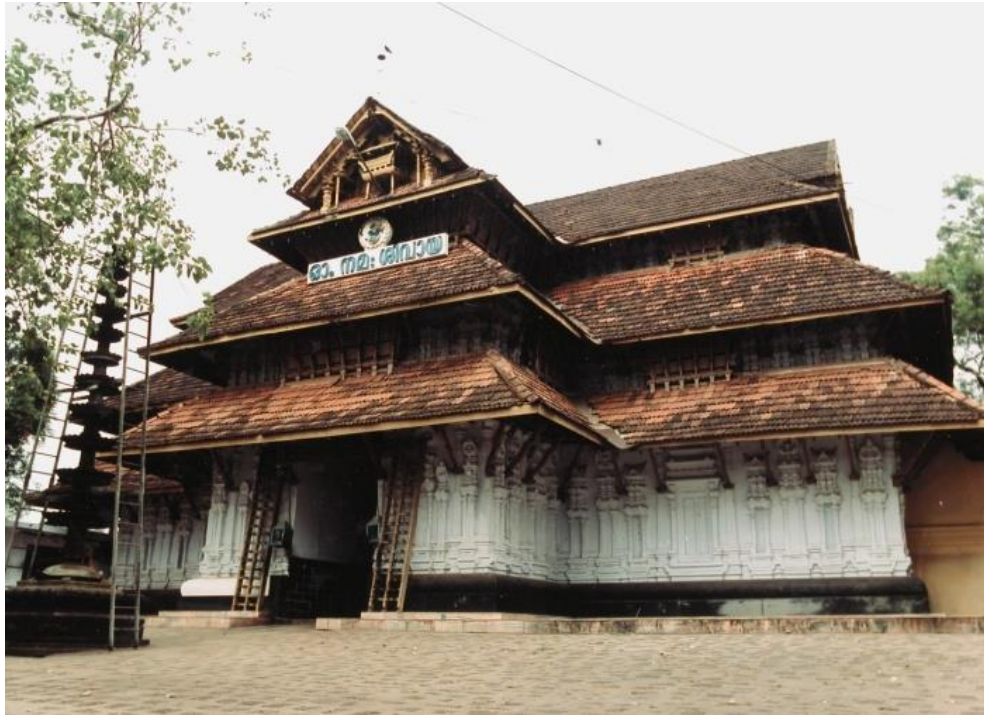
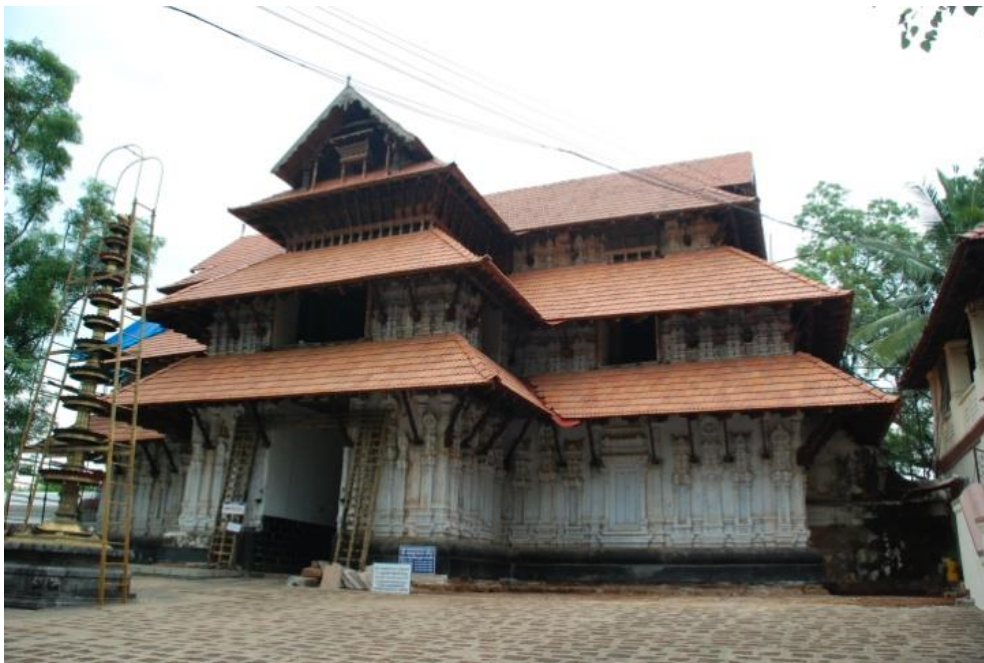
Vadakkumnatha temple, Thrissur: before and after conservation.

The restoration work of the western *gopuram* is in progress. The damaged / rotten roof members of the upper *tala* of the

*gopuram* such as rafters, beams, wall plates, vertical members etc were replaced with new teak wood members as per original design and clues. The reusable members were thoroughly repaired and strengthened by inserting new wooden pieces and joists etc. The architectural members of the uppermost roof such as wall plates beams, rafters were erected in its original position as per documentation carried out. Over the erected roof rafters of the *gopuram* repairing with new teak wood rafters has been carried out. Wood preservative oil was applied to all the architectural members of the upper *tala* of the *gopuram*. Mangalore pattern tiles were fixed on the roof of the *gopuram* uppermost tire in its original pattern and elevation (PI 164). Plastering work with special hand-ground lime mortar in the wall of upper *tala* wall is in progress. Replacement of old wooden members in the lower and middle *tala* with new ones as per original is in progress. The totally damaged pillars were replaced with new carved wooden pillars in lower and middle *tala* in place of damaged and missing members with original feature and old clue and design is in progress.

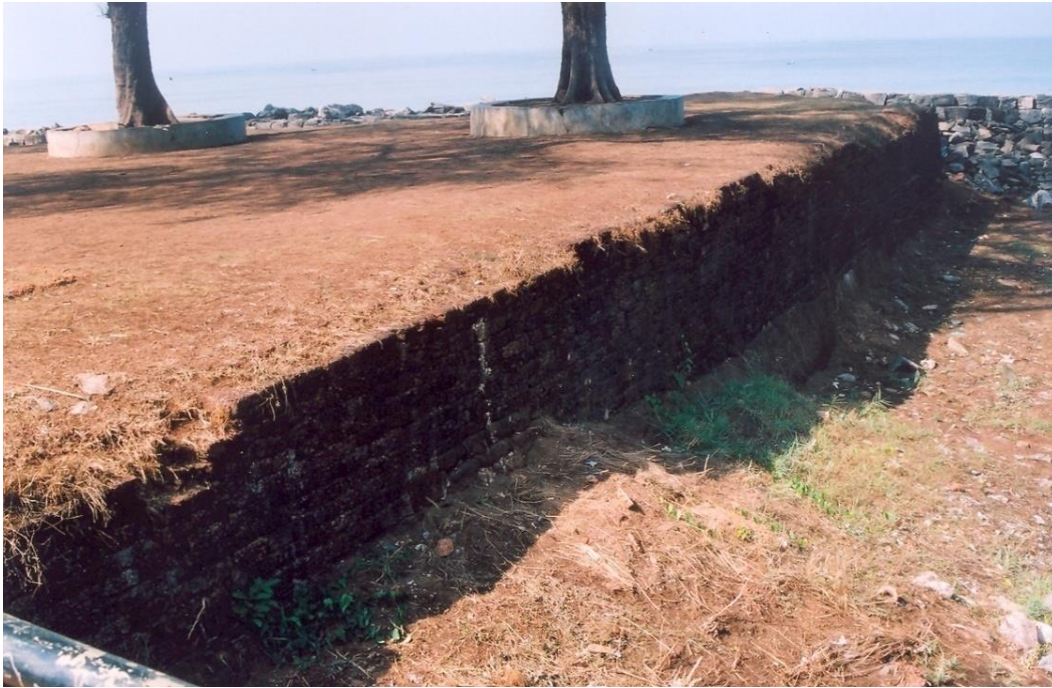
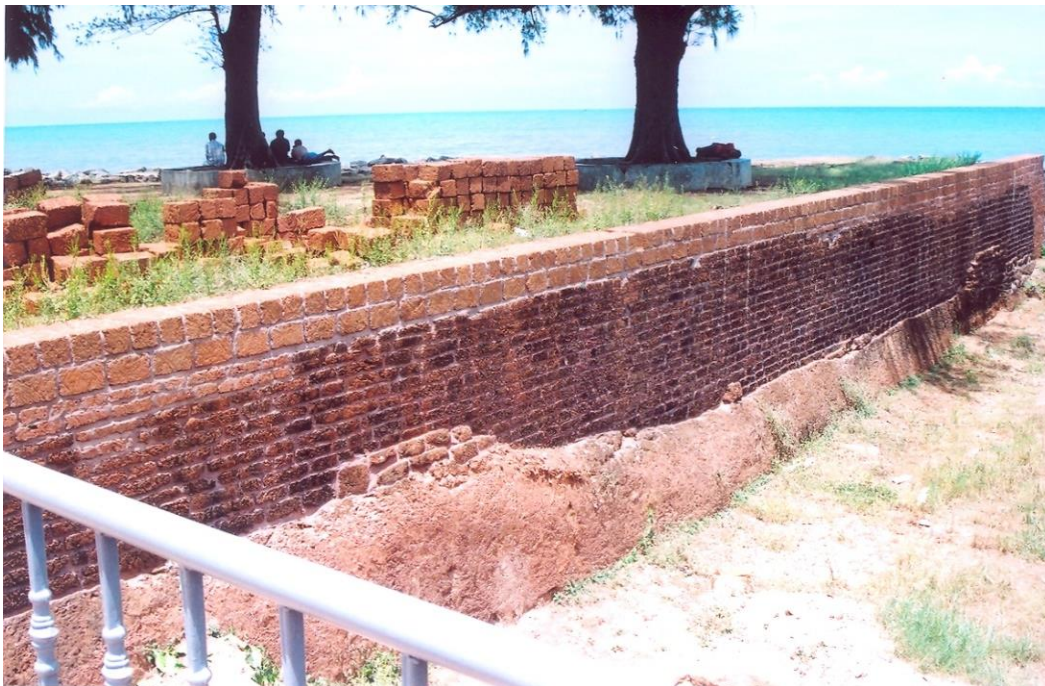
St. Angelo Fort, Kannur: before and after conservation.

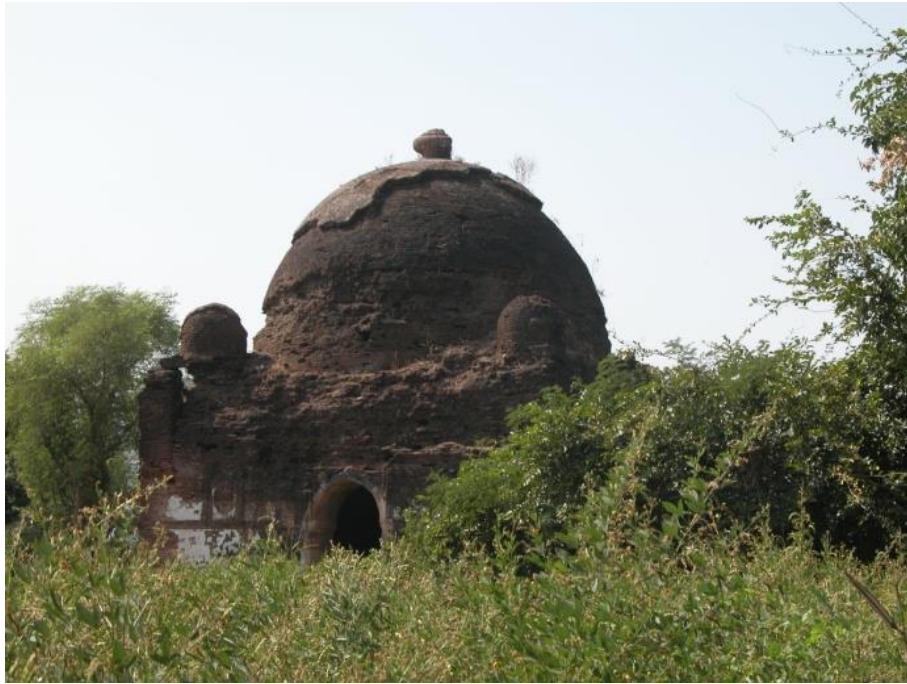
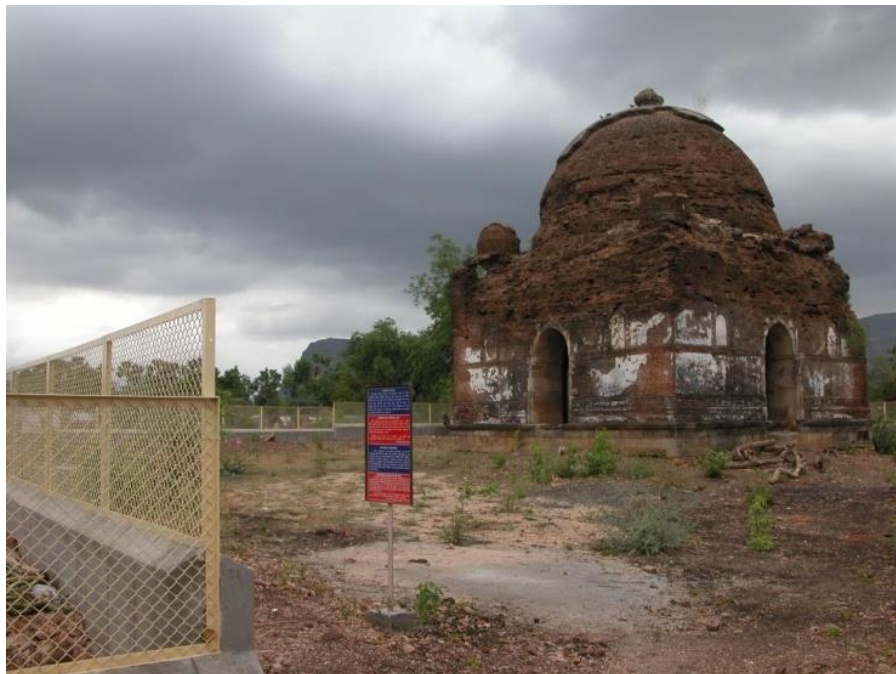
Plate 166

Champaner-Pavagadh: before and during conservation of brick dome.

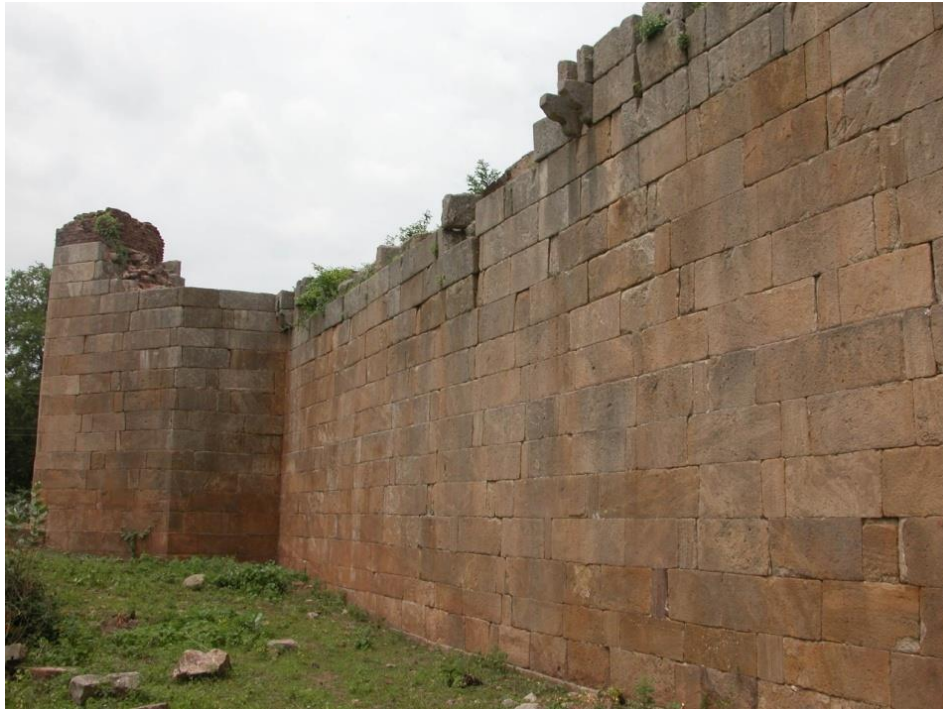
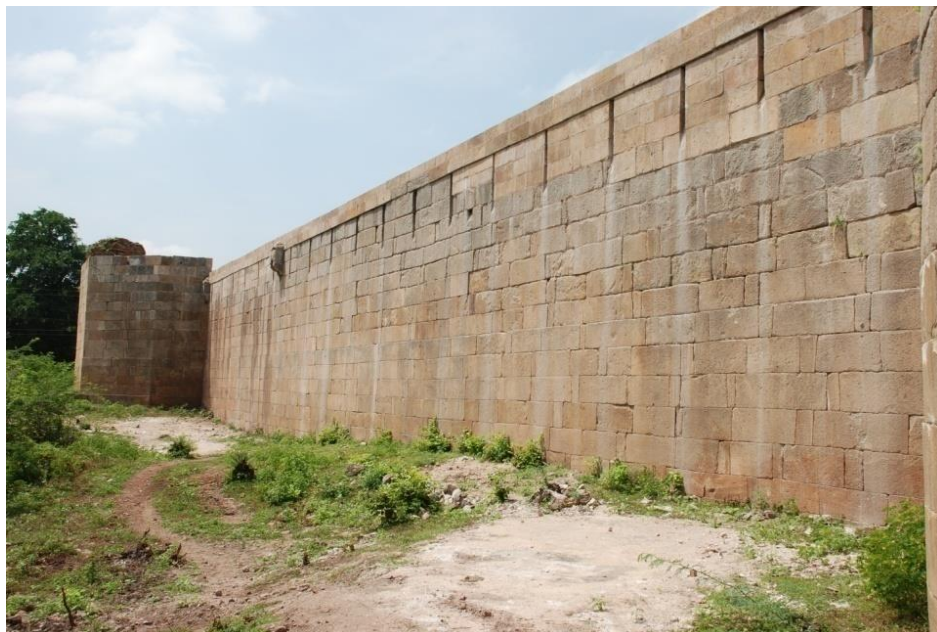
Dholka: before and after conservation of Citadel wall.
